Asbestos and Hazardous Materials Reinspection Assessment

Jindabyne Sports & Recreation Centre

The Barry Way

08/02/2023

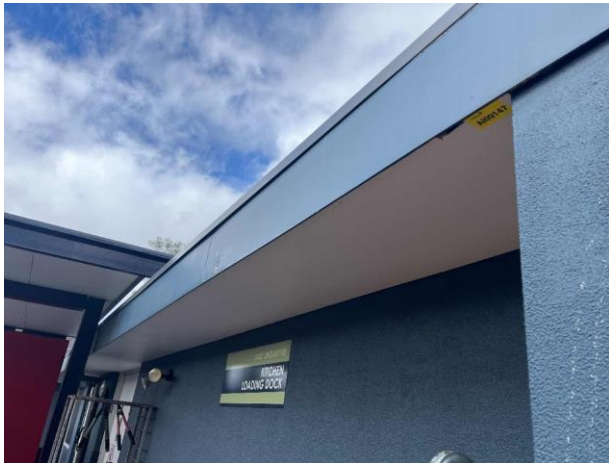
Line ID 4: External, Dining Hall, Loading Dock for Kitchen, Eaves and Fascia, Fibre Cement Sheet - No Asbestos Detected

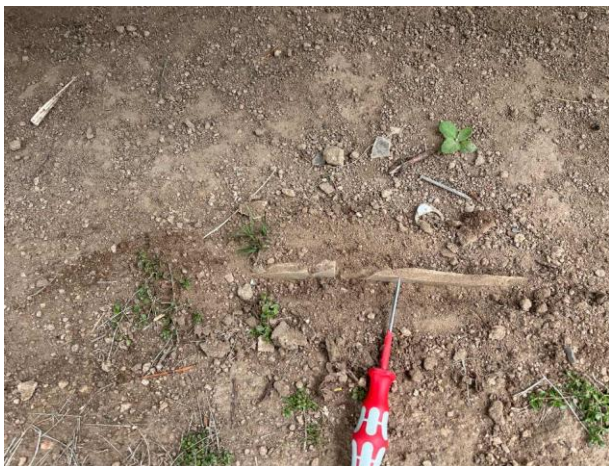
Line ID 15: External, Lodge 5, Building Perimeter, West End, Below Deck, Debris , Fibre Cement Sheet - Chrysotile Asbestos Detected

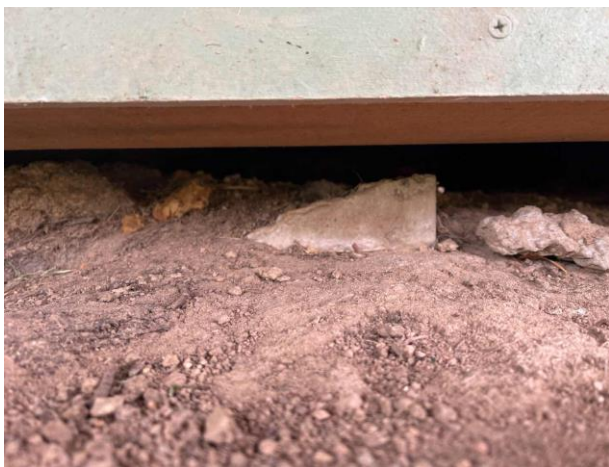
Line ID 15.2: External, Lodge 5, Building Perimeter, West End, Below Deck, Debris , Fibre Cement Sheet - Chrysotile Asbestos Detected

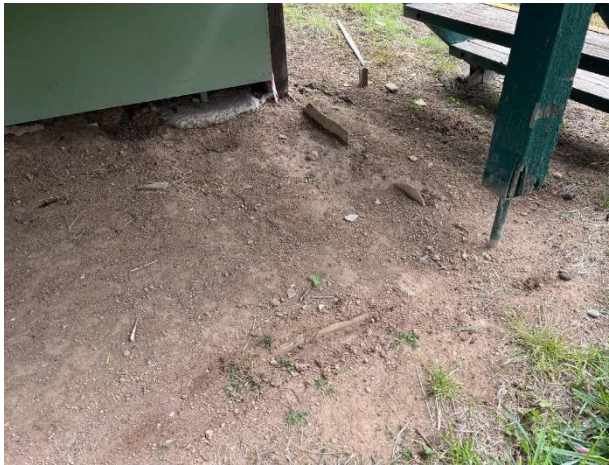
Line ID 16.1: External, Lodge 5, Building Perimeter, West End, Below Deck, in Soil, Fibre Cement Sheet - Chrysotile Asbestos Detected

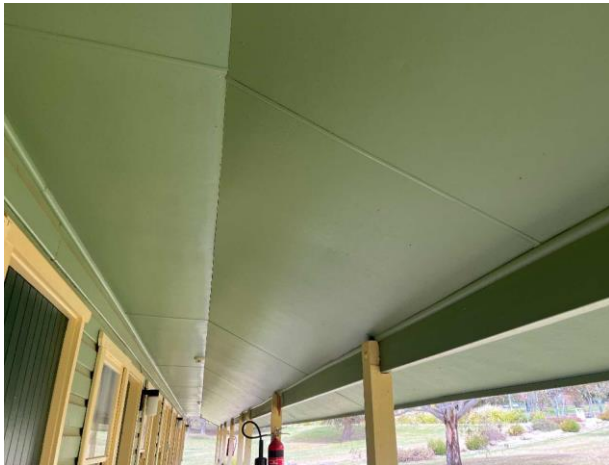
Line ID 18: External, Lodge 5, Veranda, Eave and Ceiling Lining, Fibre Cement Sheet - No Asbestos Detected

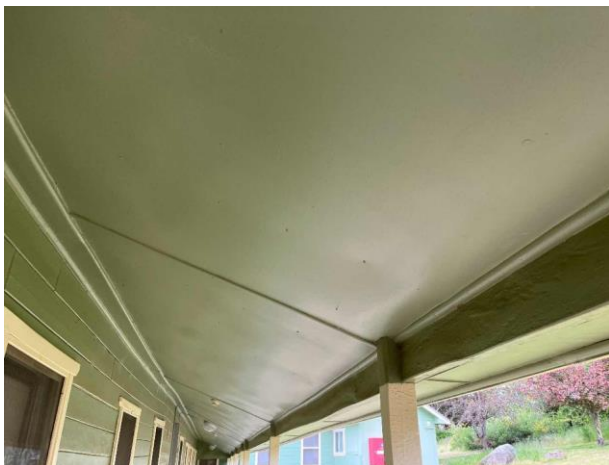
Line ID 20: External, Lodge 6, Accommodation Block, Eave and Veranda Ceiling, Fibre Cement Sheet - No Asbestos Detected

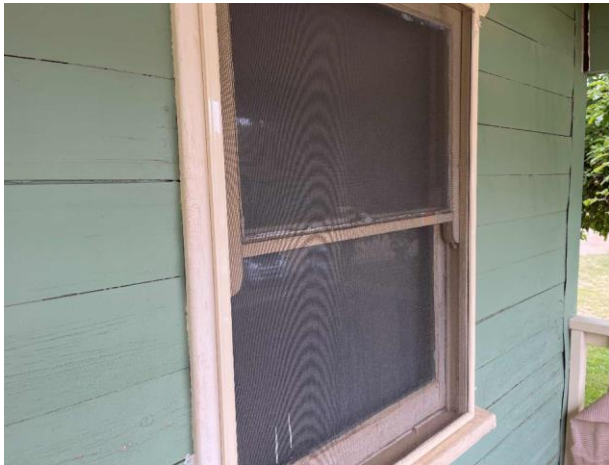
Line ID 22: External, Lodge 6, Rear Standalone House, Window Frames, Window Caulking - No Asbestos Detected

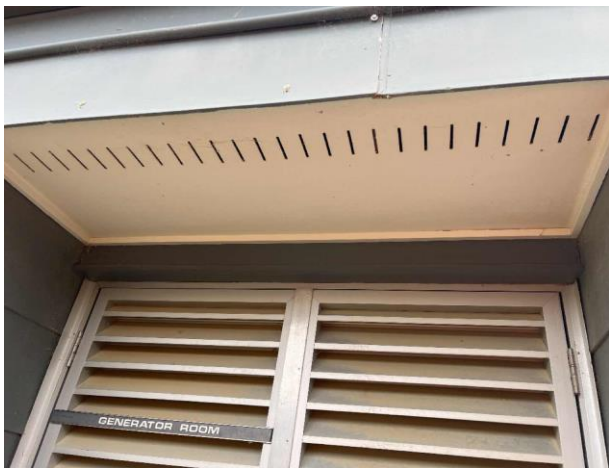
Line ID 25: External, Maintenance, Covered Walkway, Porch Ceiling, Fibre Cement Sheet - Chrysotile Asbestos Detected

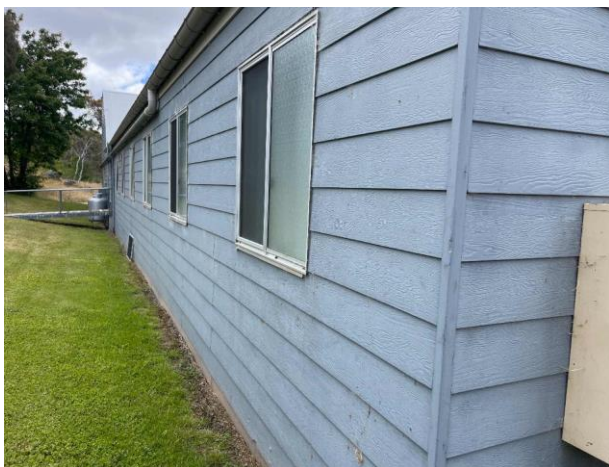
Line ID 27: External, Margin Lodge, Covered Walkways, Walls, Weatherboard Cladding, Fibre Cement Sheet - No Asbestos Detected

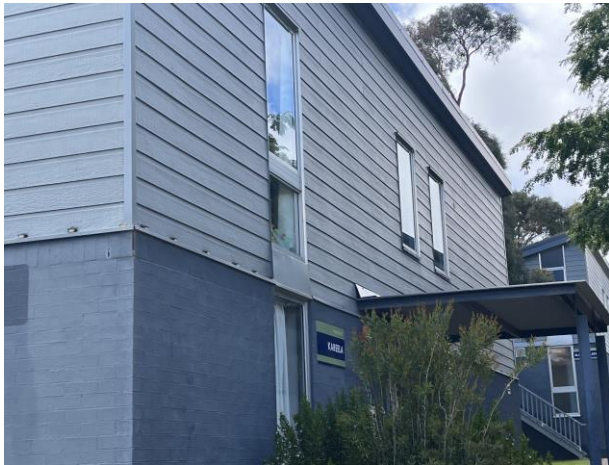
Line ID 32: External, Student Lodges, Kareela Lodge, Outer Walls, Weatherboard, Fibre Cement Sheet - No Asbestos Detected

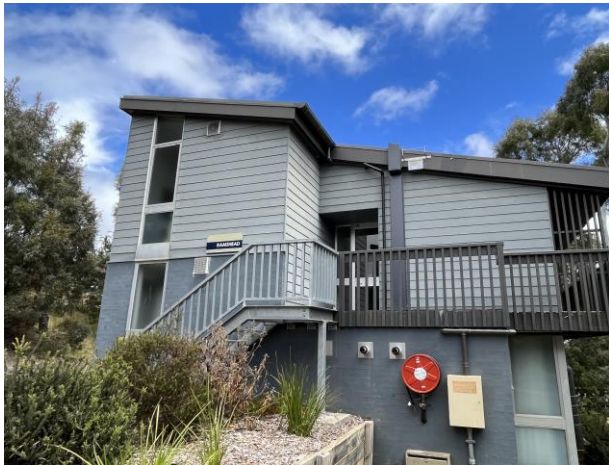
Line ID 36: External, Student Lodges, Ramshead Lodge, Outer Walls, Weatherboard, Fibre Cement Sheet - No Asbestos Detected

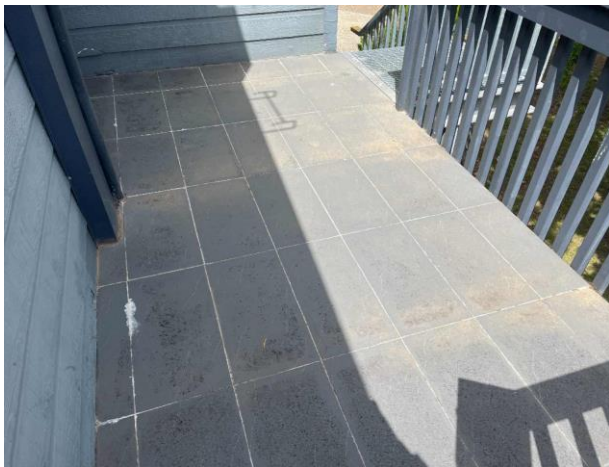
Line ID 39: External, Student Lodges, Snowgums Lodge, Side Entrance to Level 1, Below Tiles to Deck, Compressed Cement Sheeting - Chrysotile Asbestos Detected

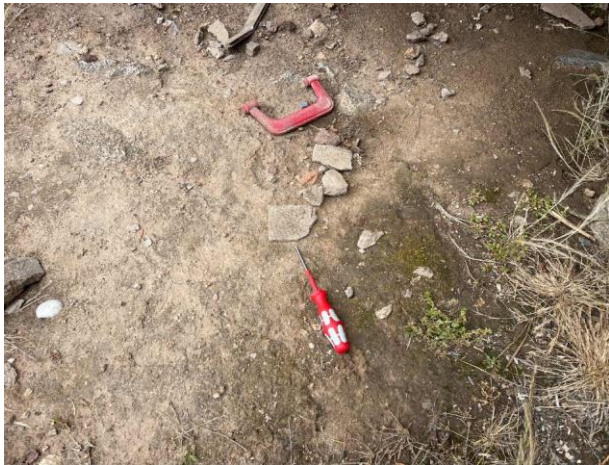
Line ID 40.1: External, TAFE, Classroom Building, Adjacent Puzzle Room Entry, Ground, Fibre Cement Sheet Debris - Chrysotile & Amosite Asbestos Detected

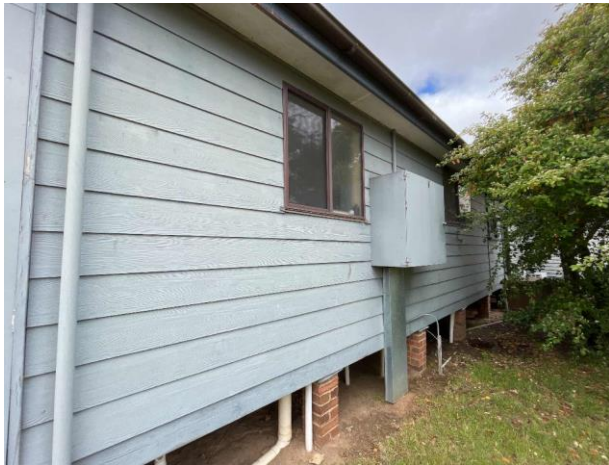
Line ID 44: External, TAFE, Classroom Building, North East Area, Weatherboard, Fibre Cement Sheet - No Asbestos Detected

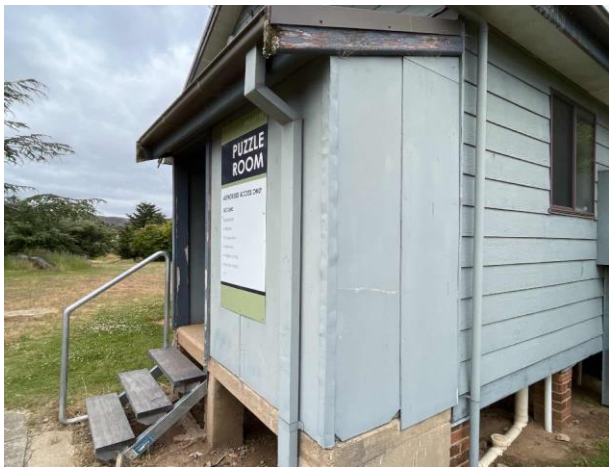
Line ID 46: External, TAFE, Classroom Building, Puzzle Room, Wall Panels, Fibre Cement Sheet - Chrysotile & Amosite Asbestos Detected

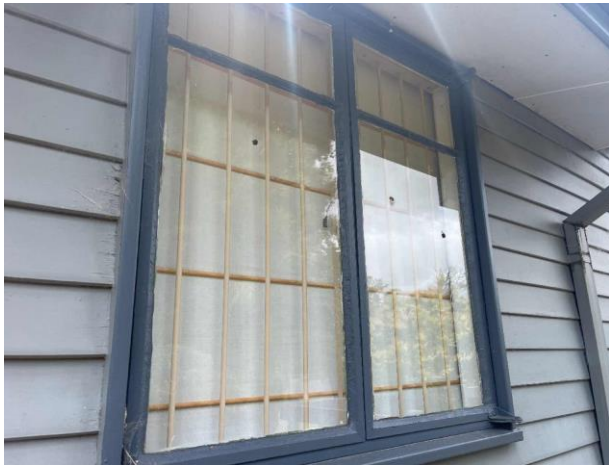
Line ID 49: External, TAFE, Classroom Building, Window Frames, Window Caulking - Chrysotile Asbestos Detected

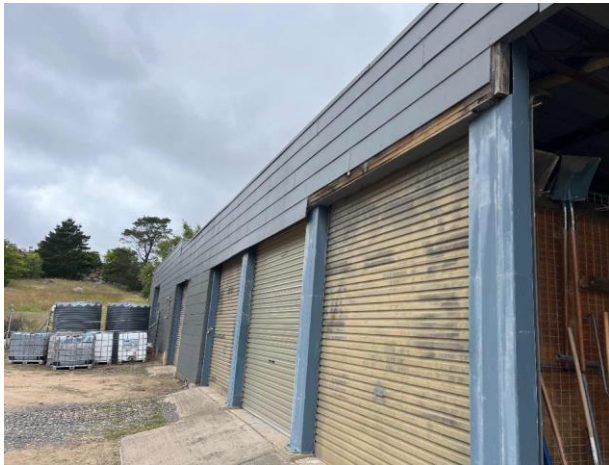
Line ID 52: External, Workshop, Roller Door Area, Wall Panels, Fibre Cement Sheet - Chrysotile Asbestos Detected

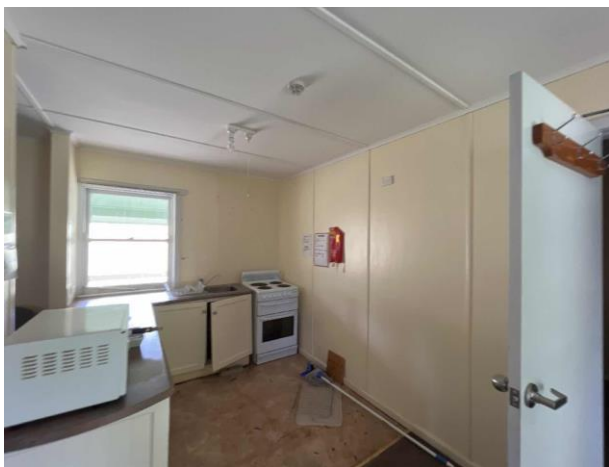
Line ID 55: Internal, Lodge 5, Common Room, Wall and Ceiling Lining, Fibre Cement Sheeting - No Asbestos Detected

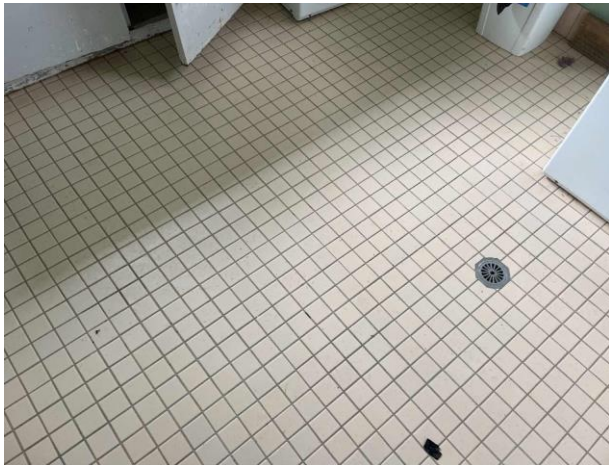
Line ID 57: Internal, Lodge 6, Laundry, Below Ceramic Tiles to Floor, Compressed Cement Sheet - Suspected Asbestos

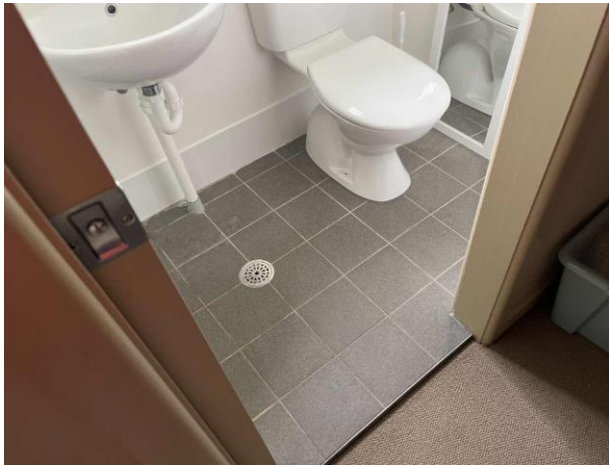
Line ID 59: Internal, Lodge 6, Rear Standalone House, Bathroom, Below Ceramic Tiles to Floor, Compressed Cement Sheet - Suspected Asbestos

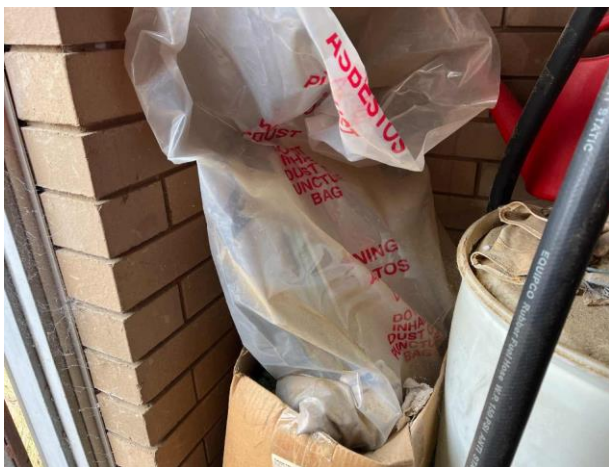
Line ID 61: Internal, Maintenance, Chemical Store, Waste Bag of Asbestos Adjacent Entry Door, Fibre Cement Sheet - Suspected Asbestos

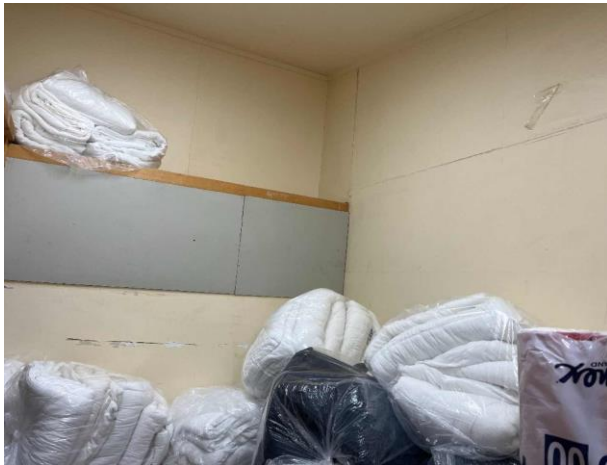
Line ID 63: Internal, Maintenance, Generator Room, Wall Lining, Fibre Cement Sheet - Chrysotile Asbestos Detected

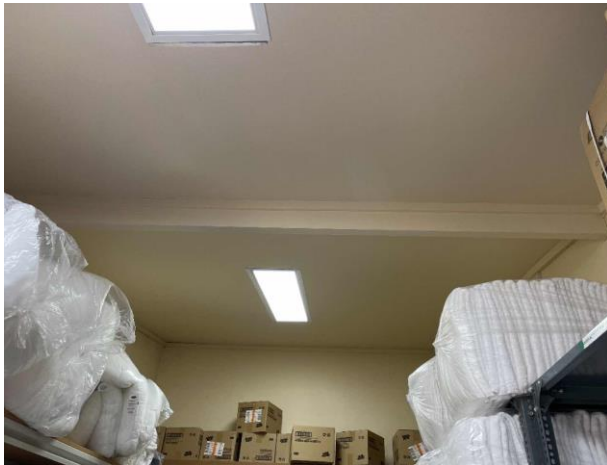
Line ID 65: Internal, Maintenance, Laundry, Ceiling Lining, Fibre Cement Sheet - Chrysotile Asbestos Detected

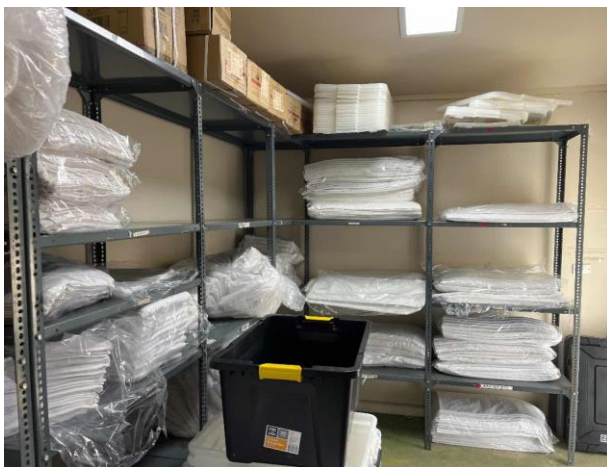
Line ID 66.1: Internal, Maintenance, Laundry, Wall Lining, Fibre Cement Sheet - Chrysotile Asbestos Detected

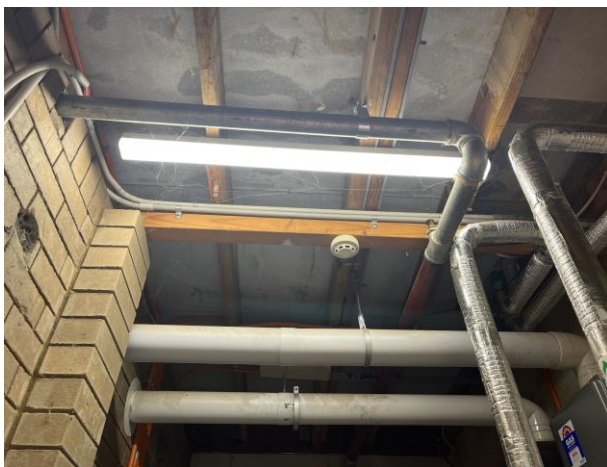
Line ID 106: Internal, Student Lodges, Kareela Lodge, Basement Plant Room, High Ceiling Lining, Compressed Cement Sheetting - Chrysotile Asbestos Detected

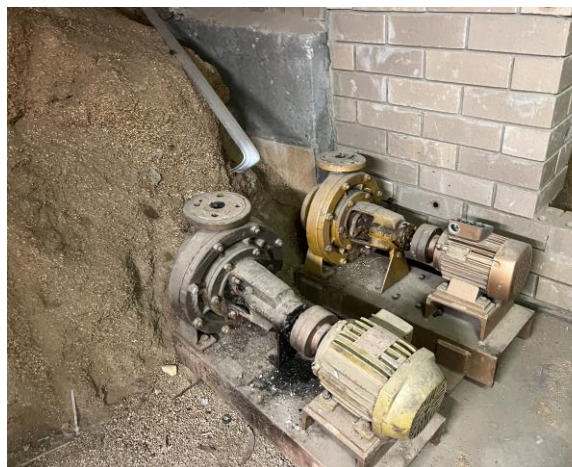
Line ID 112: Internal, Student Lodges, Kareela Lodge, Redundant Plant Equipment, Loose Gasket , Gasket Material - Chrysotile Asbestos Detected

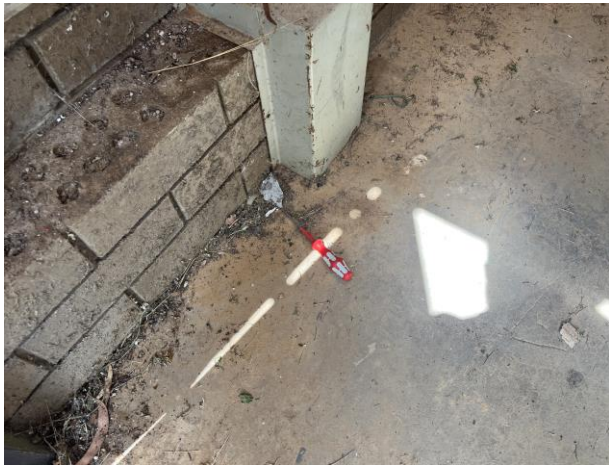
Line ID 114: Internal, Student Lodges, Merritts Lodge, Basement Plant Room, Adjacent Brick Pillar, Compressed Cement Sheeting Debris - Chrysotile Asbestos Detected

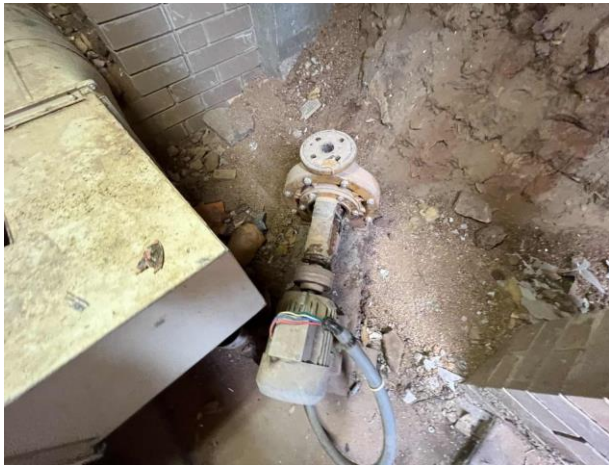
Line ID 142: Internal, Student Lodges, Snowgums Lodge, Redundant Plant Equipment, Loose Gasket , Gasket Material - Chrysotile Asbestos Detected

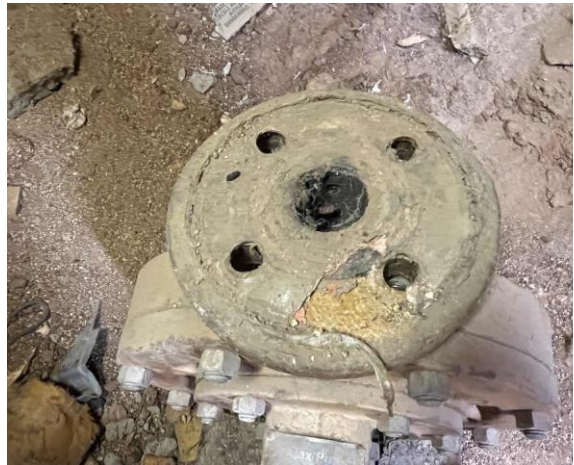
Line ID 142.1: Internal, Student Lodges, Snowgums Lodge, Redundant Plant Equipment, Loose Gasket , Gasket Material - Chrysotile Asbestos Detected

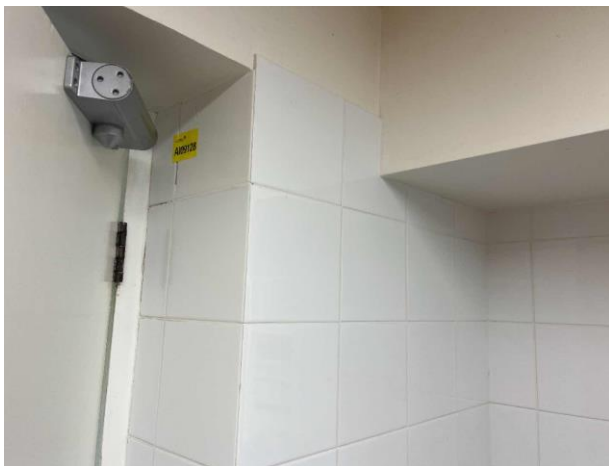
Line ID 143: Internal, Student Lodges, Snowgums Lodge, Toilets, Walls Behind Tiles, Fibre Cement Sheet - No Asbestos Detected

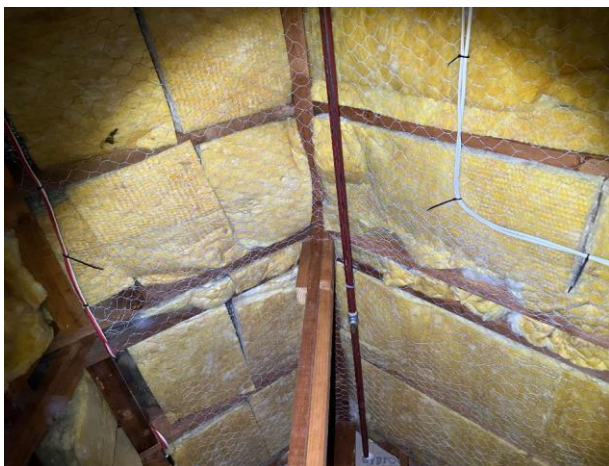
Line ID 166.1: Internal, Margin Lodge, Ceiling Void, Wall and Roof Lining, Insulation Batts - Suspected SMF

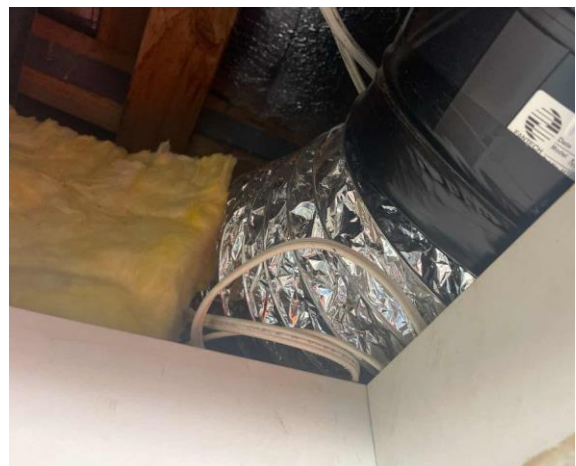
Line ID 167: Internal, Milton Lodge, Accommodation Block, Air Conditioning Ductwork, Insulation Material - Suspected SMF

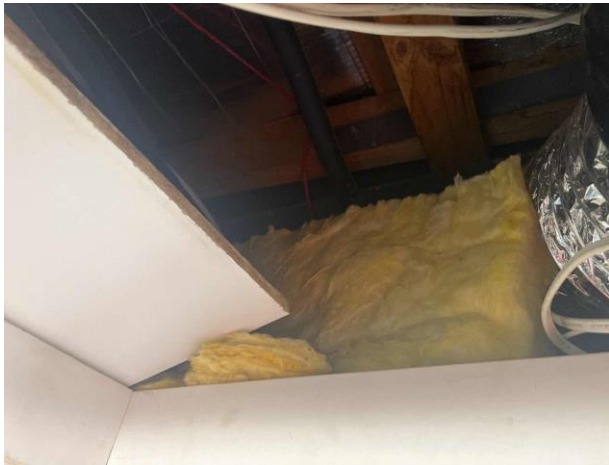
Line ID 168: Internal, Milton Lodge, Accommodation Block, Ceiling Void, Insulation Batts - Suspected SMF
