## Office of Sport

# Asbestos and Hazardous Materials Reinspection Assessment V2

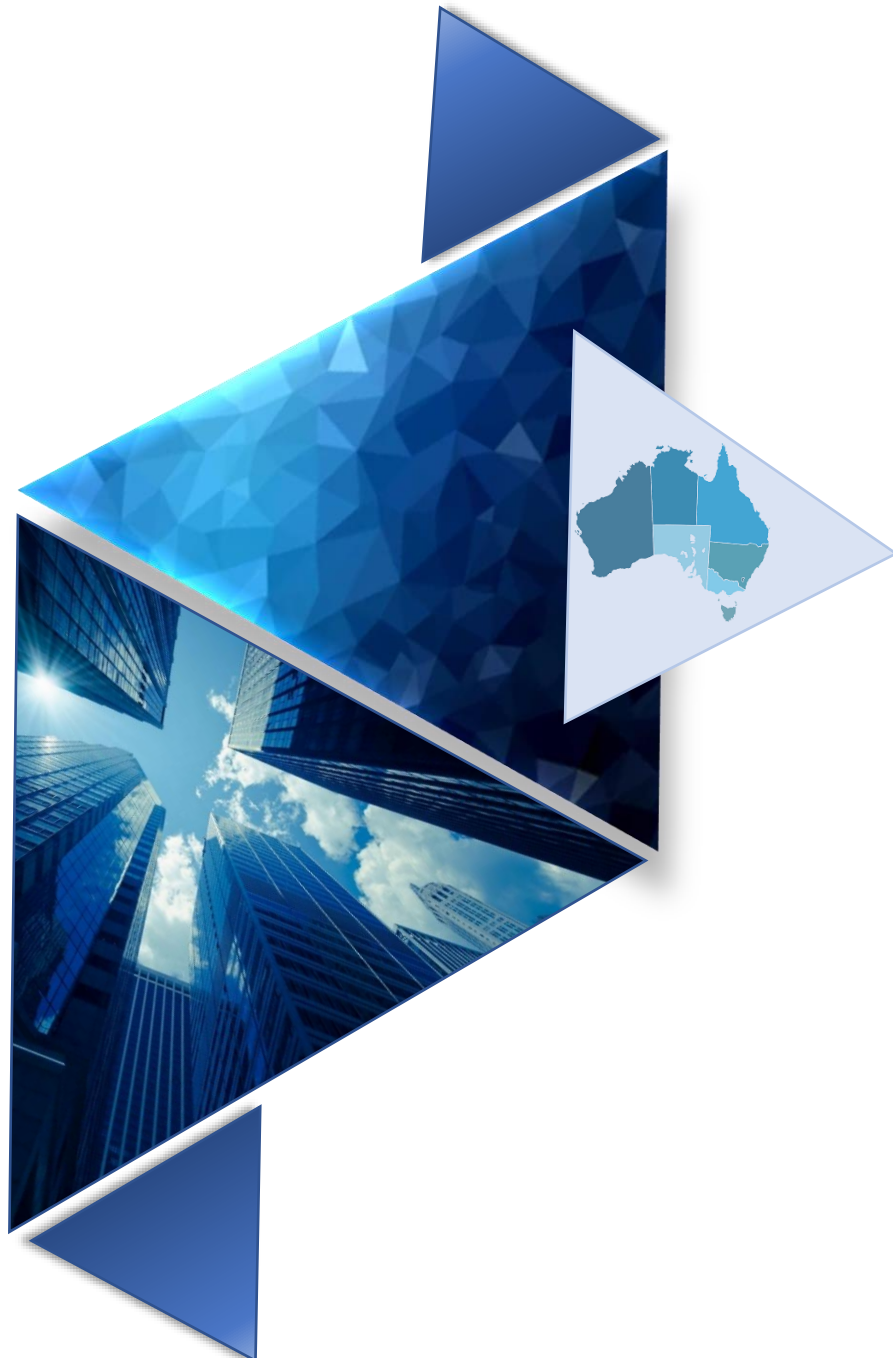
This page has been left intentionally blank

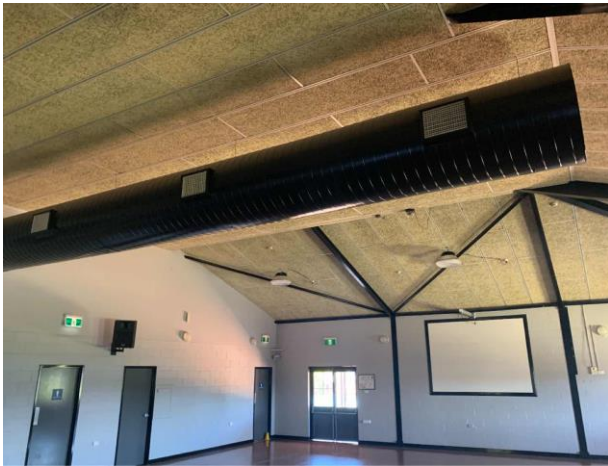
Line ID 153: Internal, Homestead, Throughout, Ceiling Space, Air Conditioning Ductwork, Insulation Material - Suspected SMF

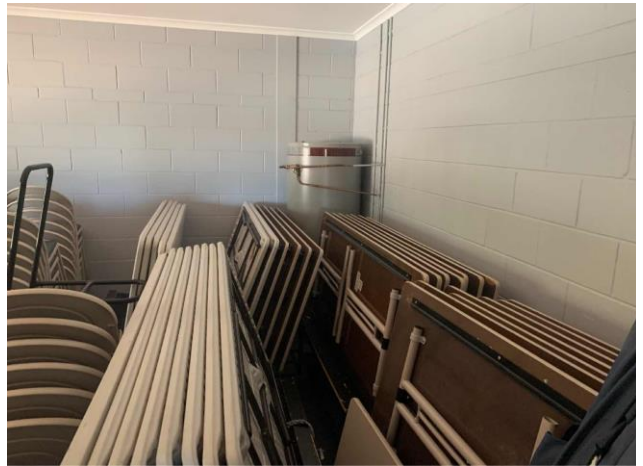
Line ID 154: Internal, Homestead, Throughout, Chair Storage Room, Hot Water Heater, Internal Insulation - Suspected SMF

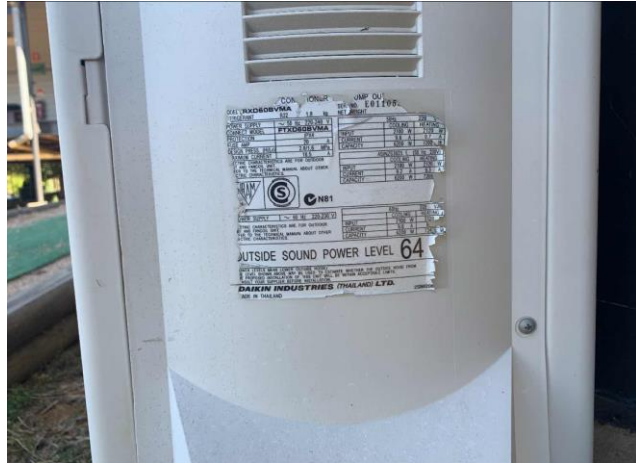
Line ID 164: External, Lodges Inc. Dilapidated Toilet B, Elevations, North, Air Conditioning Unit, R22 Hydrochlorofluorocarbon (HCFC) - ODS Refrigerant

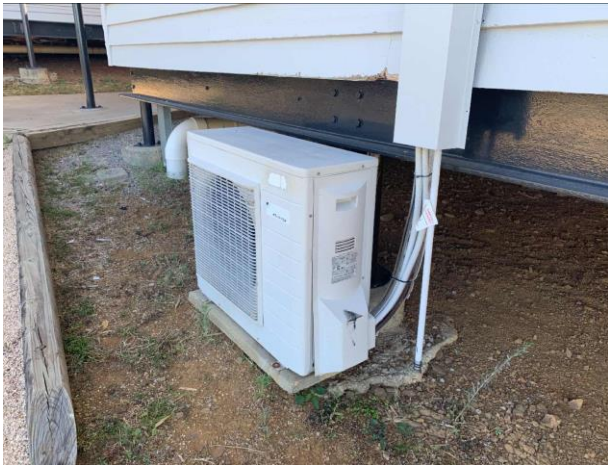
Line ID 164.1: External, Lodges Inc. Dilapidated Toilet B, Elevations, North, Air Conditioning Unit, R22 Hydrochlorofluorocarbon (HCFC) - ODS Refrigerant

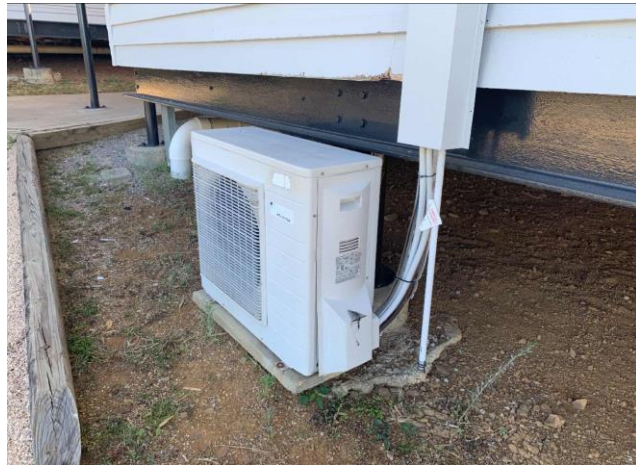
Line ID 165: External, Lodges Inc. Dilapidated Toilet B, Block C, South Elevation, Air Conditioning Units, R22 Hydrochlorofluorocarbon (HCFC) - ODS Refrigerant

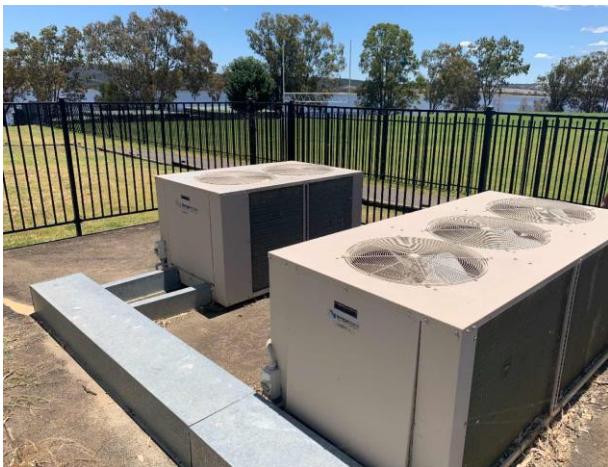
Line ID 166: External, Pool Pump House, Awning North Adjacent to Pool, HVAC Enclosure, Compressor Units, Unknown Refrigerant - Suspected ODS

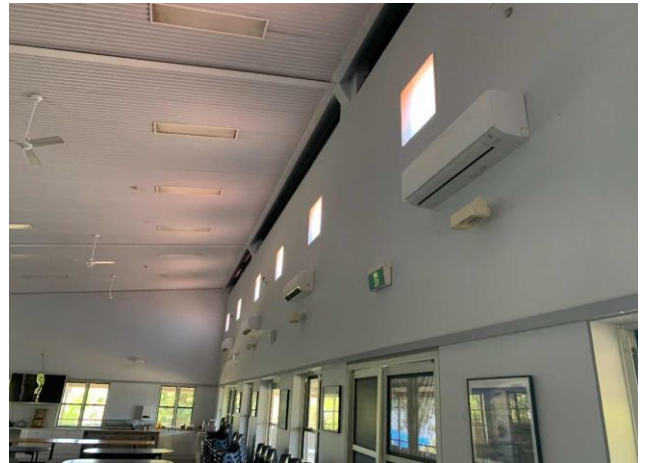
Line ID 169: Internal, Dining Hall, Throughout, Air Conditioning Units, Unknown Refrigerant - Suspected ODS

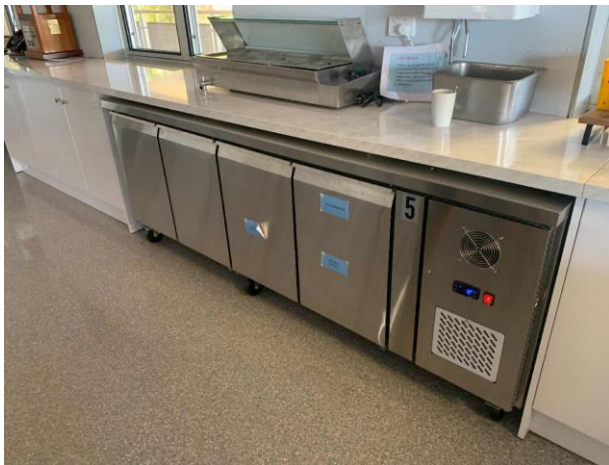
Line ID 170: Internal, Dining Hall, Throughout, Kitchen, Refrigeration Units, Unknown Refrigerant - Suspected ODS

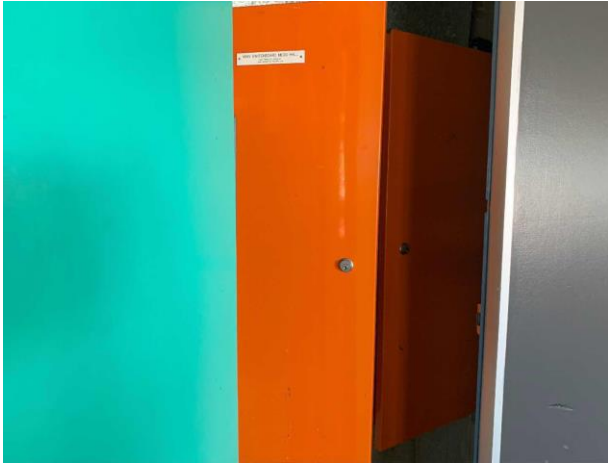
Line ID 176: Internal, Dining Hall, Basement, Within Closet and Roller Storage Area, Electrical Boxes - Presumed to contain asbestos or hazardous materials

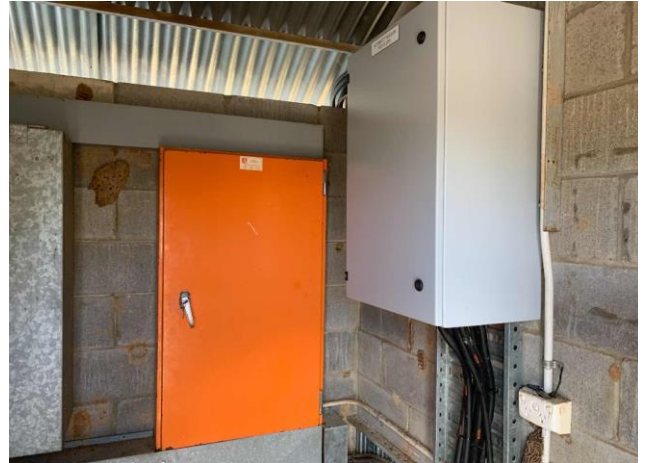
Line ID 176.1: Internal, Dining Hall, Basement, Within Closet and Roller Storage Area, Electrical Boxes - Presumed to contain asbestos or hazardous materials

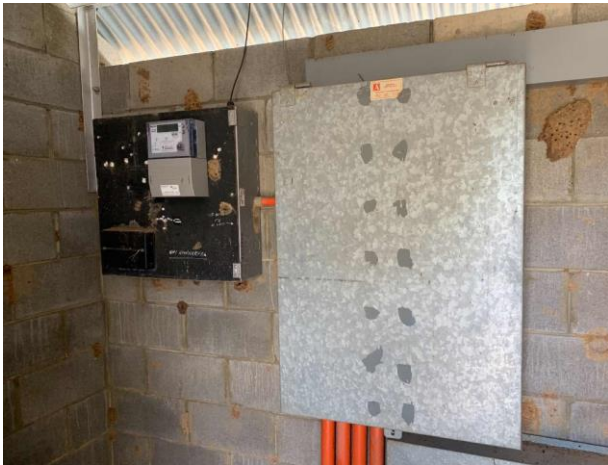
Line ID 176.2: Internal, Dining Hall, Basement, Within Closet and Roller Storage Area, Electrical Boxes - Presumed to contain asbestos or hazardous materials

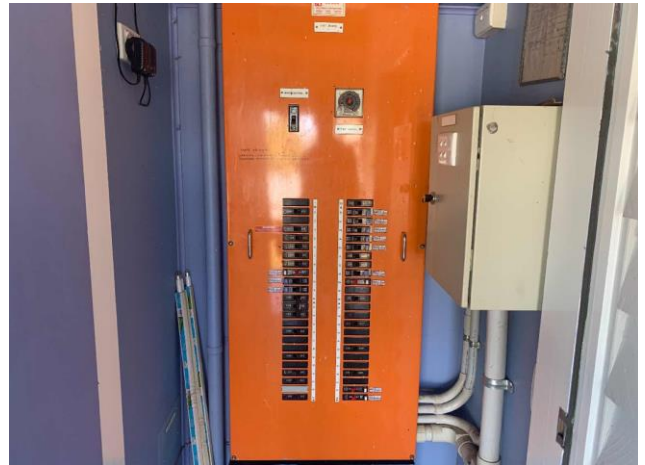
Line ID 181: Internal, Lodges Inc. Dilapidated Toilet Block, Block A, Central, Closet, Electrical Box - Presumed to contain asbestos or hazardous materials

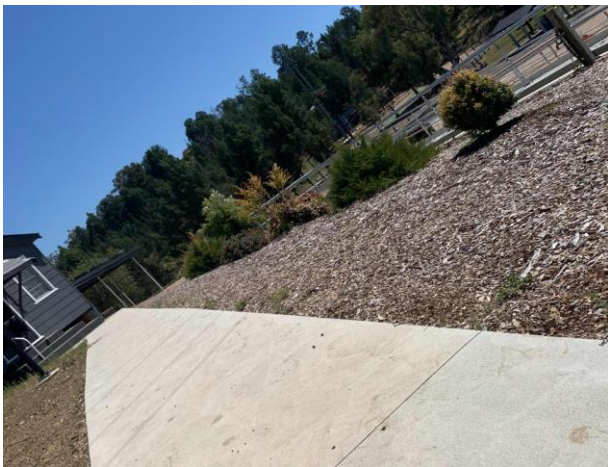
Line ID 184: Internal, Old Female Toilet Block, Throughout - Previously Demolished
