Asbestos and Hazardous Materials Reinspection Assessment

Lake Burrendong Sport and Recreation Centre

205 Tara Road

08/02/2023

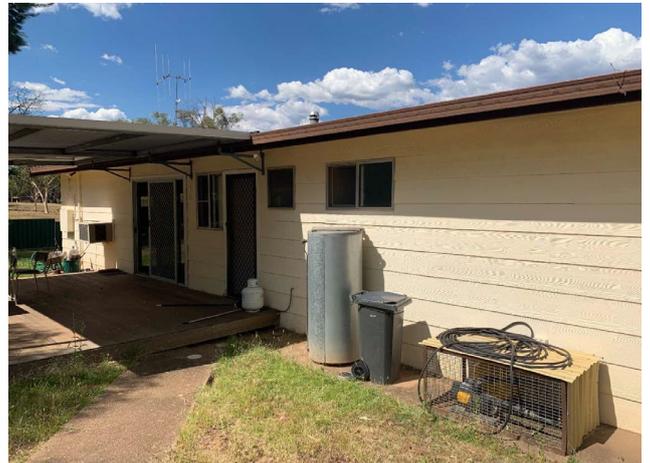
Line ID 6: External, Client Services Coordinator Residence, Garage, Wall Cladding, Compressed Cement Sheet - Chrysotile Asbestos Detected

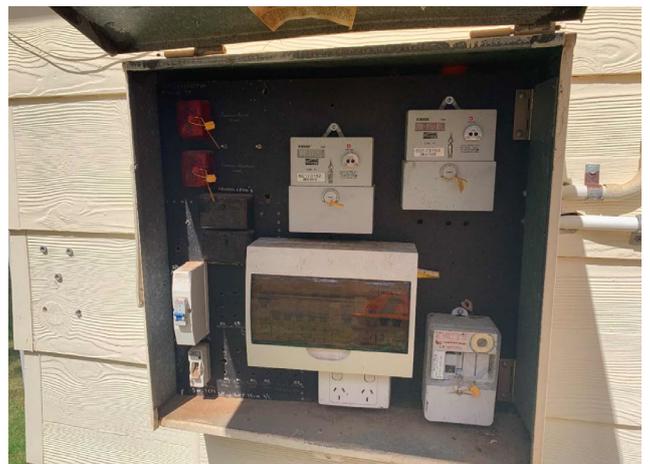
Line ID 8: External, Client Services Coordinator Residence, Residence, Wall Cladding, Compressed Cement Sheet - Chrysotile Asbestos Detected

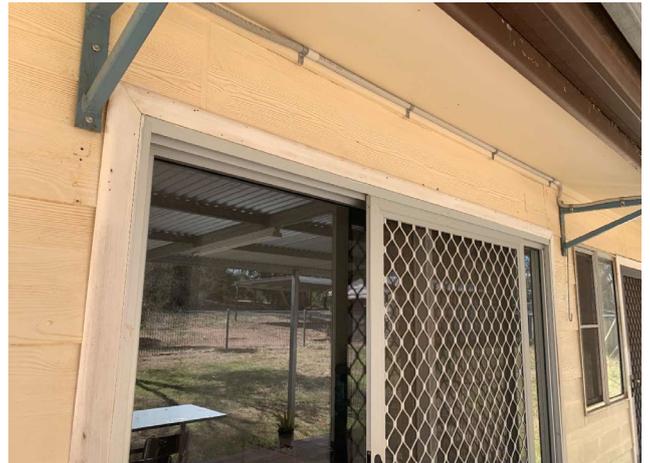
Line ID 11: External, General Managers Residence, East (Main) & West (Rear), Veranda Ceiling, Compressed Cement Sheet - Chrysotile Asbestos Detected

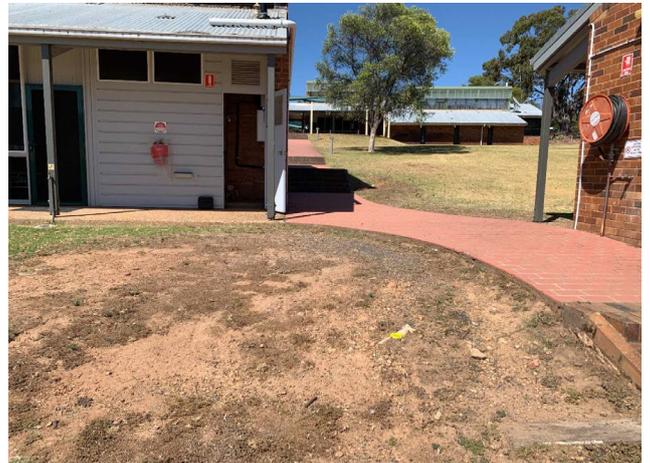
Line ID 13: External, Grounds South Adj to Yarraman/Meroo Lodges, East Adj to Visiting Staff Lodges, Protruding Redundant Pipe, Moulded Fibre Cement - Chrysotile and Amosite Asbestos Detected

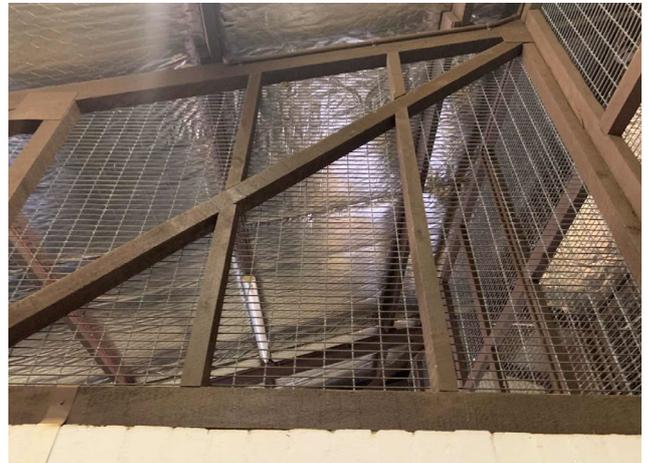
Line ID 160: Internal, Lakeside Cottages 1 & 2, Cottage 1 & 2, Ceiling Space Throughout, Loose Insulation Material - Suspected SMF

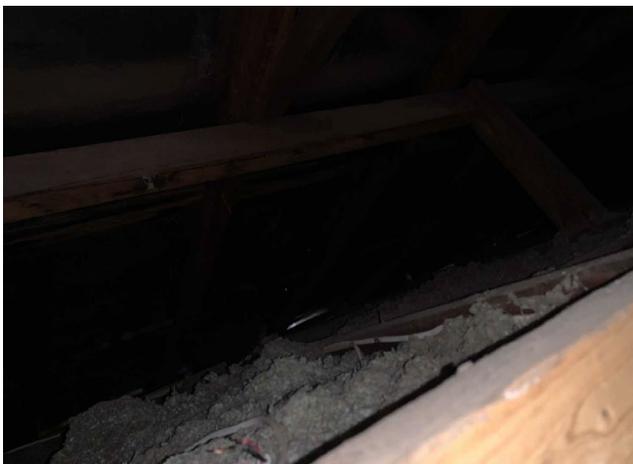
Line ID 165: Internal, Service Coordinator Residence, Ceiling Space Throughout, Floor Between Timber Framework, Insulation Batts - Suspected SMF
