Asbestos and Hazardous Materials Reinspection Assessment

Jindabyne Sports & Recreation Centre

The Barry Way

08/02/2023

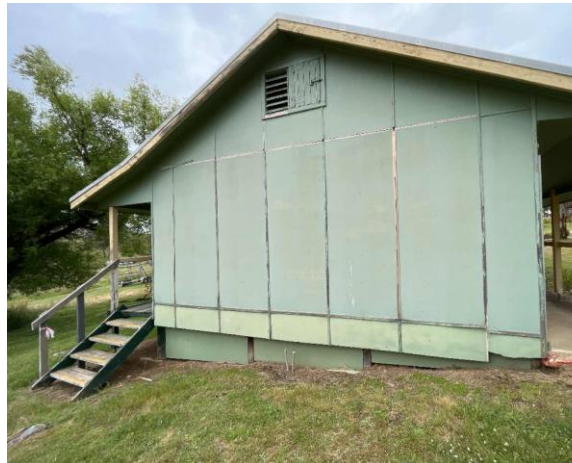
Line ID 14: External, Lodge 5, Building Perimeter, Walls at Building Ends, Fibre Cement Sheet - No Asbestos Detected

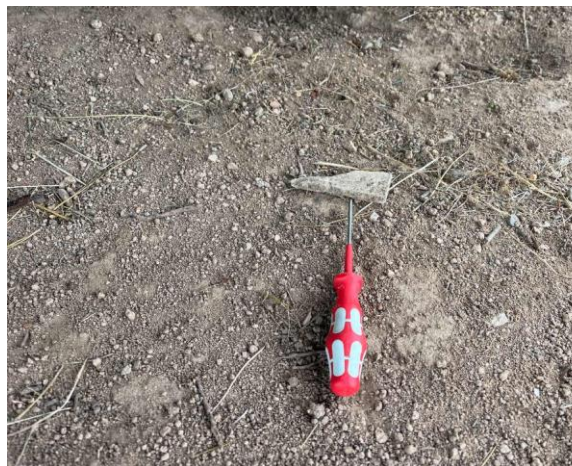
Line ID 15.1: External, Lodge 5, Building Perimeter, West End, Below Deck, Debris , Fibre Cement Sheet - Chrysotile Asbestos Detected

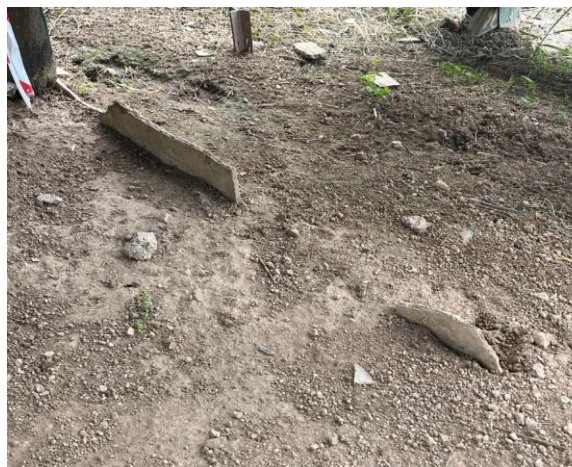
Line ID 16: External, Lodge 5, Building Perimeter, West End, Below Deck, in Soil, Fibre Cement Sheet - Chrysotile Asbestos Detected

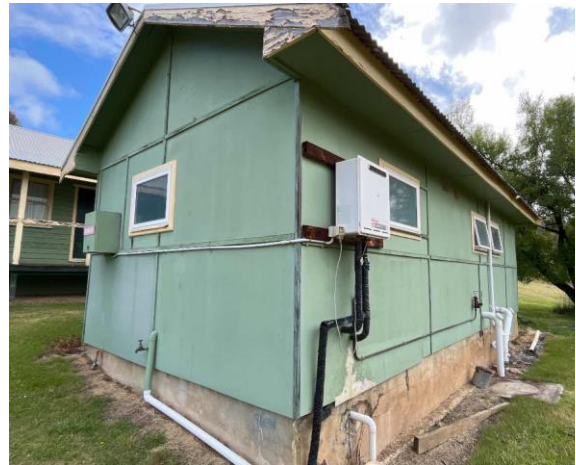
Line ID 17: External, Lodge 5, Toilet Block, Wall and Eave Linings, Fibre Cement Sheet - No Asbestos Detected

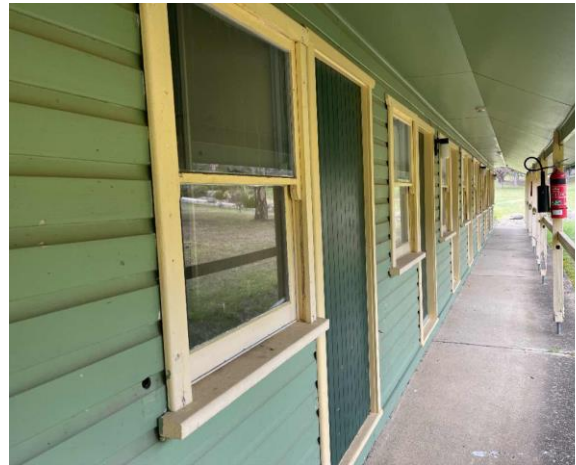
Line ID 19: External, Lodge 5, Veranda, Timber Windows, Window Caulking - No Asbestos Detected

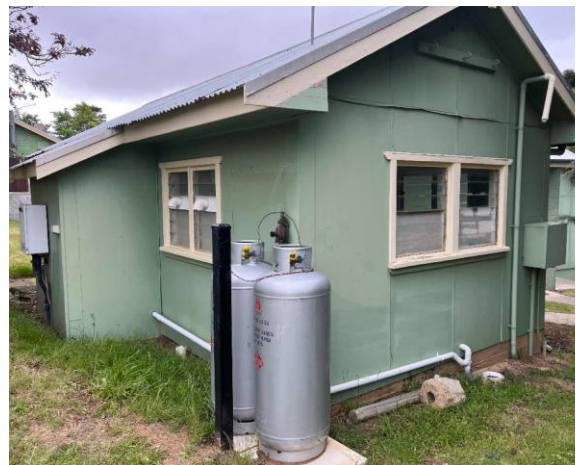
Line ID 21: External, Lodge 6, Guest Laundry, Wall Lining, Fibre Cement Sheet - Chrysotile, Amosite and Crocidolite Asbestos Detected

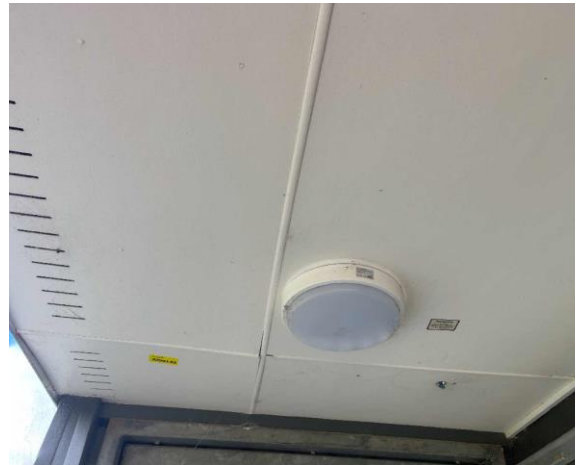
Line ID 24: External, Maintenance, Covered Walkway, Eaves Lining, Fibre Cement Sheet - Chrysotile Asbestos Detected

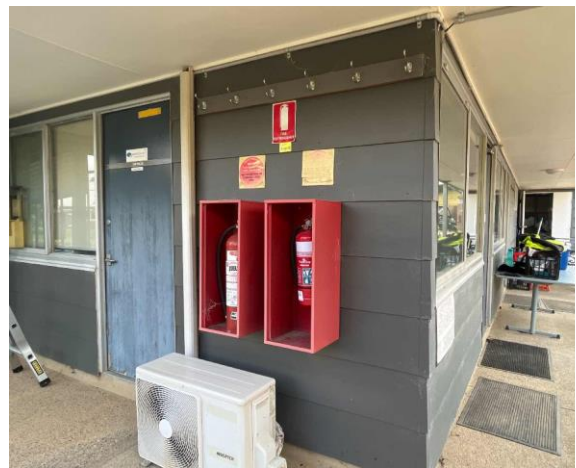
Line ID 26: External, Maintenance, Covered Walkway, Wall Panels, Fibre Cement Sheet - Chrysotile Asbestos Detected

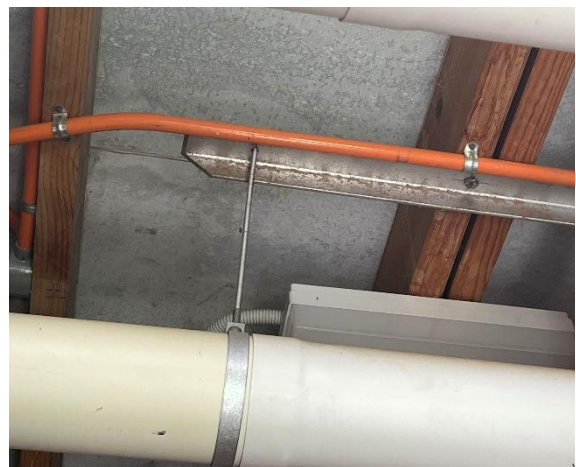
Line ID 29: External, Student Lodges, Blacksallees Lodge, Side Entrance to Level 1, Below Tiles to Deck, Compressed Cement Sheeting - Chrysotile Asbestos Detected

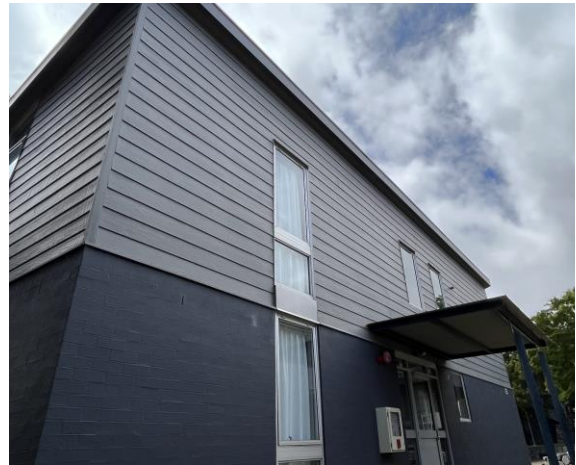
Line ID 34: External, Student Lodges, Merritts Lodge, Outer Walls, Weatherboard, Fibre Cement Sheet - No Asbestos Detected

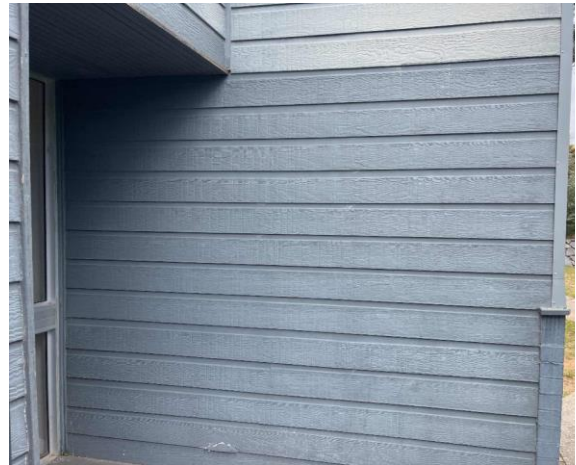
Line ID 38: External, Student Lodges, Snowgums Lodge, Outer Walls, Weatherboard, Fibre Cement Sheet - No Asbestos Detected

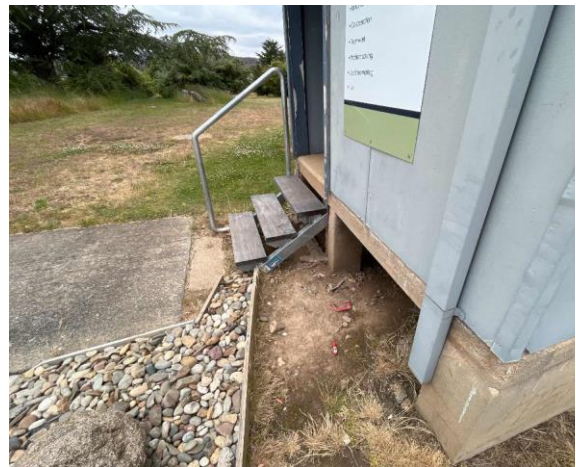
Line ID 40: External, TAFE, Classroom Building, Adjacent Puzzle Room Entry, Ground, Fibre Cement Sheet Debris - Chrysotile & Amosite Asbestos Detected

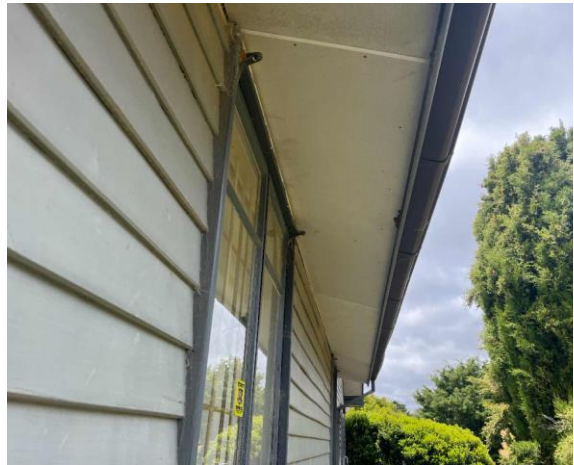
Line ID 41: External, TAFE, Classroom Building, Eaves, Fibre Cement Sheet - No Asbestos Detected

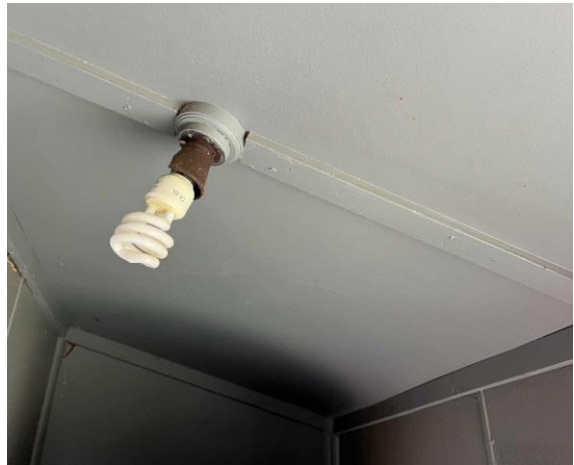
Line ID 45: External, TAFE, Classroom Building, Puzzle Room, Ceiling Lining, Fibre Cement Sheet - Chrysotile & Amosite Asbestos Detected

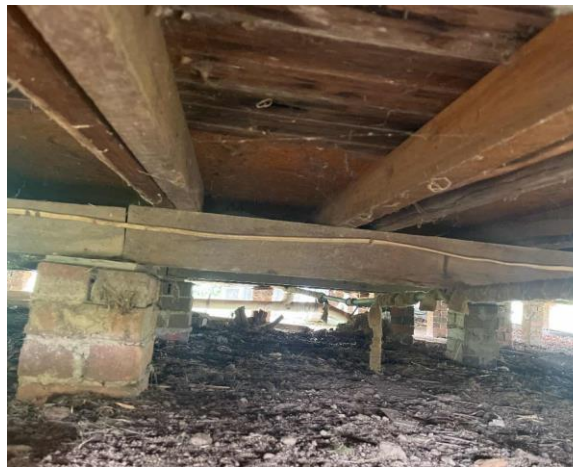
Line ID 47: External, TAFE, Classroom Building, Subfloor, Packers to Columns, Fibre Cement Sheeting - Chrysotile, Amosite and Crocidolite Asbestos Detected

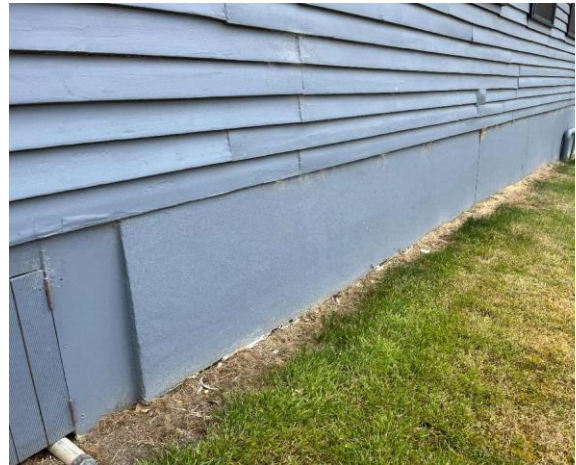
Line ID 51: External, Torino Lodge, Rear Lower Section to Subfloor, Low Level Panels, Fibre Cement Sheet - No Asbestos Detected

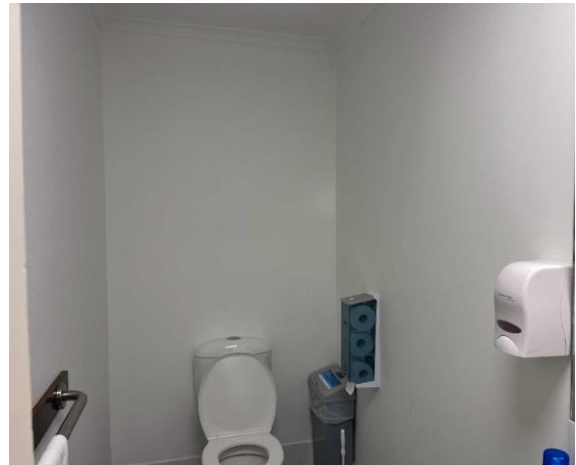
Line ID 54: Internal, Jillamatong Lodge, Bathroom, Wall Lining, Fibre Cement Sheet - Suspected Asbestos

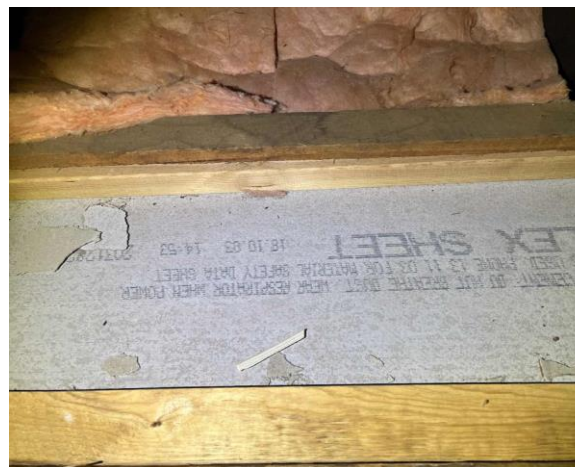
Line ID 55.1: Internal, Lodge 5, Common Room, Wall and Ceiling Lining, Fibre Cement Sheeting - No Asbestos Detected

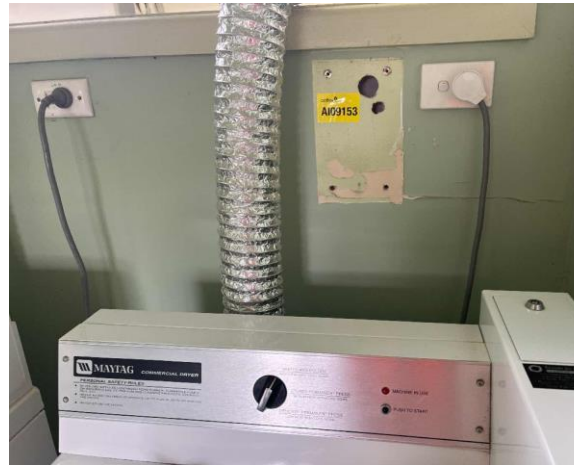
Line ID 58: Internal, Lodge 6, Laundry, Wall Lining, Fibre Cement Sheet - No Asbestos Detected

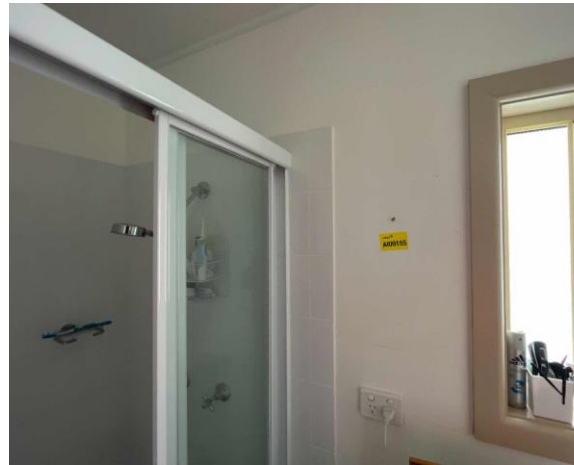
Line ID 60: Internal, Lodge 6, Rear Standalone House, Toilet and Shower, Wall Lining, Fibre Cement Sheet - No Asbestos Detected

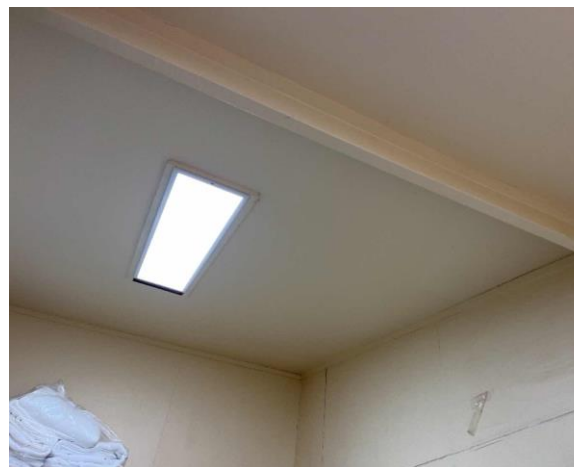
Line ID 62: Internal, Maintenance, Generator Room, Ceiling Lining, Fibre Cement Sheet - Chrysotile Asbestos Detected

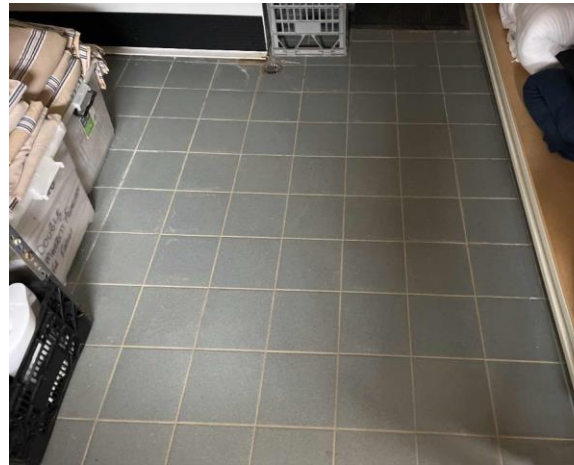
Line ID 64: Internal, Maintenance, Laundry, Below Ceramic Tiles to Floor, Compressed Cement Sheeting - Suspected Asbestos

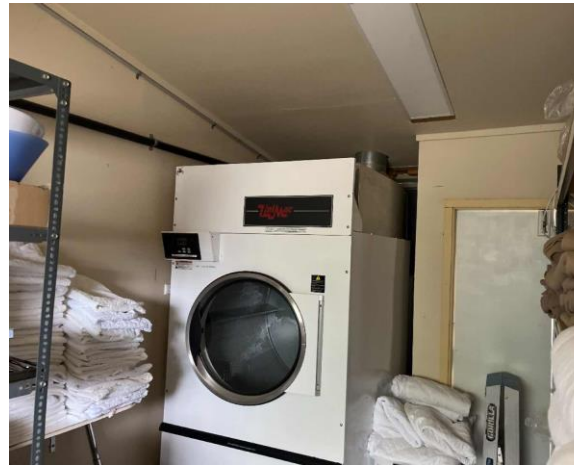
Line ID 66: Internal, Maintenance, Laundry, Wall Lining, Fibre Cement Sheet - Chrysotile Asbestos Detected

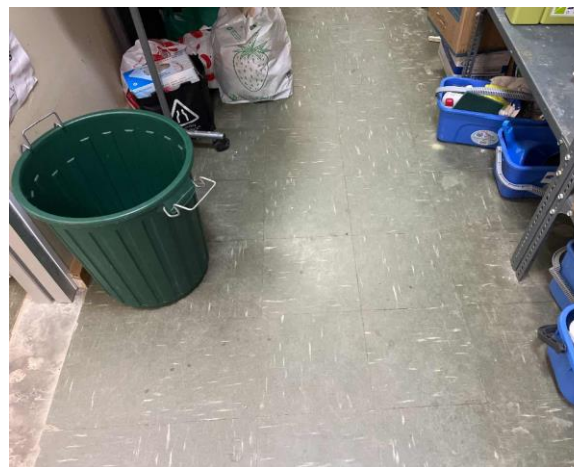
Line ID 67: Internal, Maintenance, Offices and Stores, Floor Covering, Grey Vinyl Floor Tiles - No Asbestos Detected

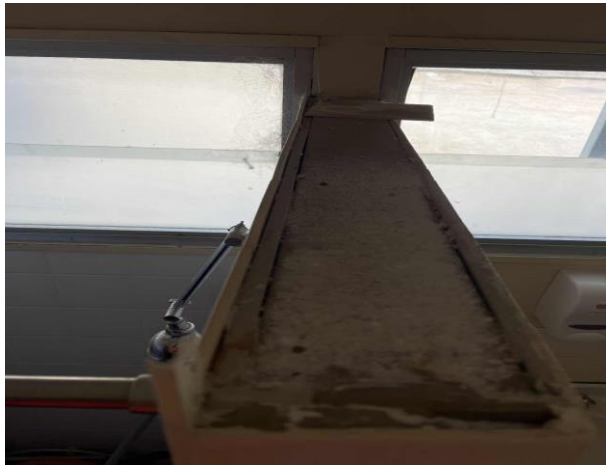
Line ID 68: Internal, Maintenance, Shower and Toilet, Partition Wall, Fibre Cement Sheet - Chrysotile Asbestos Detected

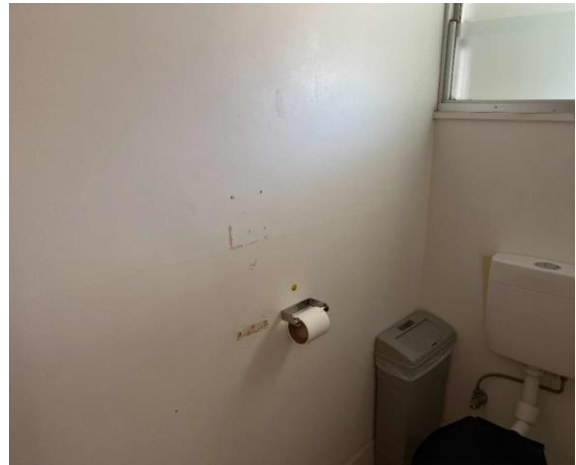
Line ID 69: Internal, Maintenance, Shower and Toilet, Walls and Behind Sink, Fibre Cement Sheet - Chrysotile Asbestos Detected

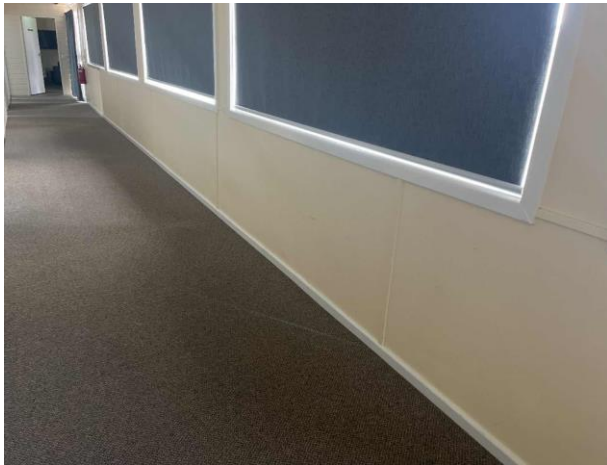
Line ID 70: Internal, Margin Lodge, Corridor, Below Windows, Infill Panels, Fibre Cement Sheet - No Asbestos Detected

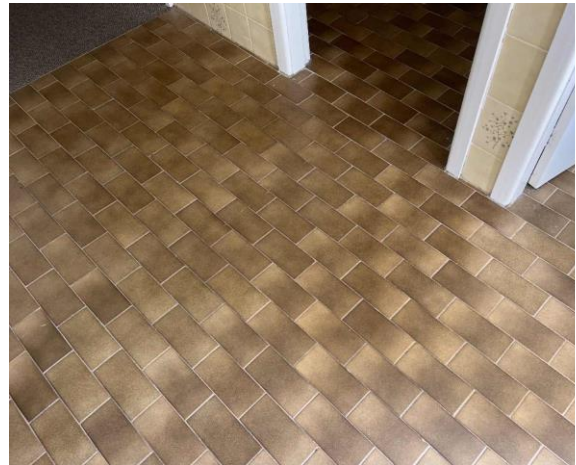
Line ID 71: Internal, Margin Lodge, Laundry & Toilets, Below Ceramic Tiles to Floor, Compressed Cement Sheeting - Suspected Asbestos

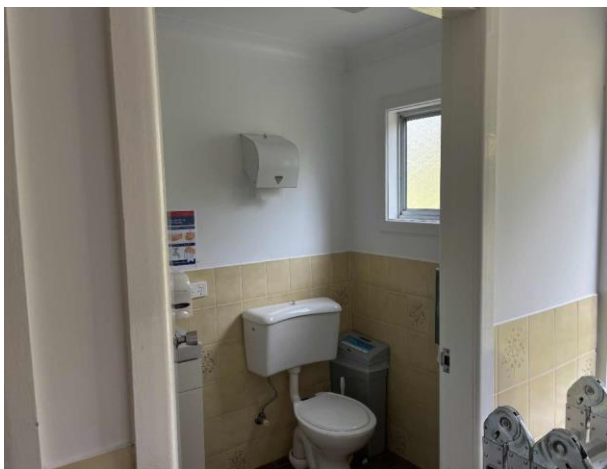
Line ID 72: Internal, Margin Lodge, Laundry & Toilets, Toilets and Laundry, Walls, Fibre Cement Sheet - No Asbestos Detected

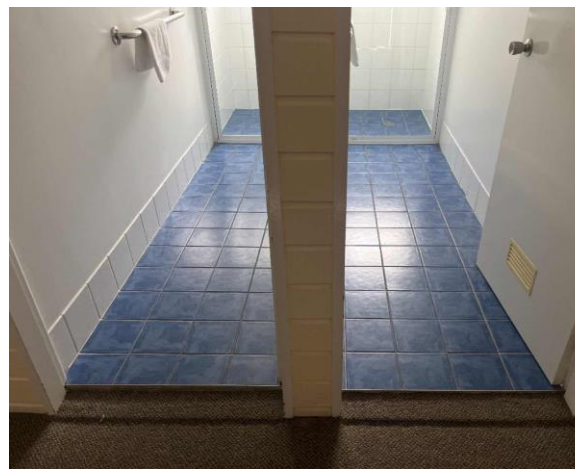
Line ID 73: Internal, Margin Lodge, Showers, Below Ceramic Tiles to Floor, Compressed Cement Sheeting - Suspected Asbestos

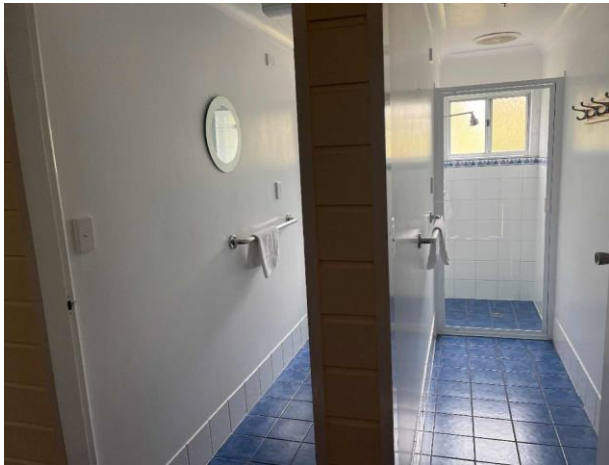
Line ID 74: Internal, Margin Lodge, Showers, Walls, Fibre Cement Sheet - No Asbestos Detected

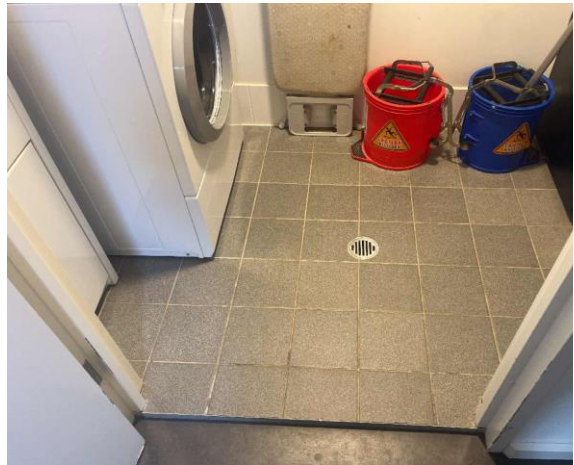
Line ID 75: Internal, Milton Lodge, Accommodation Block, Laundry, Floor Below Ceramic Tiles, Compressed Cement Sheet - Suspected Asbestos

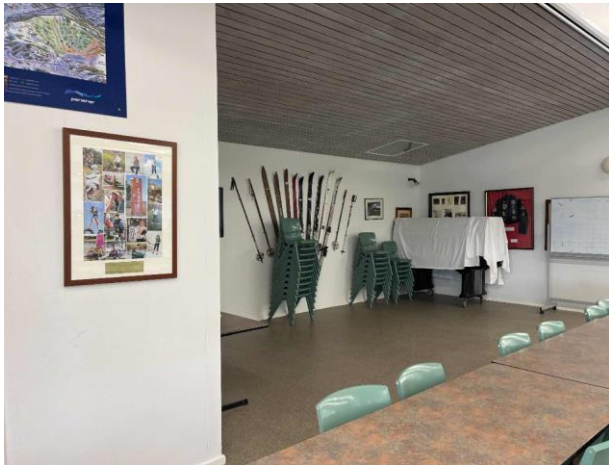
Line ID 76: Internal, Moguls Restaurant, Dining Hall, Display Area, Wall Lining, Fibre Cement Sheet - No Asbestos Detected

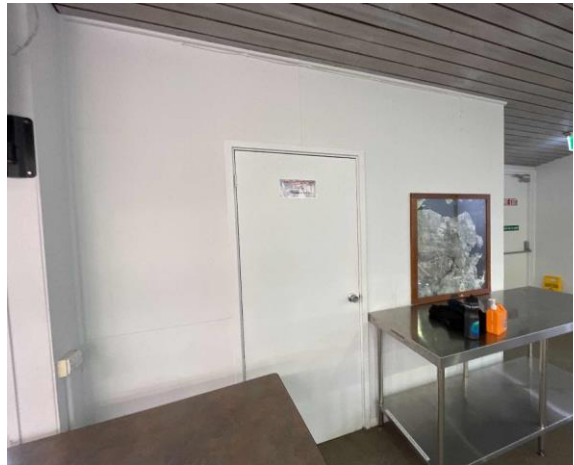
Line ID 77: Internal, Moguls Restaurant, Dining Hall, Storeroom 2, Wall Lining, Fibre Cement Sheet - No Asbestos Detected

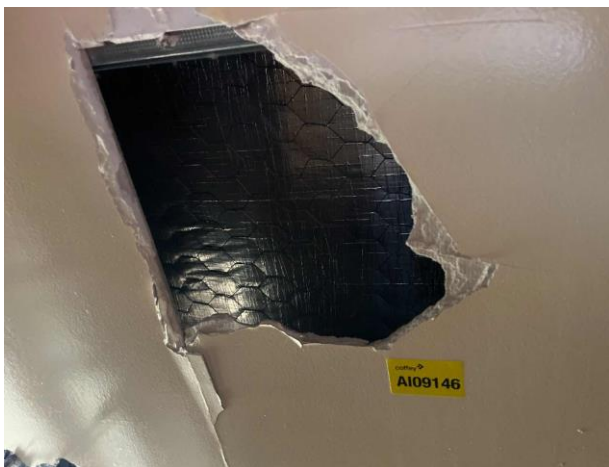
Line ID 78: Internal, Moguls Restaurant, Kitchen, Ceiling Void, Fibre Cement Sheet - No Asbestos Detected

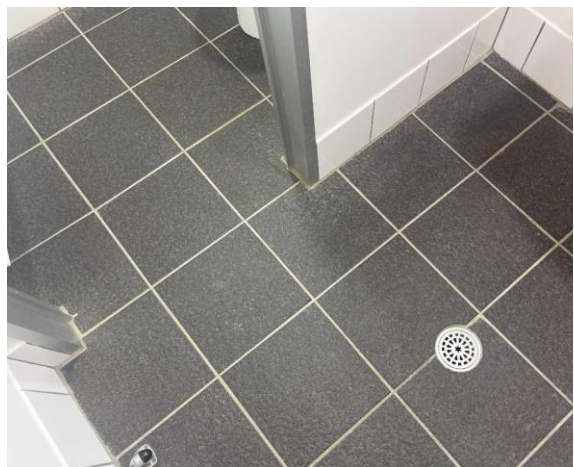
Line ID 82: Internal, Reception, Toilets, Below Ceramic Tiles to Floor, Compressed Cement Sheet - Suspected Asbestos

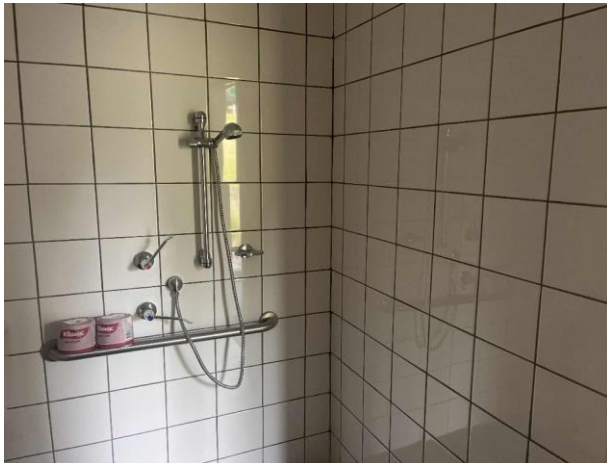
Line ID 83: Internal, Reception, Toilets, Shower, Wall behind Ceramic Tiles, Compressed Cement Sheet - Suspected Asbestos

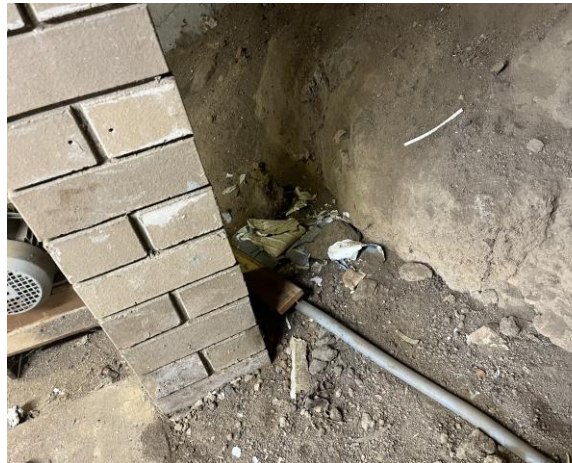
Line ID 84: Internal, Student Lodges, Blacksallees Lodge, Basement Plant Room, Adjacent Brick Pillar, Compressed Cement Sheetting Debris - Chrysotile Asbestos Detected

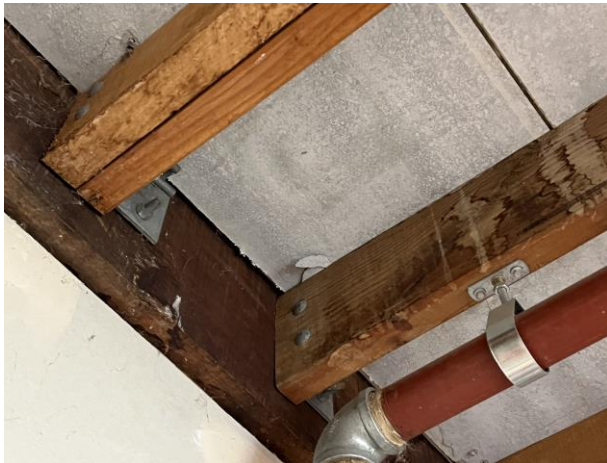
Line ID 86: Internal, Student Lodges, Blacksallees Lodge, Basement Plant Room, High Ceiling Lining, Compressed Cement Sheetting - Chrysotile Asbestos Detected

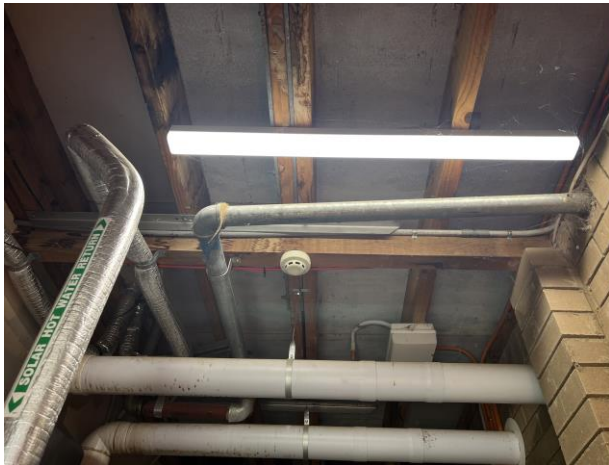
Line ID 115: Internal, Student Lodges, Merritts Lodge, Basement Plant Room, Ceiling Lining, Compressed Cement Sheeting - Chrysotile Asbestos Detected

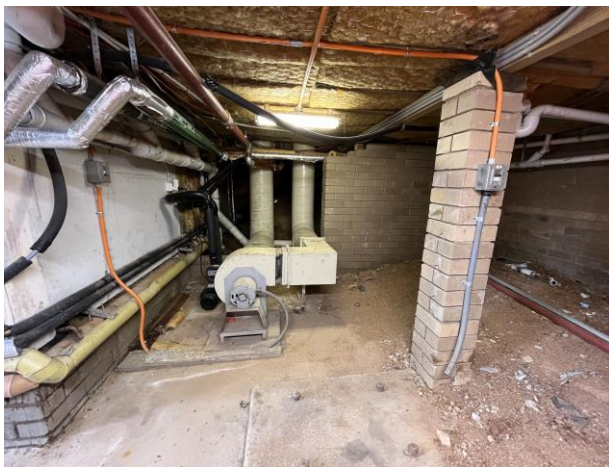
Line ID 117: Internal, Student Lodges, Merritts Lodge, Basement Plant Room, Wall Lining, Fibre Cement Sheet - Chrysotile Asbestos Detected

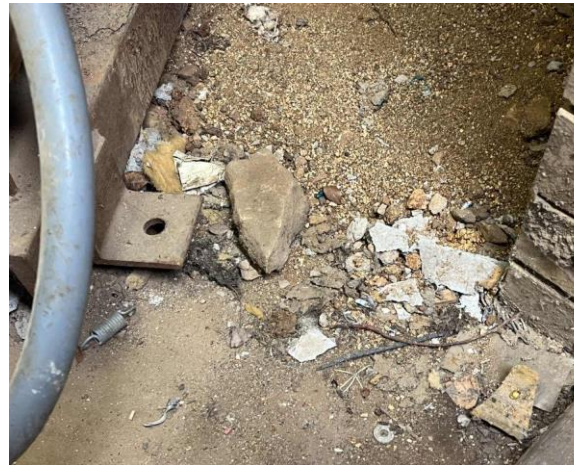
Line ID 134: Internal, Student Lodges, Snowgums Lodge, Basement Plant Room, Adjacent Brick Pillar, Compressed Cement Sheeting Debris - Chrysotile Asbestos Detected

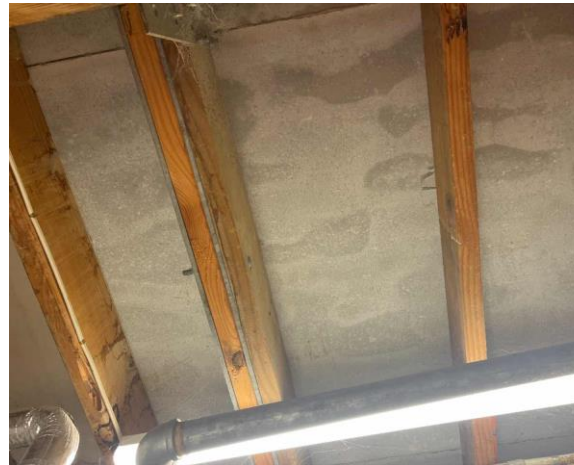
Line ID 135: Internal, Student Lodges, Snowgums Lodge, Basement Plant Room, Ceiling Lining, Compressed Cement Sheeting - Chrysotile Asbestos Detected

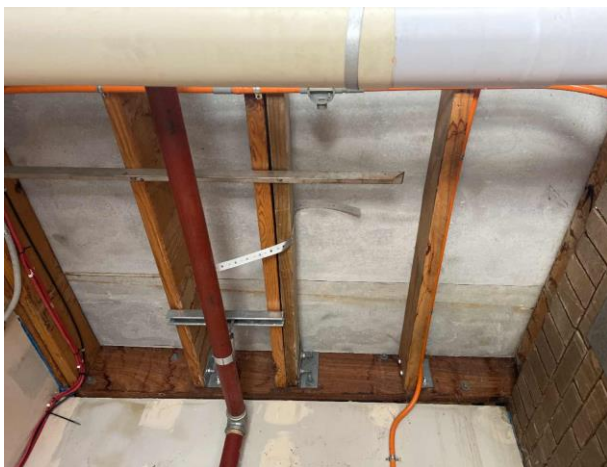
Line ID 136: Internal, Student Lodges, Snowgums Lodge, Basement Plant Room, High Ceiling Lining, Compressed Cement Sheeting - Chrysotile Asbestos Detected

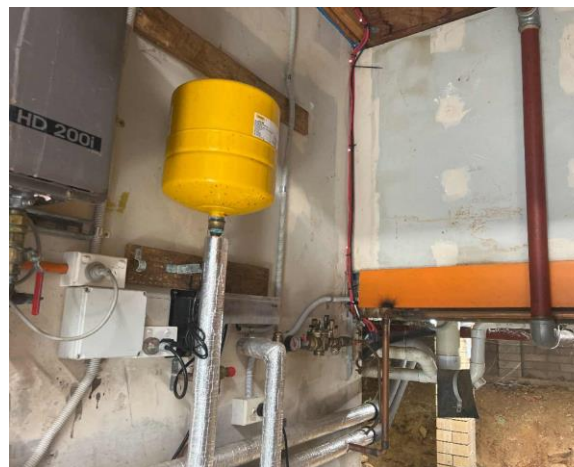
Line ID 136.1: Internal, Student Lodges, Snowgums Lodge, Basement Plant Room, High Ceiling Lining, Compressed Cement Sheeting - Chrysotile Asbestos Detected

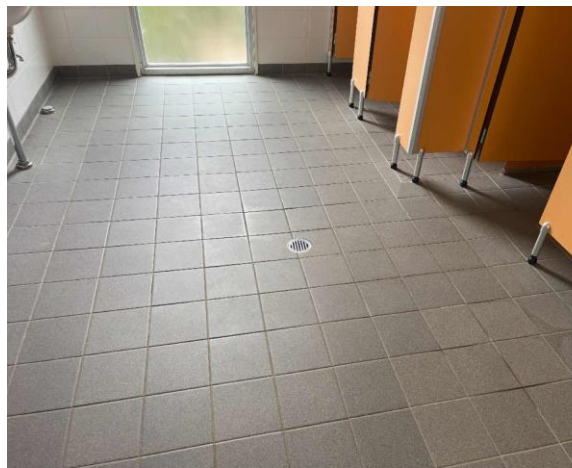
Line ID 140: Internal, Student Lodges, Snowgums Lodge, Level 1, Bathroom and Toilets, Floor Below Ceramic Tiles, Compressed Cement Sheeting - Chrysotile Asbestos Detected

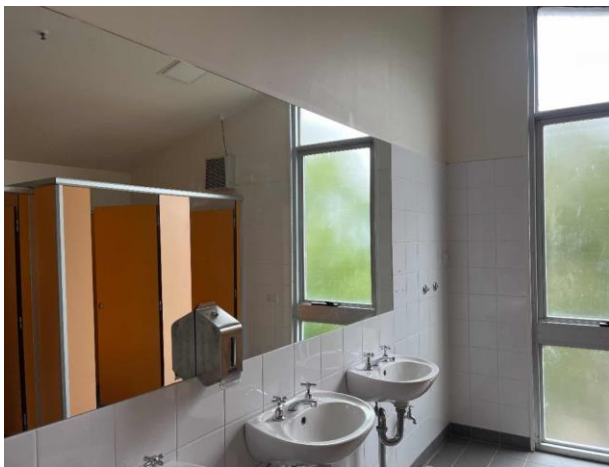
Line ID 140.1: Internal, Student Lodges, Snowgums Lodge, Level 1, Bathroom and Toilets, Floor Below Ceramic Tiles, Compressed Cement Sheeting - Chrysotile Asbestos Detected

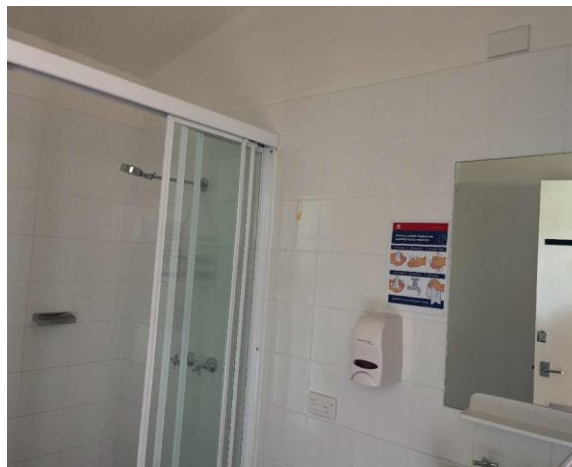
Line ID 141: Internal, Student Lodges, Snowgums Lodge, Level 1, Toilets, Walls Behind Tiles, Fibre Cement Sheet - No Asbestos Detected

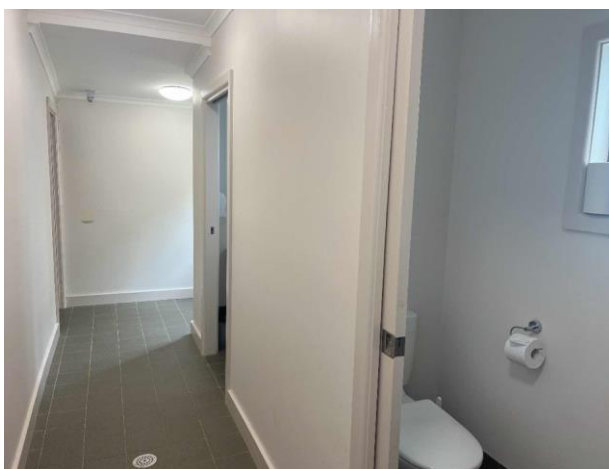
Line ID 144: Internal, TAFE, Toilets, Porch Entry, Ceiling Lining, Fibre Cement Sheet - No Asbestos Detected

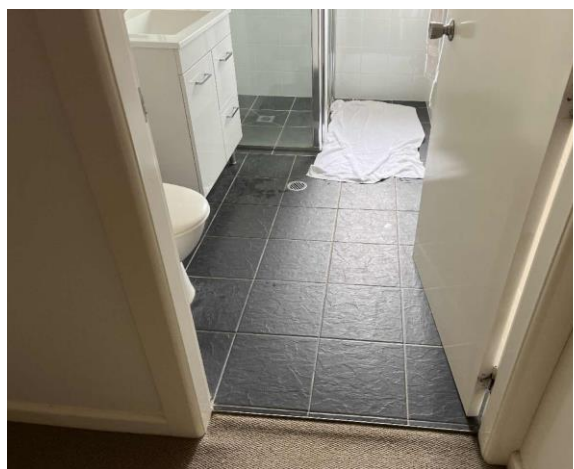
Line ID 145: Internal, TAFE, Toilets, West End of Building, Corridor and Toilets, Wall Lining, Fibre Cement Sheet - No Asbestos Detected

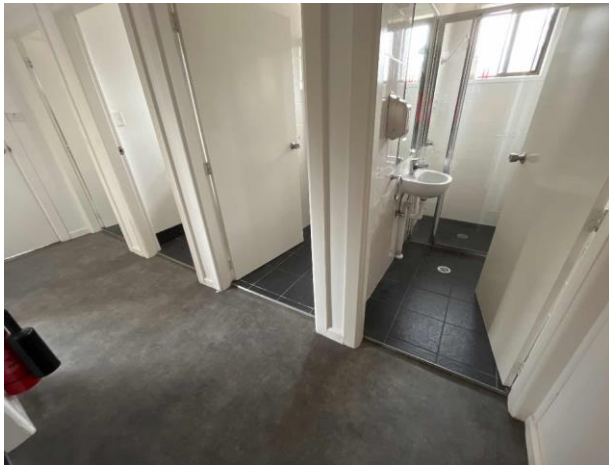
Line ID 146: Internal, Torino Lodge, JSR Catering Toilet, Below Ceramic Tiles to Floor, Compressed Cement Sheeting - Suspected Asbestos

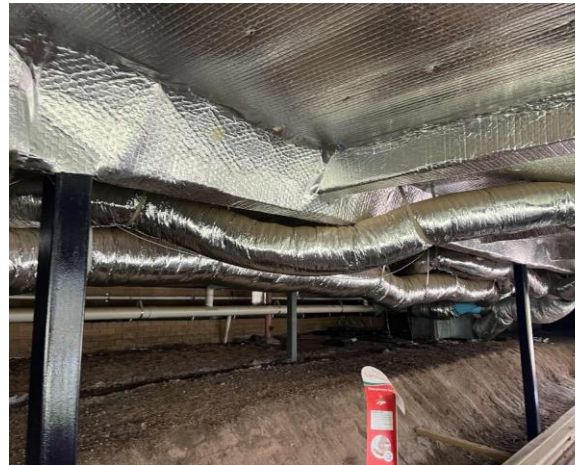
Line ID 153: External, Dining Hall, Subfloor, Ductwork and Sheet Insulation, Insulation Material - Suspected SMF

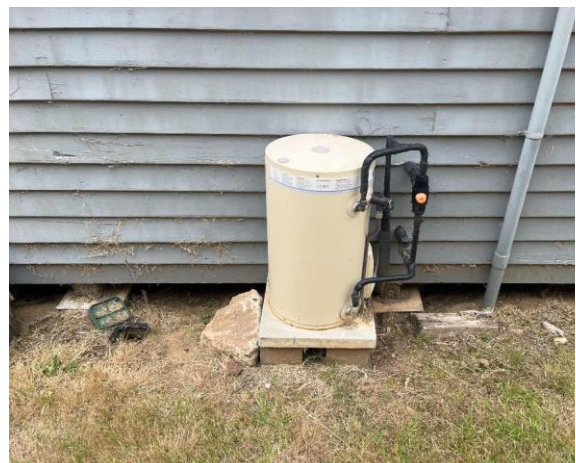
Line ID 156: External, Lodge 6, Guest Laundry, Hot Water Heater, Insulation Material - Suspected SMF

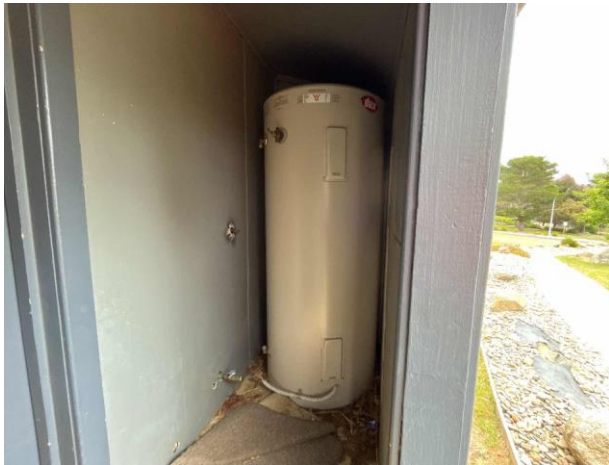
Line ID 157: External, TAFE, Classroom Building, Hot Water Unit, Insulation Material - Suspected SMF

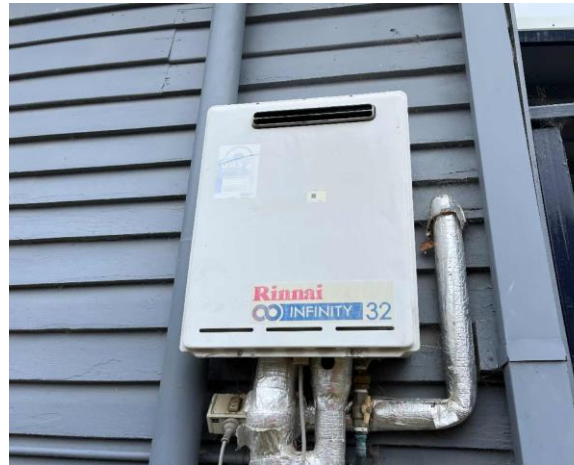
Line ID 158: External, TAFE, Classroom Building, Puzzle Room Entrance, Hot Water Unit, Insulation Material - Suspected SMF

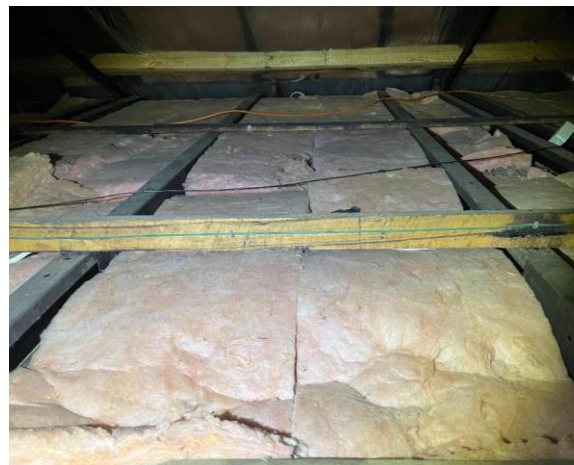
Line ID 162: Internal, Lodge 5, Ceiling Void, Throughout, Insulation Batts - Suspected SMF

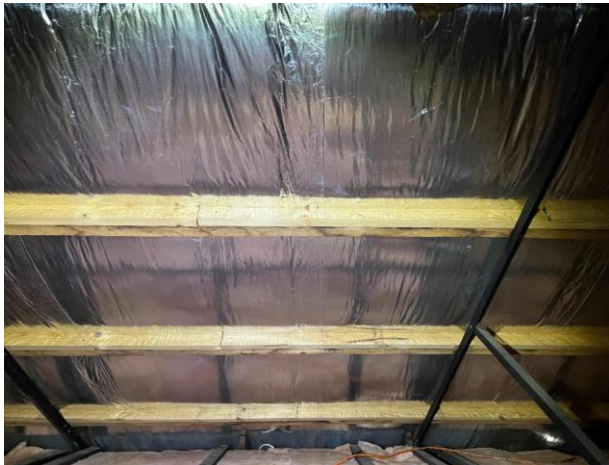
Line ID 162.1: Internal, Lodge 5, Ceiling Void, Throughout, Insulation Batts - Suspected SMF

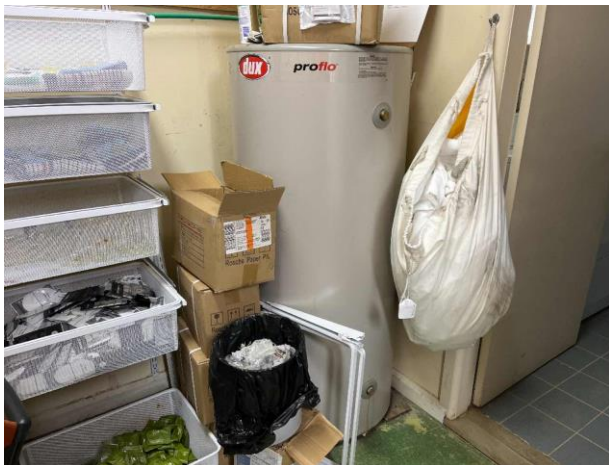
Line ID 164: Internal, Lodge 5, Common Room, Hot Water Unit, Insulation Material - Suspected SMF

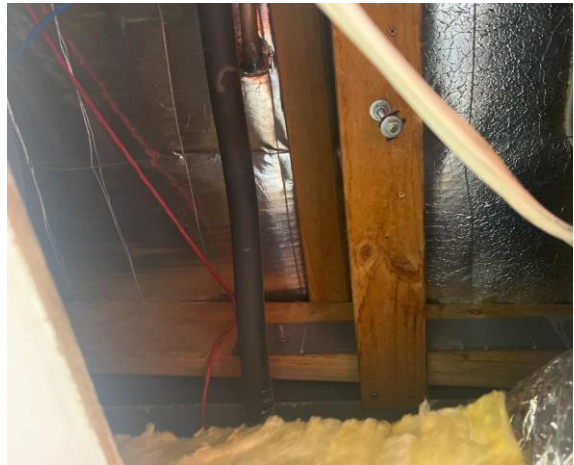
Line ID 168: Internal, Milton Lodge, Accommodation Block, Ceiling Void, Insulation Batts - Suspected SMF

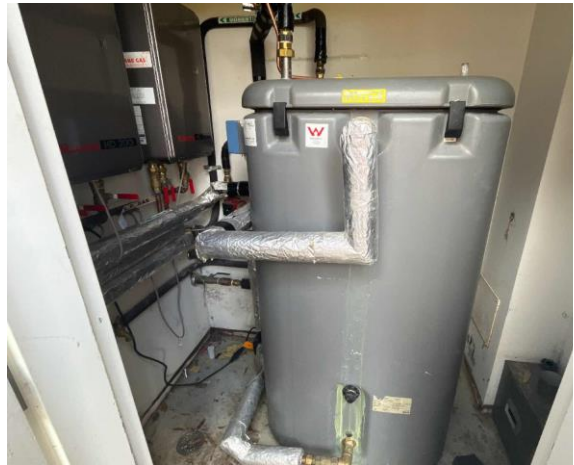
Line ID 170: Internal, Milton Lodge, Accommodation Block, Hot Water Unit, Insulation Material - Suspected SMF

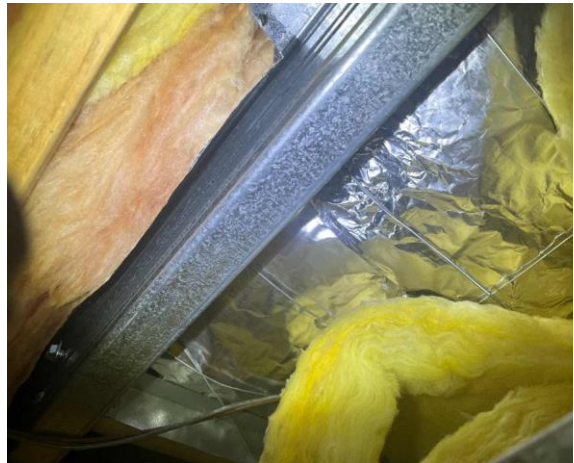
Line ID 173: Internal, Reception, Ceiling Void, Throughout, Insulation Batts - Suspected SMF

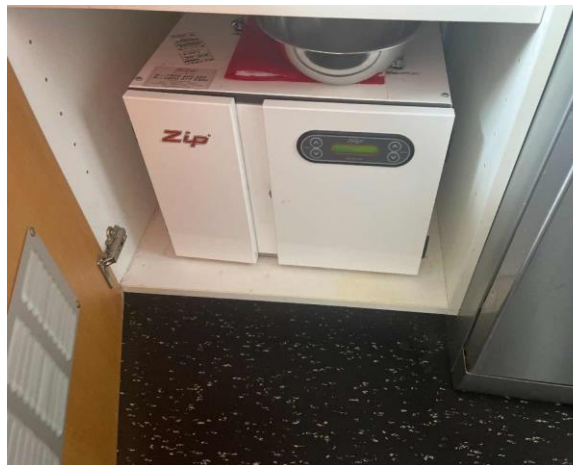
Line ID 175: Internal, Reception, Kitchen, Hot Water Unit, Insulation Material - Suspected SMF

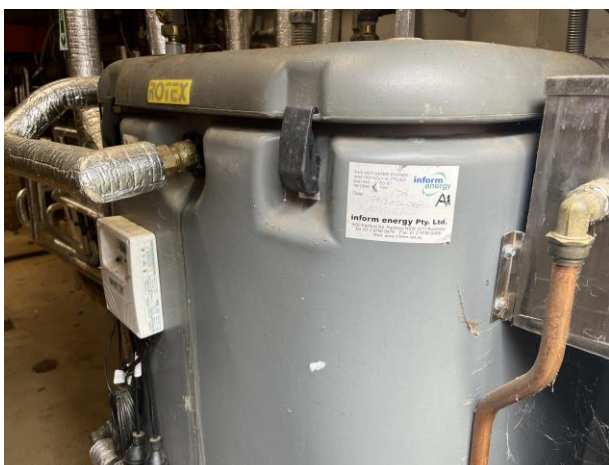
Line ID 175.1: Internal, Reception, Kitchen, Hot Water Unit, Insulation Material - Suspected SMF

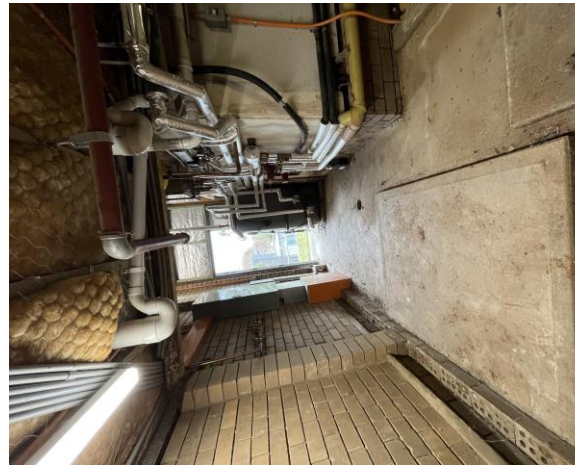
Line ID 190: Internal, Student Lodges, Merritts Lodge, Basement Plant Room, Underside of the Roof, Insulation Batts - Suspected SMF

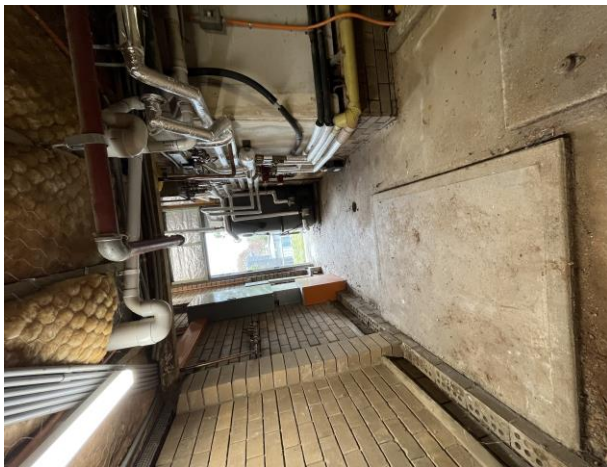
Line ID 192: Internal, Student Lodges, Ramshead Lodge, Basement Plant Room, Hot Water Unit, Insulation Material - Suspected SMF

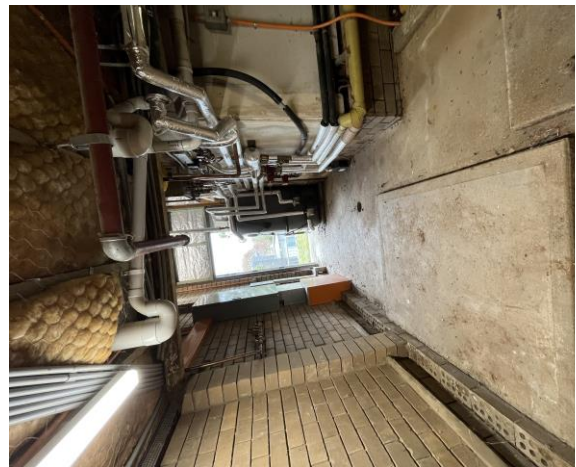
Line ID 193: Internal, Student Lodges, Ramshead Lodge, Basement Plant Room, Pipes, Insulation Material - Suspected SMF

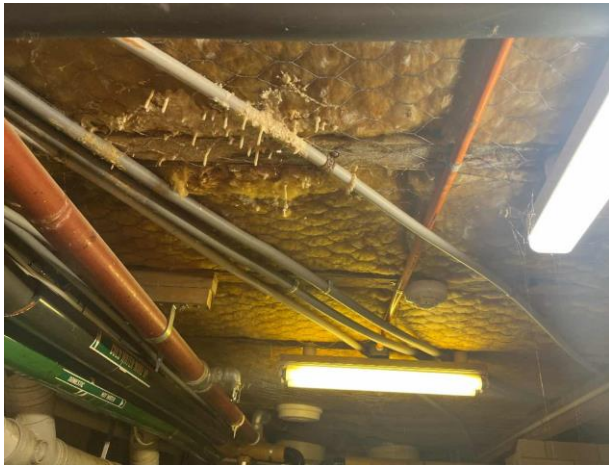
Line ID 194: Internal, Student Lodges, Ramshead Lodge, Basement Plant Room, Underside of the Roof, Insulation Batts - Suspected SMF

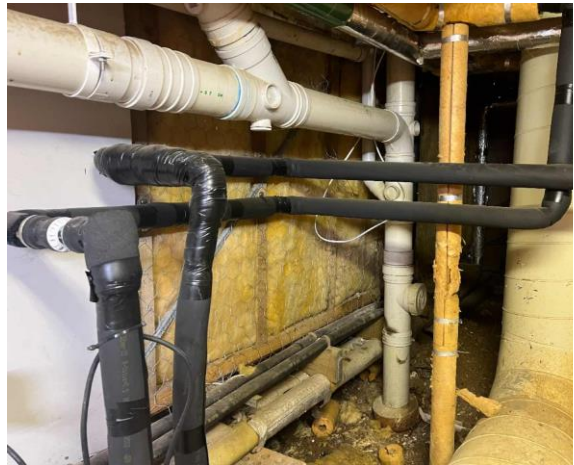
Line ID 198: Internal, Student Lodges, Snowgums Lodge, Basement Plant Room, Pipes, Insulation Material - Suspected SMF
