Asbestos and Hazardous Materials Reinspection Assessment

Lake Burrendong Sport and Recreation Centre

205 Tara Road

08/02/2023

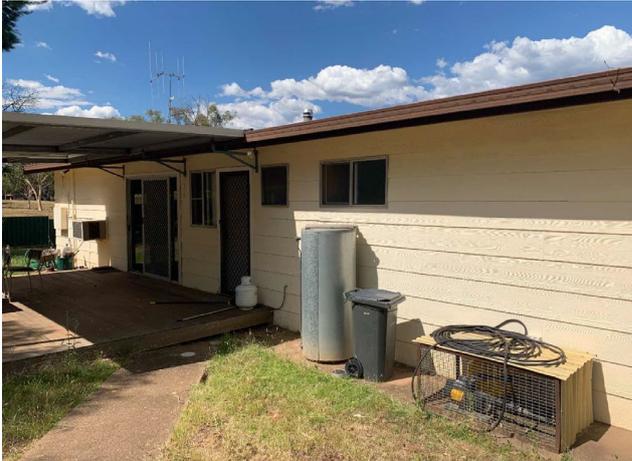
Line ID 4: External, Client Services Coordinator Residence, Elevations, Main Entrance, Porch, Ceiling Lining, Compressed Cement Sheet - Chrysotile Asbestos Detected

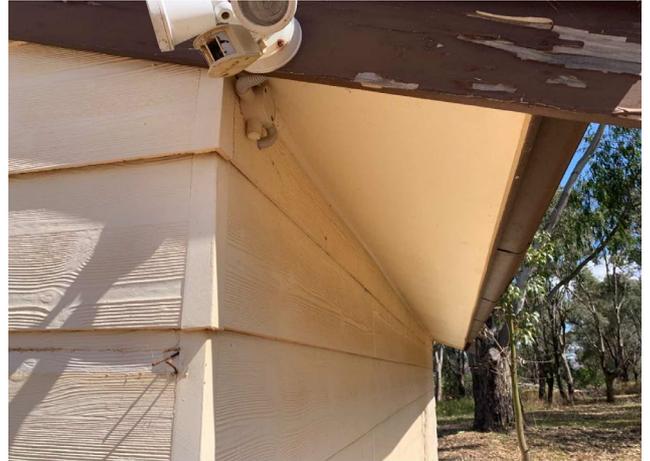
Line ID 5: External, Client Services Coordinator Residence, Garage, East and West Elevations, Eaves Lining, Compressed Cement Sheet - Chrysotile Asbestos Detected

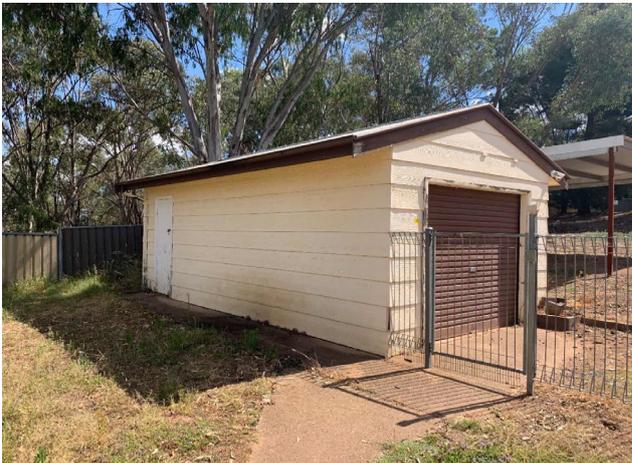
Line ID 6: External, Client Services Coordinator Residence, Garage, Wall Cladding, Compressed Cement Sheet - Chrysotile Asbestos Detected

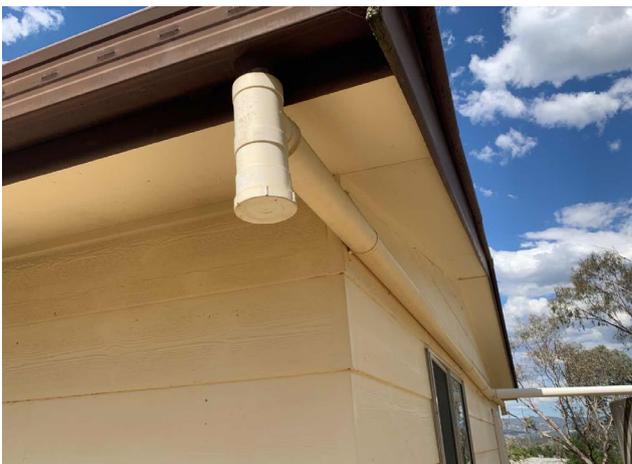
Line ID 8: External, Client Services Coordinator Residence, Residence, Wall Cladding, Compressed Cement Sheet - Chrysotile Asbestos Detected

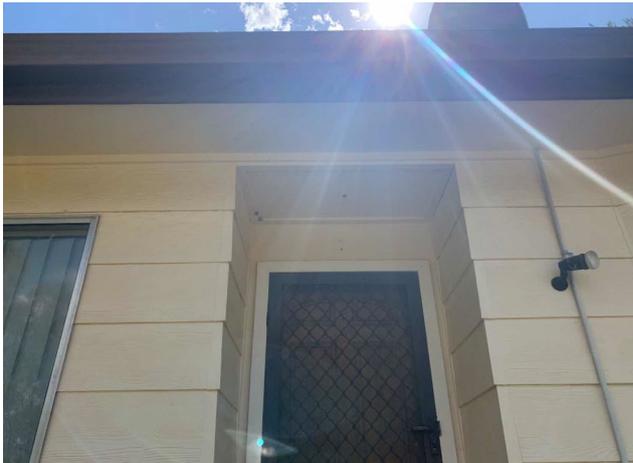
Line ID 11: External, General Managers Residence, East (Main) & West (Rear), Veranda Ceiling, Compressed Cement Sheet - Chrysotile Asbestos Detected

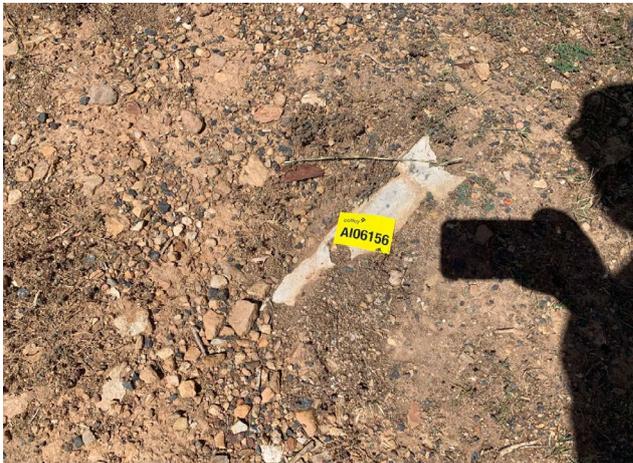
Line ID 13: External, Grounds South Adj to Yarraman/Meroo Lodges, East Adj to Visiting Staff Lodges, Protruding Redundant Pipe, Moulded Fibre Cement - Chrysotile and Amosite Asbestos Detected

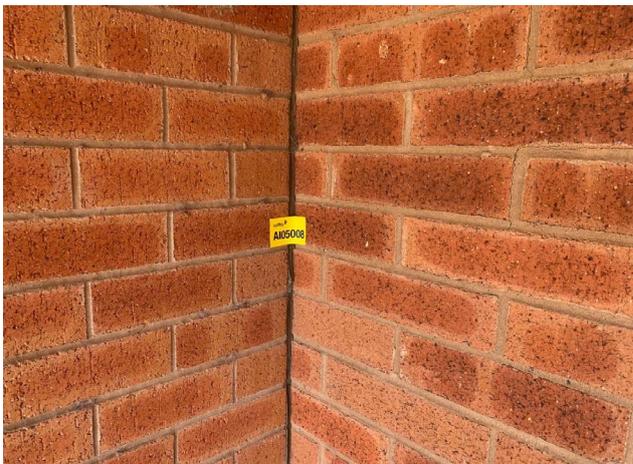
Line ID 14: External, Girrawaa Lodge, Elevations, Brickwork, Vertical Joints Throughout, Construction Joint Mastic - No Asbestos Detected

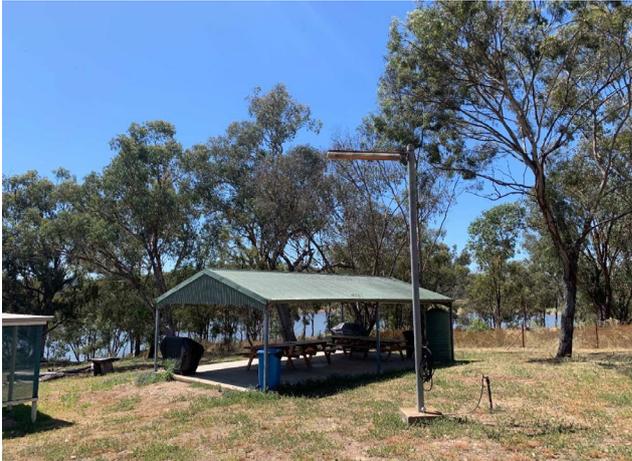
Line ID 19: External, Lakeside Cottages 1 & 2, Between Units and Cottages; Water Pump Electrical Panel, Bituminous Backing Board - None Suspected

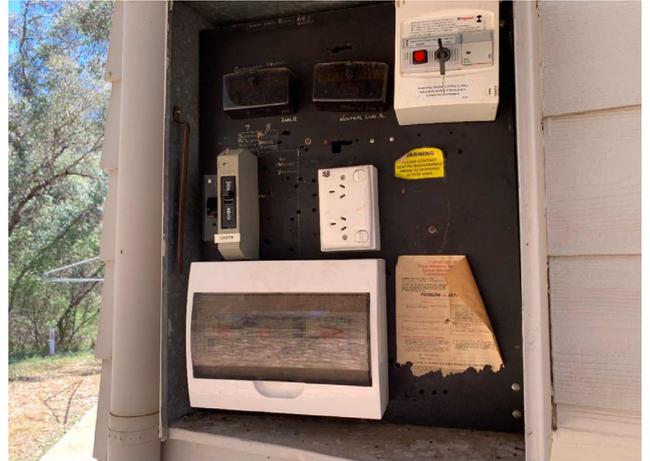
Line ID 20: External, Lakeside Cottages 1 & 2, Northwest Corner of Cottage 2 in Mounted Metal box, Bituminous Electrical Backing Board - Chrysotile Asbestos Detected

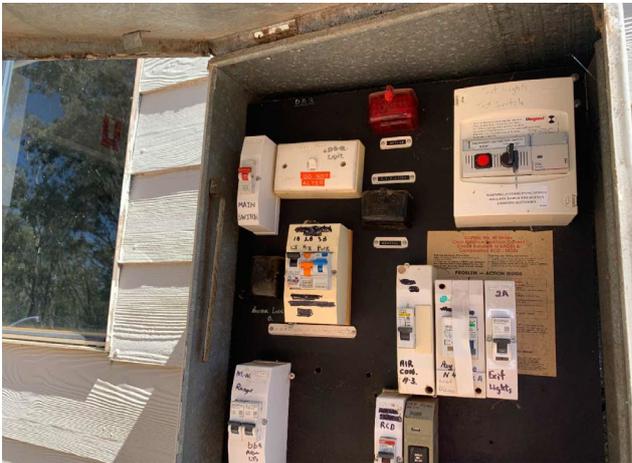
Line ID 21: External, Lakeside Cottages 1 & 2, South Side Cottage 1 in Electrical Box, Bituminous Electrical Backing Board - Chrysotile Asbestos Detected

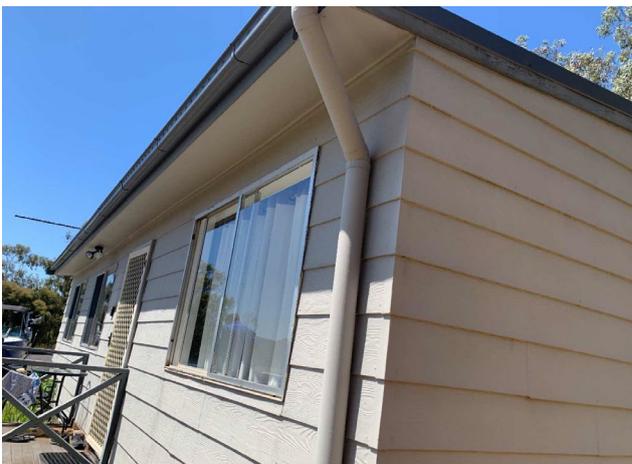
Line ID 24: External, Lakeside Cottages 1 & 2, Perimeter of Cottage 2, Eaves Lining - Sections above Windows, Compressed Cement Sheet - Chrysotile Asbestos Detected

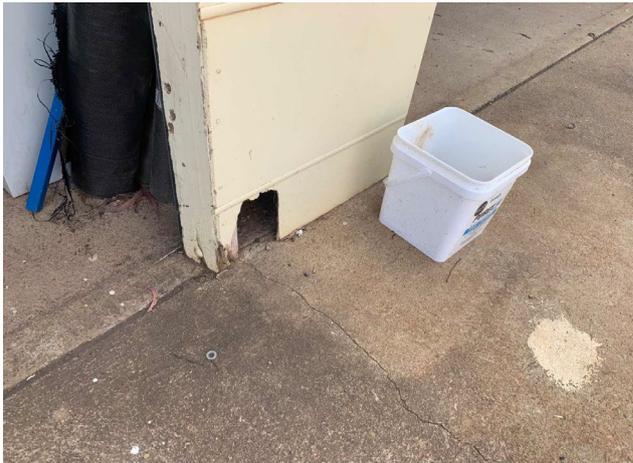
Line ID 27: External, Maintenance Workshop, Workshop South & North Wall & Machinery Shed North, Wall Cladding and Joinery, Compressed Cement Sheet - Chrysotile & Amosite Asbestos Detected

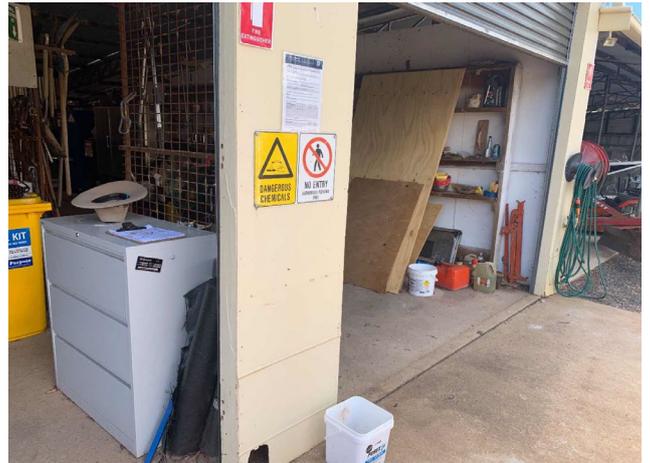
Line ID 27.1: External, Maintenance Workshop, Elevations, Workshop South & North Wall & Machinery Shed North, Wall Cladding and Joinery, Compressed Cement Sheet - Chrysotile & Amosite Asbestos Detected

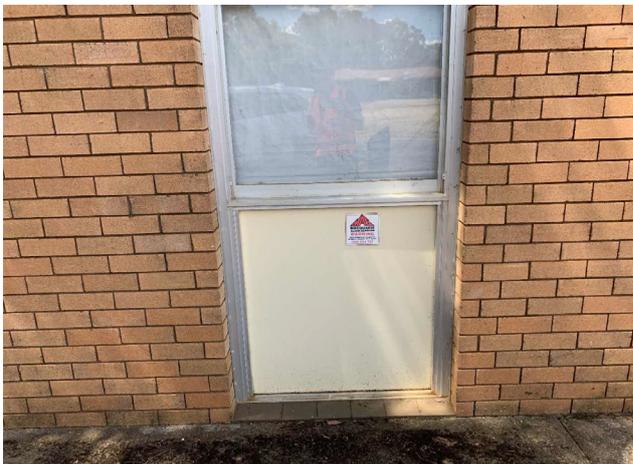
Line ID 28: External, Maintenance Workshop, Garage, Below South Window, Thick Infill Panel, Compressed Cement Sheet - Chrysotile Asbestos Detected

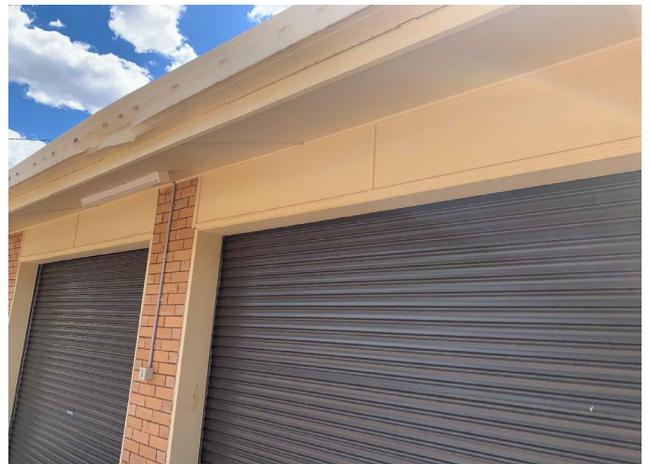
Line ID 29: External, Maintenance Workshop, Garage, East & West Elevations, Eaves Lining & Joinery, Compressed Cement Sheet - Chrysotile Asbestos Detected

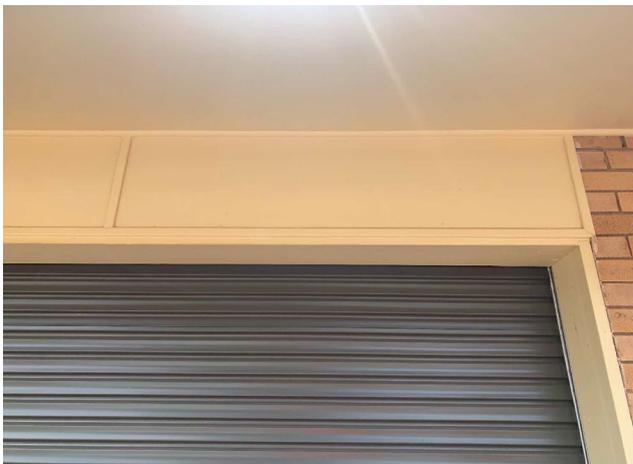
Line ID 30: External, Maintenance Workshop, Garage, Infill Panels above Roller Doors, Compressed Cement Sheet - Chrysotile Asbestos Detected

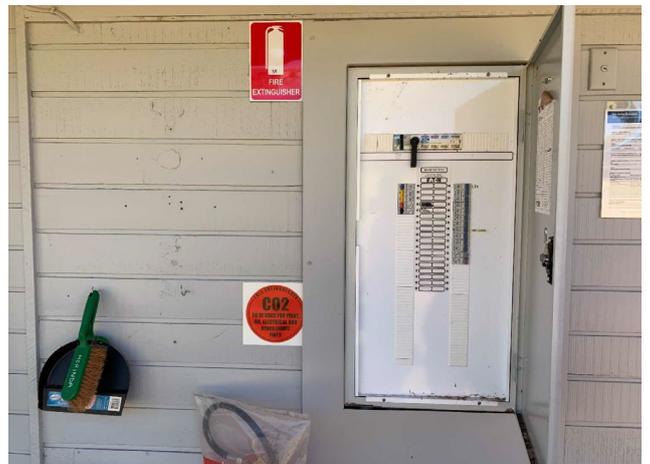
Line ID 31: External, Merinda and Curra Lodge, Elevations, DB3 Cabinet Located SW Corner of Building, Bituminous Electrical Backing Board - Suspected Asbestos

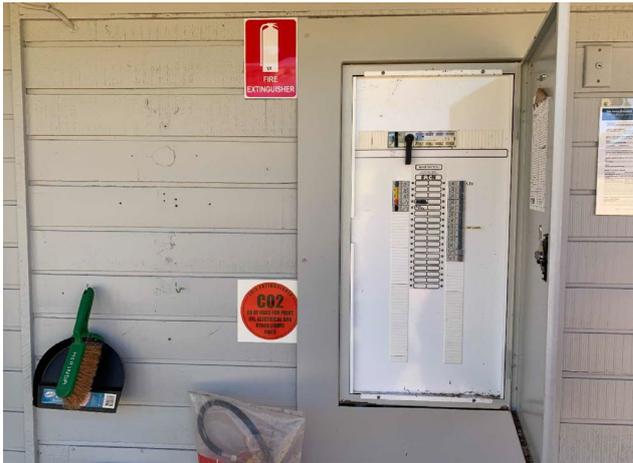
Line ID 34: External, Meroo and Yarraman Lodge, DB3 Cabinet Located SW of Building, Bituminous Electrical Backing Board - Suspected Asbestos

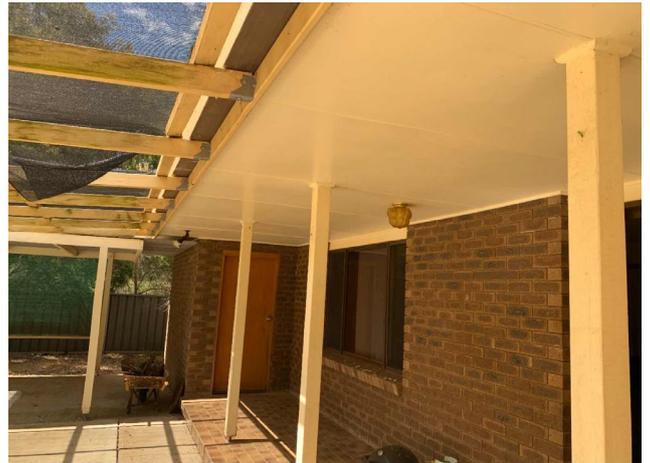
Line ID 38: External, Services Coordinator Residence, Elevations, East (Rear Entry) and West (Main Entry), Compressed Cement Sheet - Chrysotile Asbestos Detected

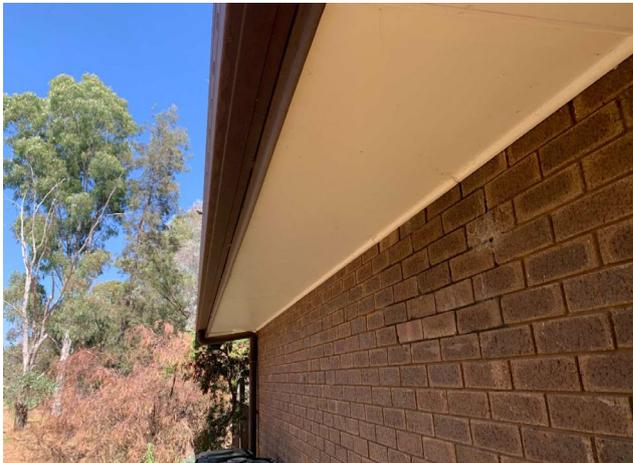
Line ID 39: External, Services Coordinator Residence, Perimeter of Residence, Eaves Lining, Compressed Cement Sheet - Chrysotile Asbestos Detected

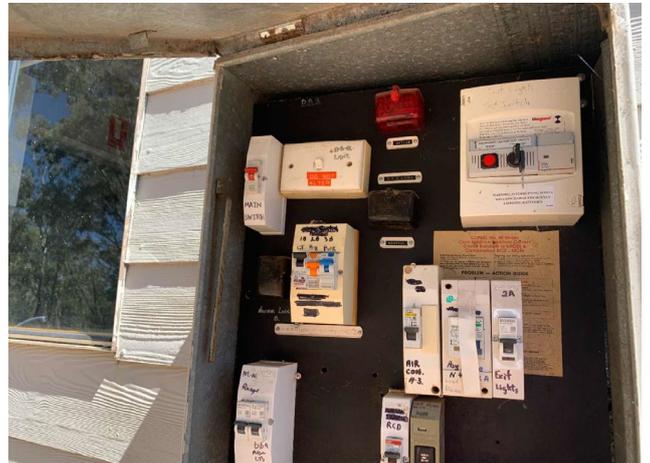
Line ID 40: External, Services Coordinator Residence, Elevations, Within Recessed Metal Box at The SE Corner of The Residence, Bituminous Electrical Backing Board - Chrysotile Asbestos Detected

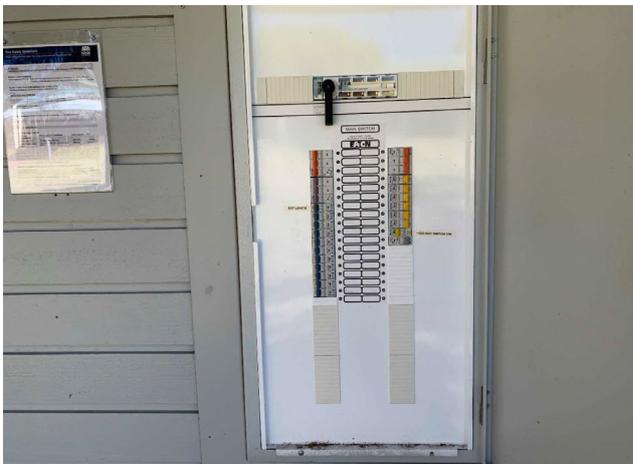
Line ID 46: External, Visiting Staff Rooms, Elevations, DB2 Cabinet Located SW Corner, Bituminous Backing Board - Suspected Asbestos

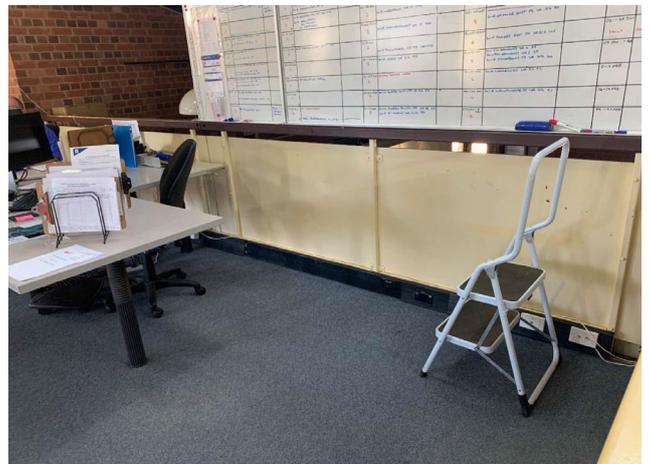
Line ID 49: Internal, Administration Complex, North Section, Balustrade Between Split Levels, Thick Infill Panels, Compressed Cement Sheet - Chrysotile Asbestos Detected

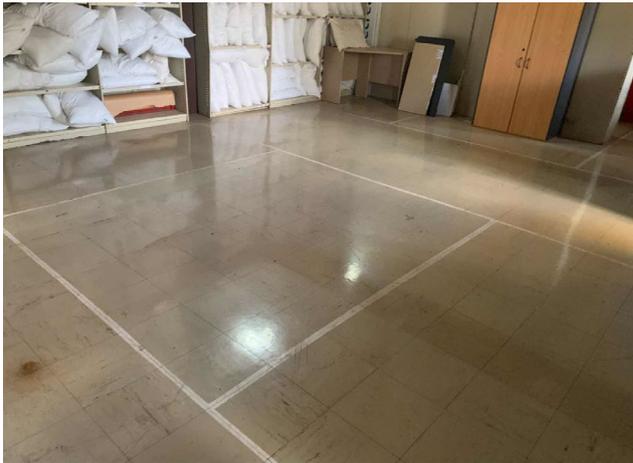
Line ID 50: Internal, Administration Complex, North Section Lower Level Supplies Area, Floor and Steps, Vinyl Floor Tiles Beige With Brown Fleck - Chrysotile Asbestos Detected

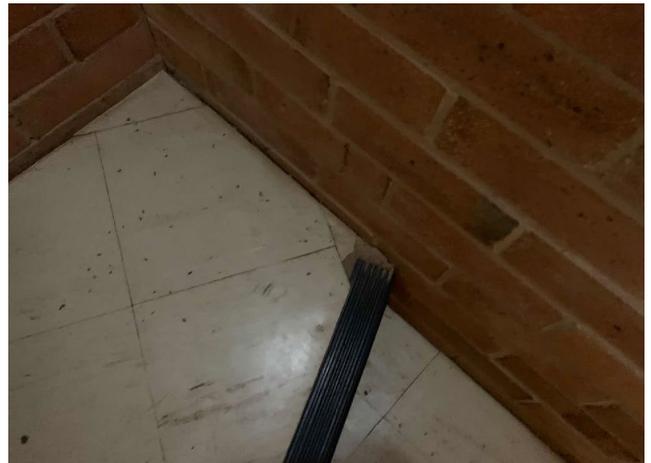
Line ID 51: Internal, Administration Complex, South Section Entry Lobby, Clinic, Shop And Level 1, Below Carpet, Beige With Brown Fleck, Vinyl Floor Tiles - Chrysotile Asbestos Detected

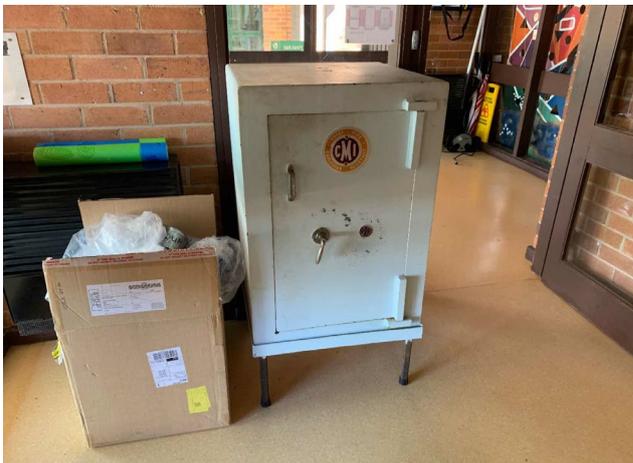
Line ID 52: Internal, Administration Complex, South Section Entry Lobby, Clinic, Shop And Level 1, Within Safe Walls, Internal Insulation - Suspected Asbestos

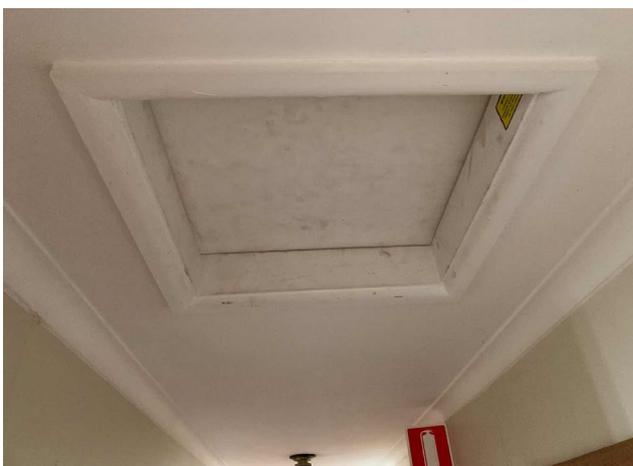
Line ID 55: Internal, Client Services Coordinator Residence, Hallway, Manhole Cover, Compressed Cement Sheet - Chrysotile & Amosite Asbestos Detected

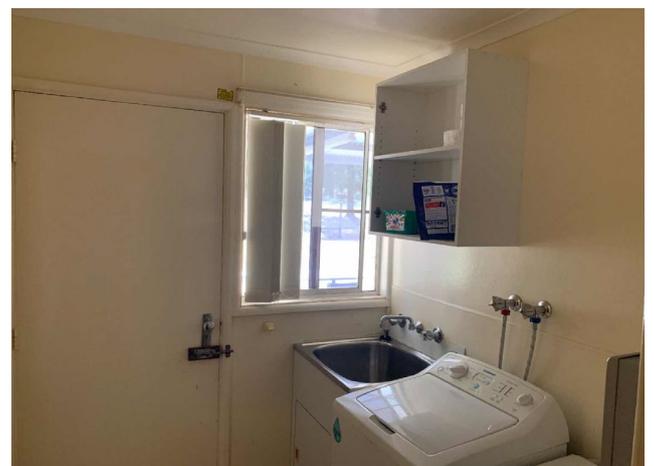
Line ID 56: Internal, Client Services Coordinator Residence, Laundry and Toilet, West Entry, Flat Wall Lining and Joinery, Compressed Cement Sheet - Chrysotile & Amosite Asbestos Detected

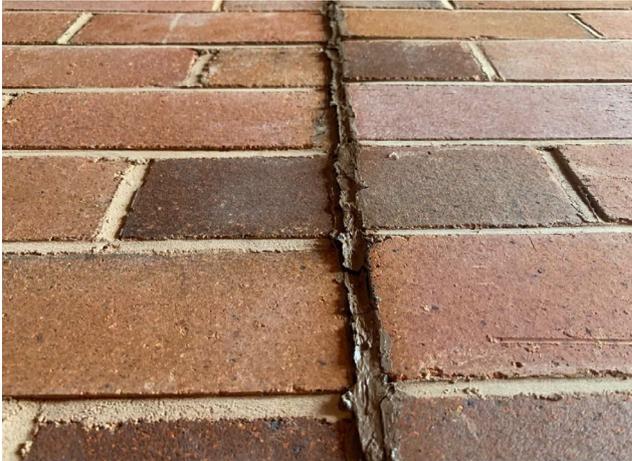
Line ID 61: Internal, Dining Hall Complex, Elevations, Vertical Wall Joints Throughout, Construction Joint Mastic - Chrysotile Asbestos Detected

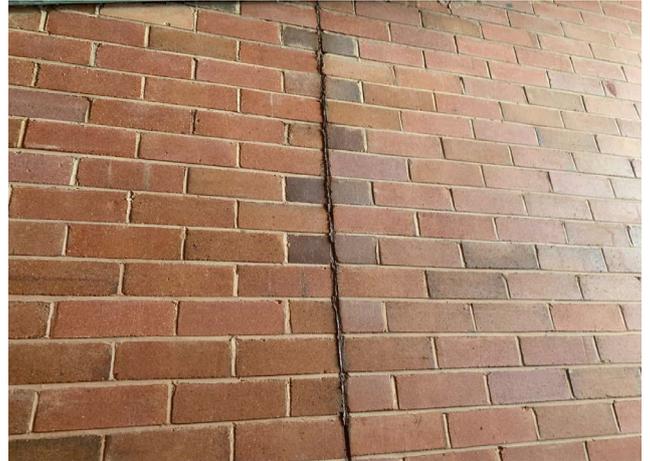
Line ID 61.1: Internal, Dining Hall Complex, Elevations, Vertical Wall Joints Throughout, Construction Joint Mastic - Chrysotile Asbestos Detected

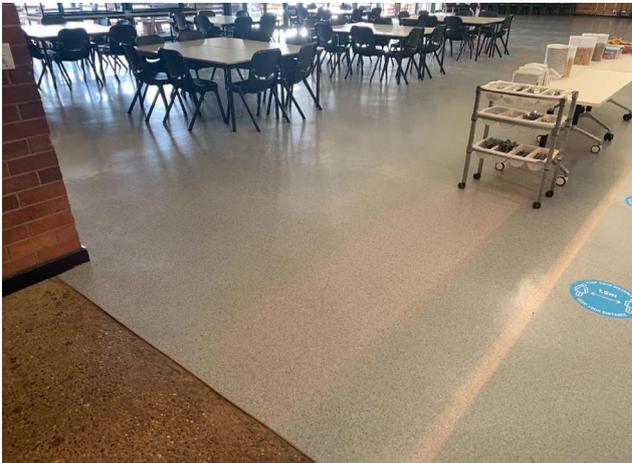
Line ID 62: Internal, Dining Hall Complex, Ground Level Dining Room And Middle Corridor, Below Linoleum Floor Covering, Beige With Brown Color Vinyl Floor Tiles - Chrysotile Asbestos Detected

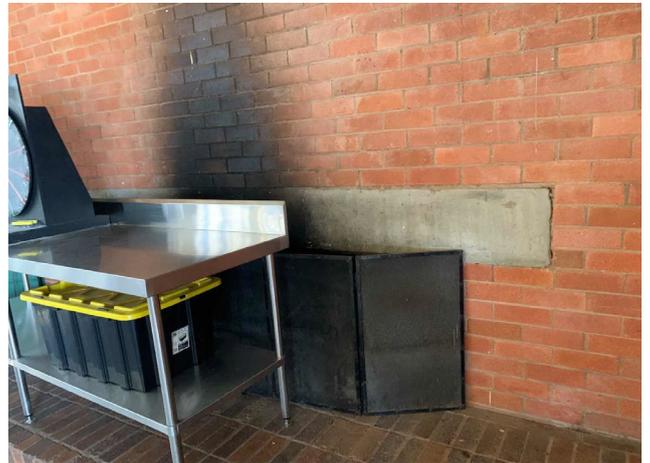
Line ID 63: Internal, Dining Hall Complex, Ground Level Dining Room And Middle Corridor, Within Fire Place and Chimney, Flue, Moulded Fibre Cement - Suspected Asbestos

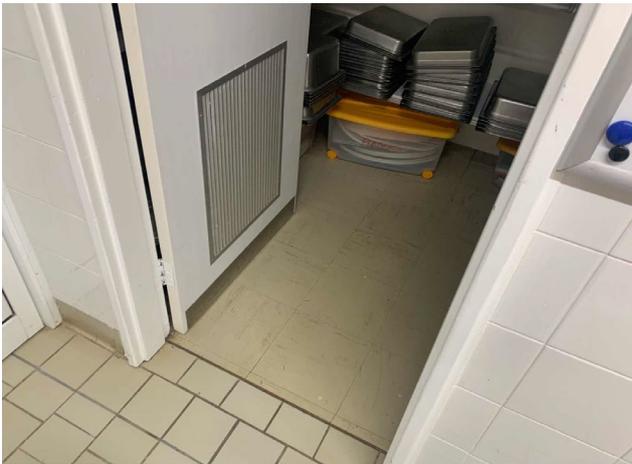
Line ID 64: Internal, Dining Hall Complex, Kitchen Store Rooms And Office, Floor Covering, Vinyl Floor Tiles - Chrysotile Asbestos Detected

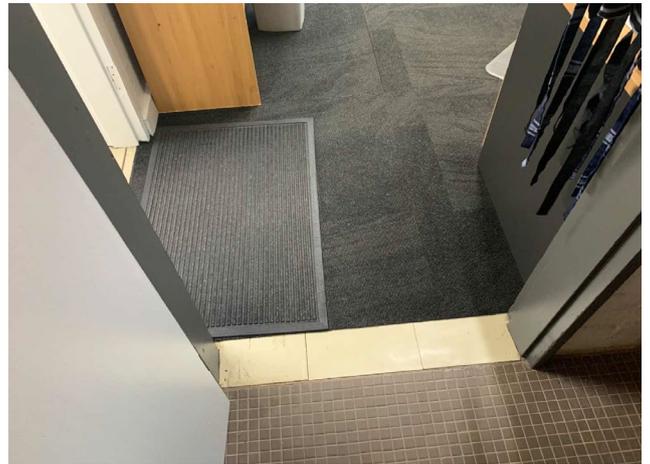
Line ID 64.1: Internal, Dining Hall Complex, Kitchen Store Rooms And Office, Floor Covering, Vinyl Floor Tiles - Chrysotile Asbestos Detected

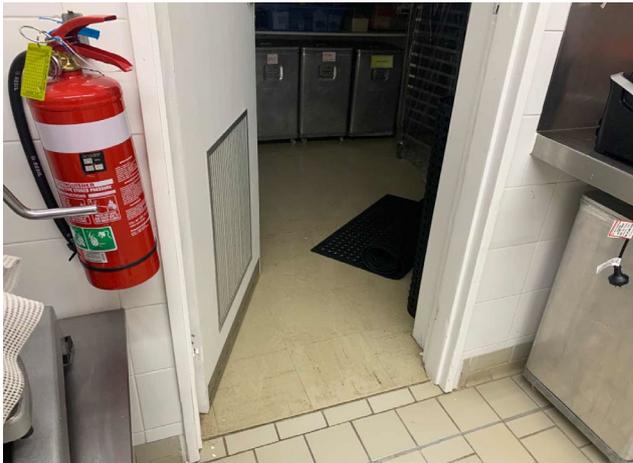
Line ID 64.2: Internal, Dining Hall Complex, Kitchen Store Rooms And Office, Floor Covering, Vinyl Floor Tiles - Chrysotile Asbestos Detected

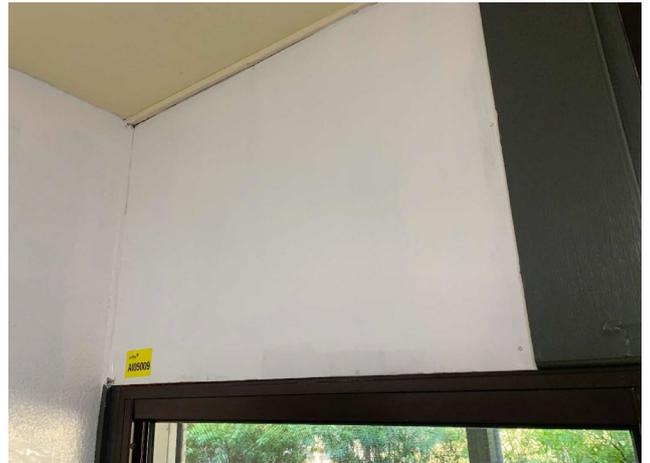
Line ID 65: Internal, Dining Hall Complex, Kitchen Store Rooms And Office, Office, Above West Entry, Panel, Compressed Cement Sheet - No Asbestos Detected

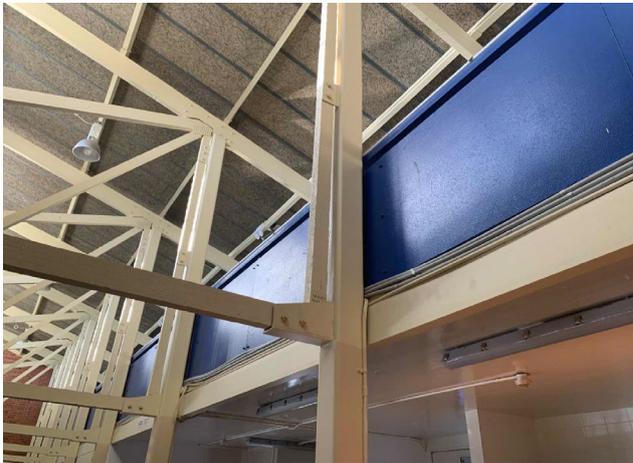
Line ID 66: Internal, Dining Hall Complex, Level 1 Balustrade, Thick Infill Panels, Compressed Cement Sheet - Chrysotile Asbestos Detected

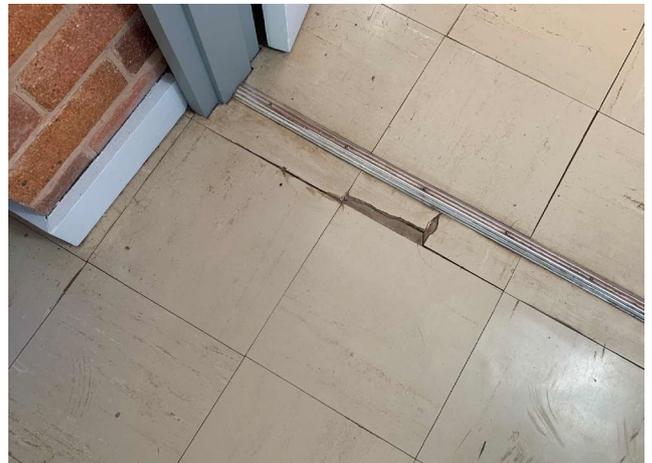
Line ID 67: Internal, Dining Hall Complex, Level 1 Throughout, Floor Covering, Vinyl Floor Tiles (Beige With Brown Fleck) - Chrysotile Asbestos Detected

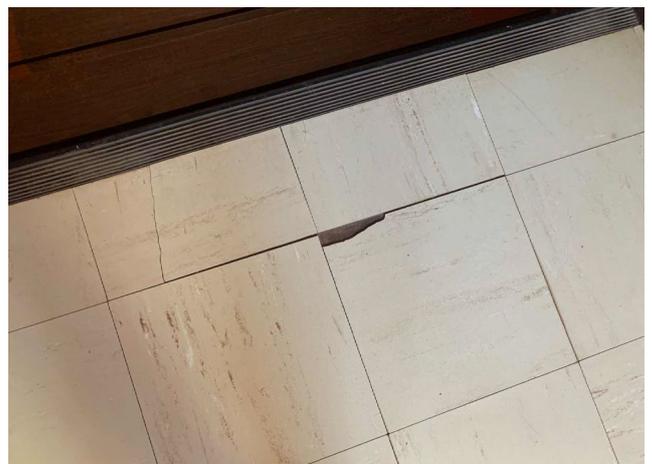
Line ID 67.1: Internal, Dining Hall Complex, Level 1 Throughout, Floor Covering, Vinyl Floor Tiles (Beige With Brown Fleck) - Chrysotile Asbestos Detected

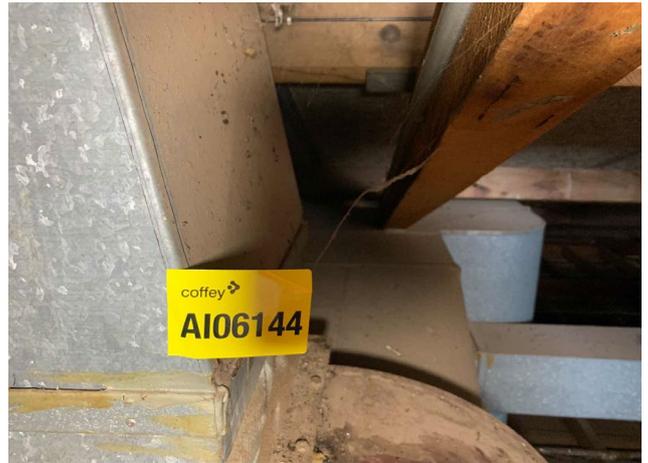
Line ID 68: Internal, Dining Hall Complex, Level 1, West Ceiling Space, Between Ductwork, Fabric Vibration Dampener - No Asbestos Detected

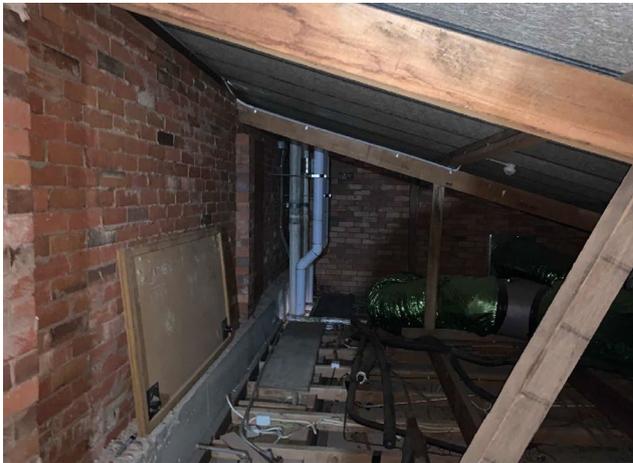
Line ID 69: Internal, Dining Hall Complex, Level 1, West Ceiling Space, Rigid Ductwork, Seams and Flanges, Mastic Sealant - No Asbestos Detected

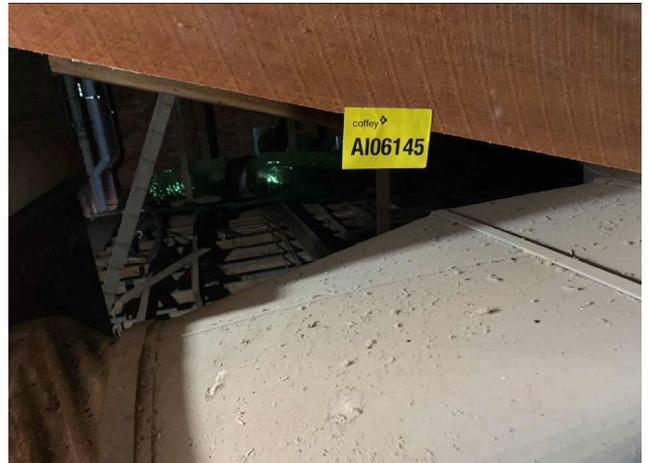
Line ID 70: Internal, Dining Hall Complex, Level 1, West Ceiling Space, South Portion of Ceiling Space, Moulded Fibre Cement - Chrysotile Asbestos Detected

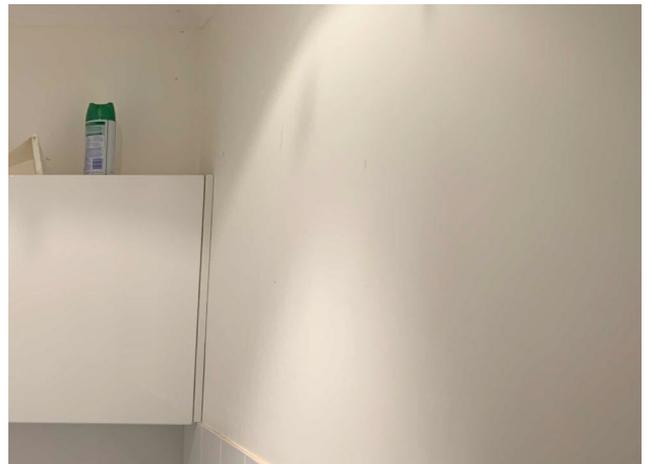
Line ID 78: Internal, General Managers Residence, Laundry, Wall Lining, Compressed Cement Sheet - Chrysotile Asbestos Detected

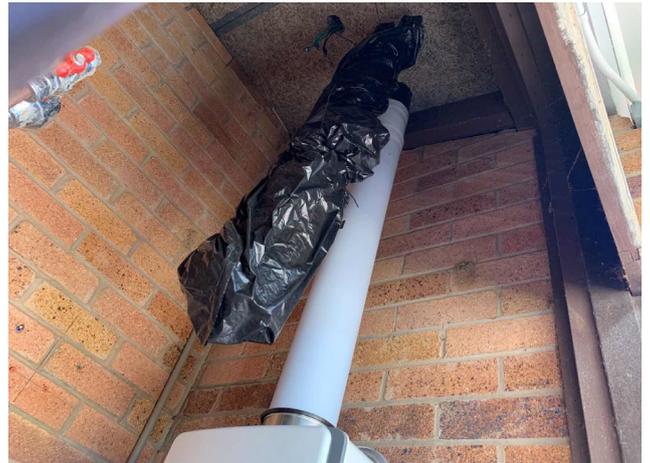
Line ID 80: Internal, Goonal and Mullion Lodge, Utilities Closets, NE And SW Closets, Flue to Hot Water System, Formed AC Flue - Chrysotile & Amosite Asbestos Detected

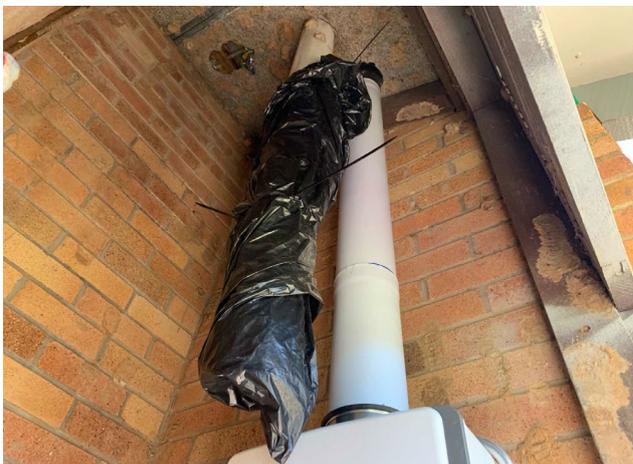
Line ID 80.1: Internal, Goonal and Mullion Lodge, Utilities Closets, NE And SW Closets, Flue to Hot Water System, Formed AC Flue - Chrysotile & Amosite Asbestos Detected

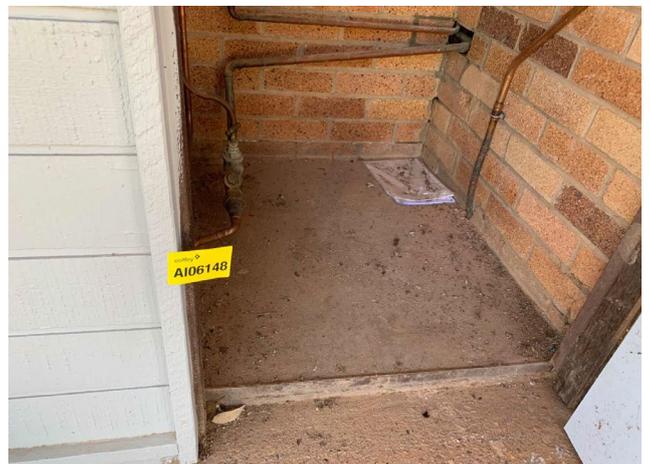
Line ID 81: Internal, Goonal and Mullion Lodge, Utilities Closets, NE And SW Closets, In Base Collar of Hot Water System Flues, Woven Rope - Chrysotile Asbestos Detected

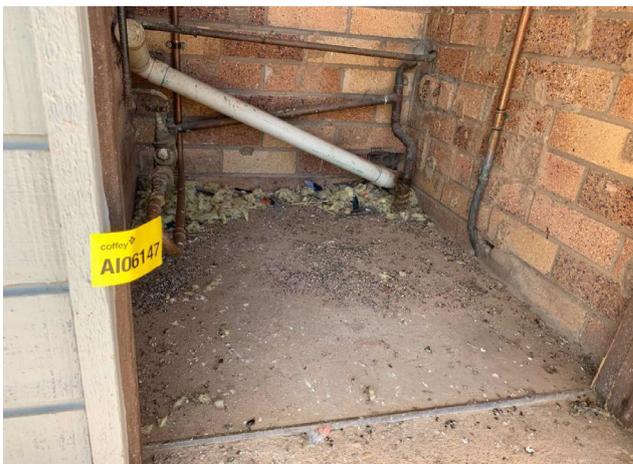
Line ID 82: Internal, Goonal and Mullion Lodge, Utilities Closets, NE Closet, Surfaces Throughout, Dust - No Asbestos Detected

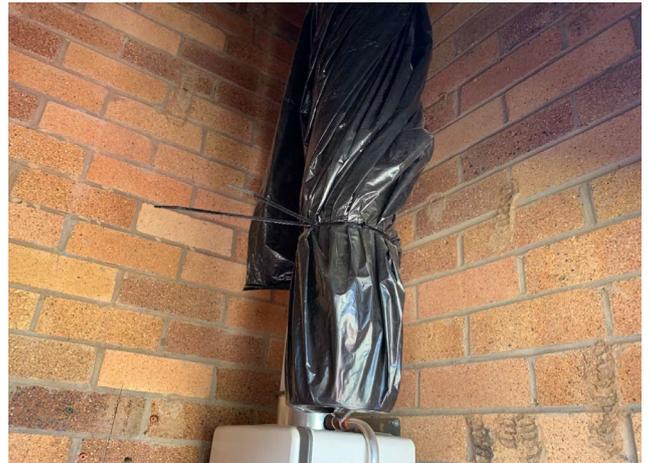
Line ID 105: Internal, Merinda and Curra Gurra Lodge, NE and SW Closets, Hot Water System, Formed Asbestos Cement Flue Pipe - Chrysotile & Amosite Asbestos Detected

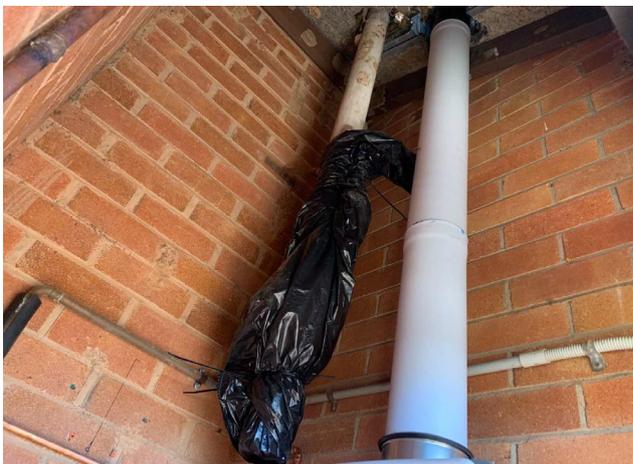
Line ID 105.1: Internal, Merinda and Curra Gurra Lodge, NE and SW Closets, Hot Water System, Formed Asbestos Cement Flue Pipe - Chrysotile & Amosite Asbestos Detected

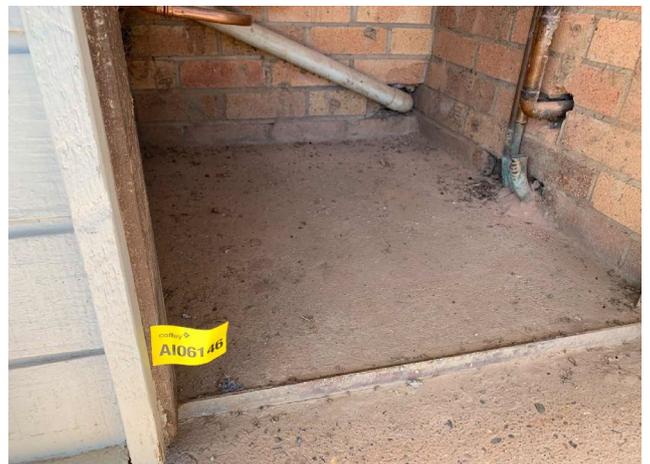
Line ID 106: Internal, Merinda and Curra Gurra Lodge, Utilities Closets, NE and SW Closets, in the Base Collar of Hot Water System Flues, Woven Rope - Chrysotile Asbestos Detected

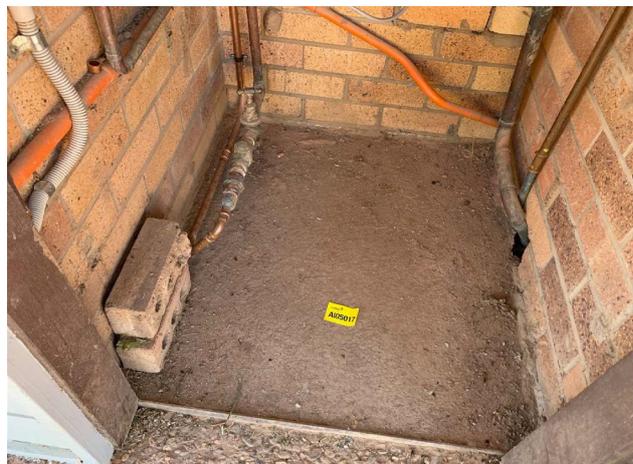
Line ID 107: Internal, Merinda and Curra Gurra Lodge, Utilities Closets, NE Closet, Surfaces Throughout, Dust - No Asbestos Detected

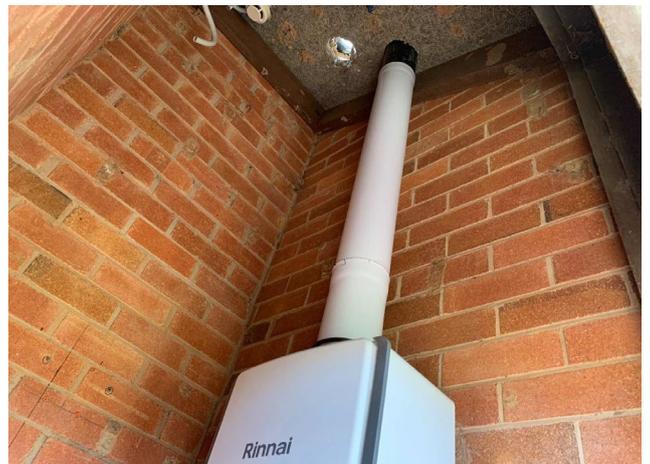
Line ID 108: Internal, Merinda and Curra Gurra Lodge, Utilities Closets, SW Closet, Surfaces Throughout, Dust - No Asbestos Detected

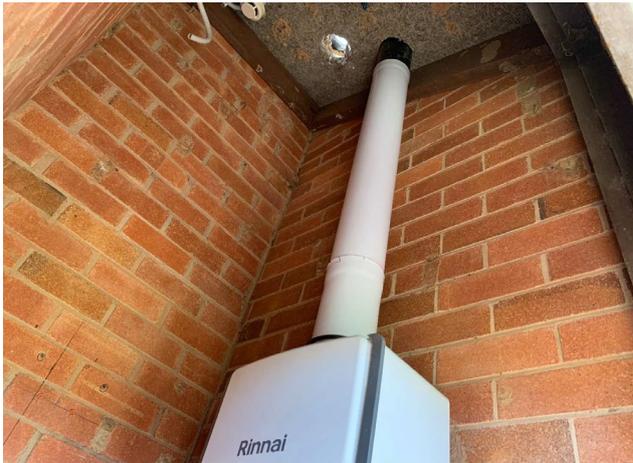
Line ID 111: Internal, Meroo and Yarraman Lodge, Utilities Closets, NE Closet, Formed AC Flue To The Domestic Hot Water System, Asbestos Containing Flue - Removed

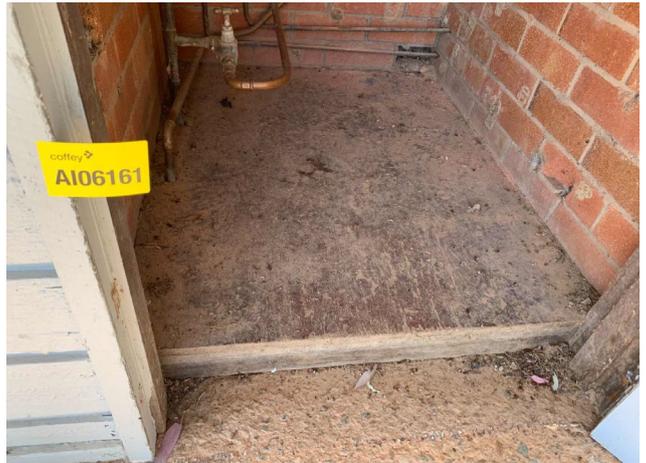
Line ID 112: Internal, Meroo and Yarraman Lodge, Utilities Closets, NE Closet, In Base Collar Of Hot Water System Flues, Woven Rope - Removed

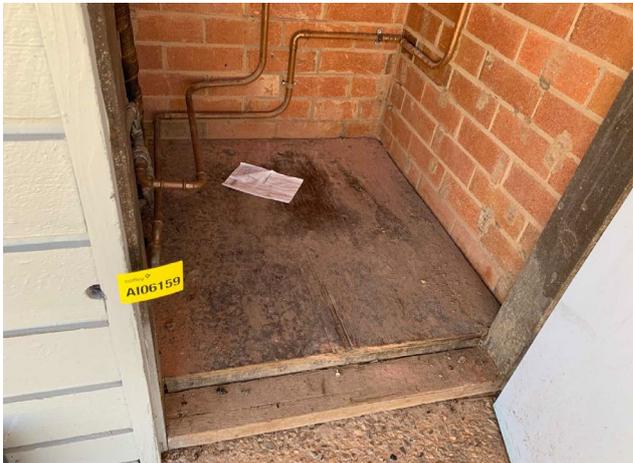
Line ID 113: Internal, Meroo and Yarraman Lodge, Utilities Closets, NE Closet, Surfaces Throughout, Dust - No Asbestos Detected

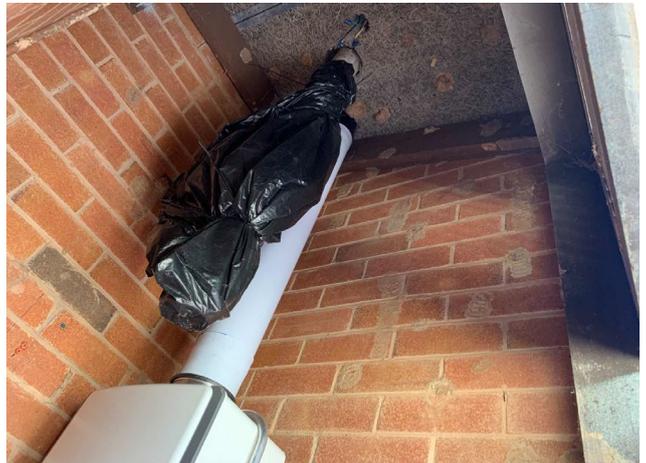
Line ID 114: Internal, Meroo and Yarraman Lodge, Utilities Closets, SE Closet, Surfaces Throughout, Dust - No Asbestos Detected

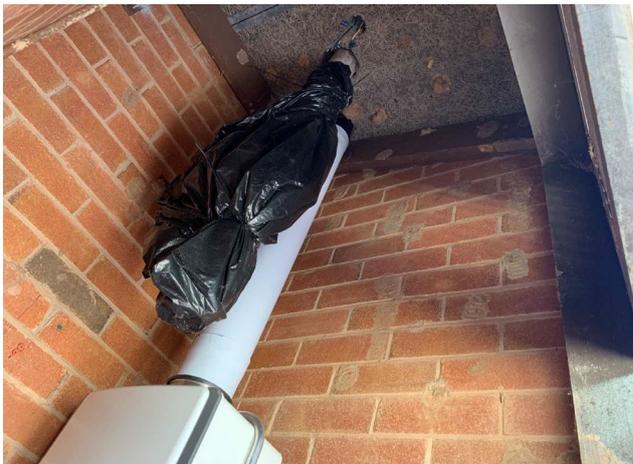
Line ID 115: Internal, Meroo and Yarraman Lodge, Utilities Closets, SW Closet, Domestic Hot Water System, Moulded Cement Flue - Chrysotile Asbestos Detected

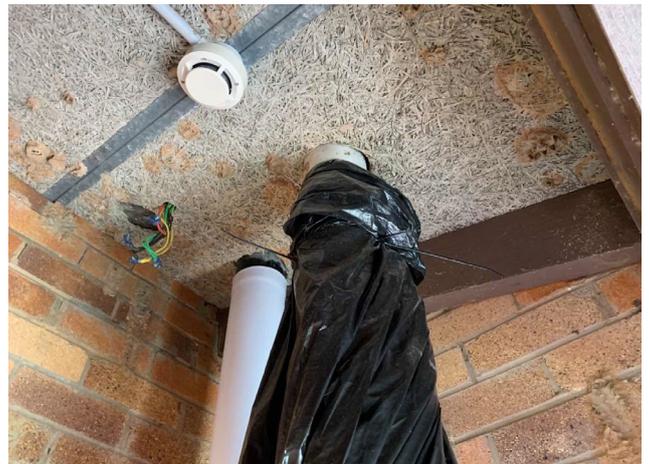
Line ID 124: Internal, Staff Lodge (Staff Residence), Staff Residence, Shower/Toilet Amenities to Units 1-4, Wall Lining, Compressed Cement Sheeting - Suspected Asbestos

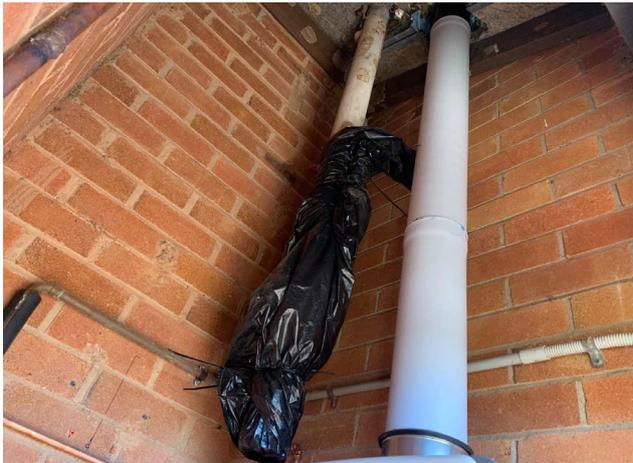
Line ID 128: Internal, Visiting Staff Rooms, Utilities Closets, NE Closet, Base Collar of Hot Water System Flues, Woven Rope Within Flue Pipe - Chrysotile Asbestos Detected

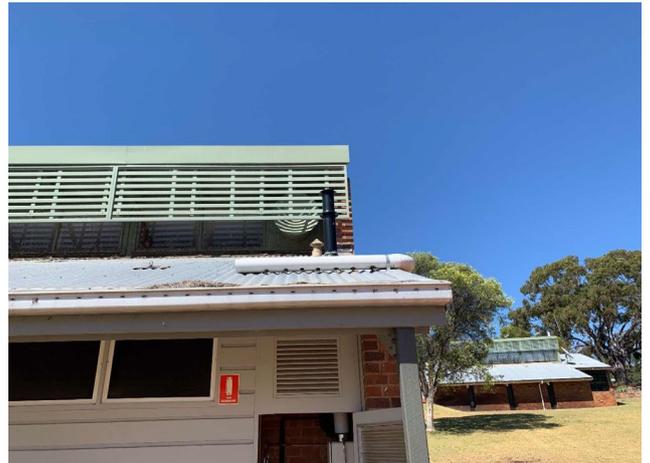
Line ID 129: Internal, Visiting Staff Rooms, Utilities Closets, NE Closet, Domestic Hot Water System, Flue Pipes - Chrysotile & Amosite Asbestos Detected

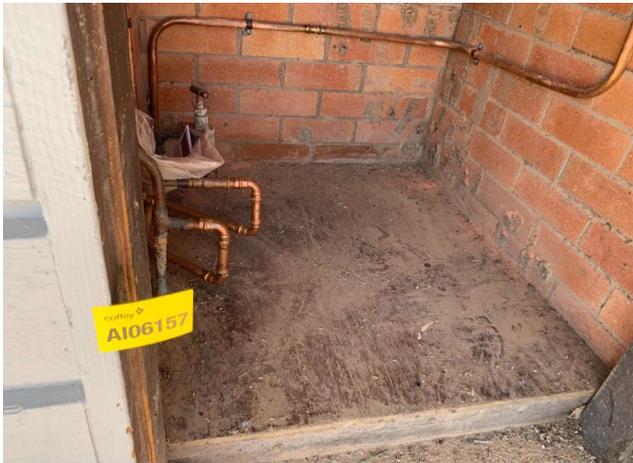
Line ID 129.1: Internal, Visiting Staff Rooms, Utilities Closets, NE Closet, Domestic Hot Water System, Flue Pipes - Chrysotile & Amosite Asbestos Detected

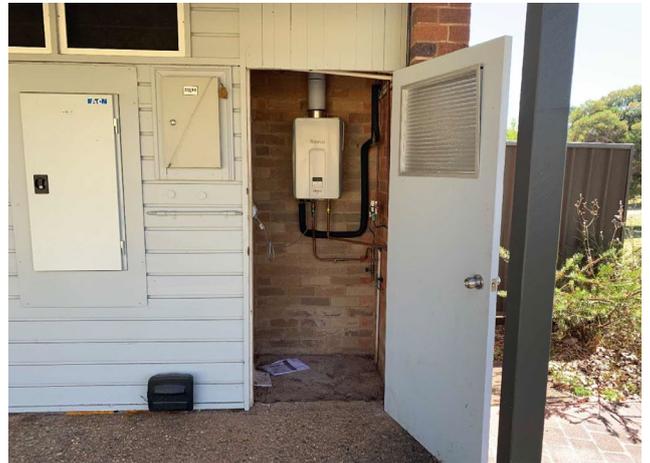
Line ID 130: Internal, Visiting Staff Rooms, Utilities Closets, NE Closet, Throughout Surfaces, Dust - No Asbestos Detected

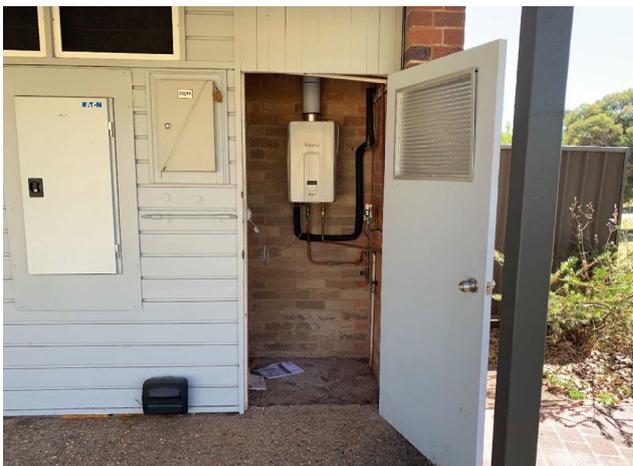
Line ID 131: Internal, Visiting Staff Rooms, Utilities Closets, SW Closet, Flue to The Domestic Hot Water System, Asbestos Containing Flue - Chrysotile & Amosite Asbestos Detected

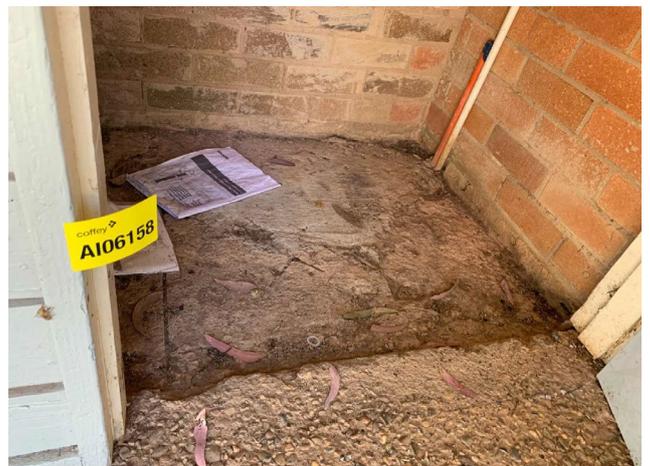
Line ID 132: Internal, Visiting Staff Rooms, Utilities Closets, SW Closet, In Base Collar Of Hot Water System Flues, Woven Rope - No Asbestos Detected

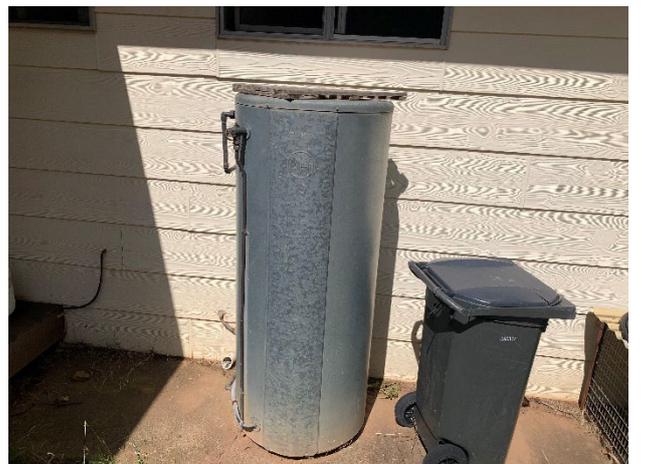
Line ID 139: External, Client Services Coordinator Residence, Residence, West Side, Rheem Domestic Hot Water System, Internal Insulation Material - Suspected SMF

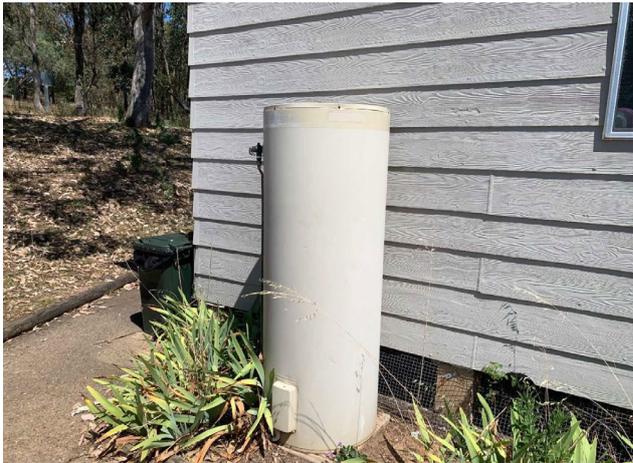
Line ID 140: External, General Managers Residence, Elevations, West Side of Residence (Wall Mounted), Beasley Domestic Hot Water System, Insulation Material - Suspected SMF

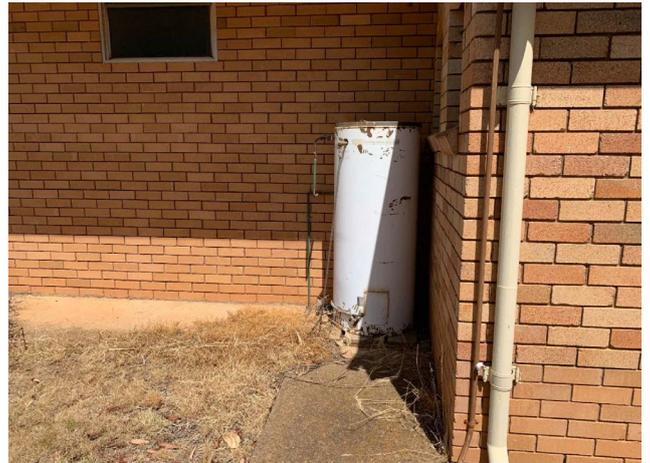
Line ID 141: External, Lakeside Cottages 1 & 2, Elevations, SW Corner, Rheem Domestic Hot Water System, Internal Insulation Material - Suspected SMF
