Asbestos and Hazardous Materials Reinspection Assessment

Lake Burrendong Sport and Recreation Centre

205 Tara Road

08/02/2023

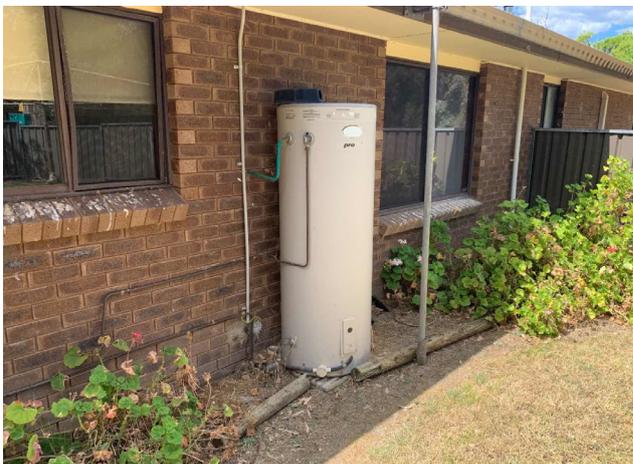
Line ID 142: External, Maintenance Workshop, Garage, West Side, Zip Domestic Hot Water System, Internal Insulation Material - Suspected SMF

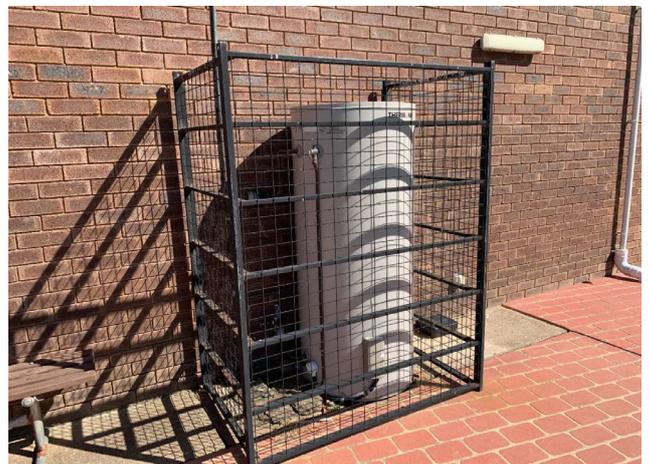
Line ID 143: External, Services Coordinator Residence, Elevations, North Side of Residence, Vulcan Domestic Hot Water System, Internal Insulation Material - Suspected SMF

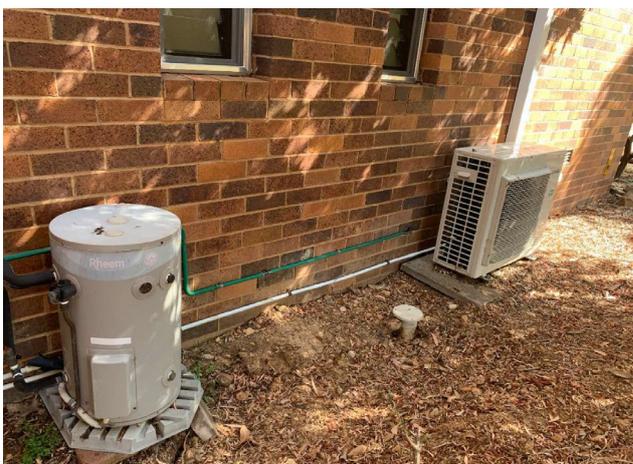
Line ID 146: External, Swimming Pool Complex, Ablutions Building, South Side, Square Hot Water System, Internal Insulation Material - Suspected SMF

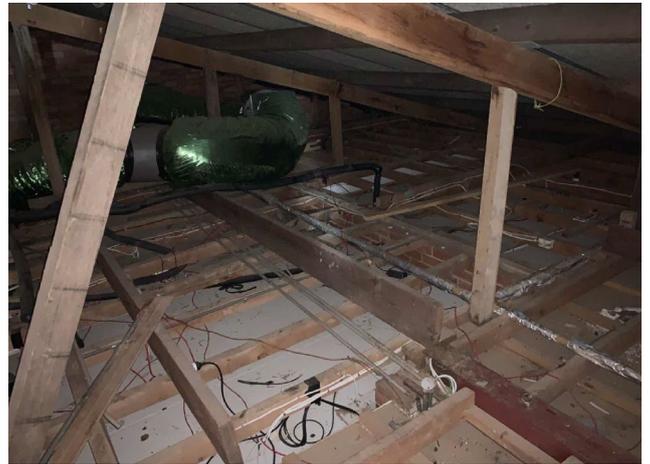
Line ID 153: Internal, Dining Hall Complex, Ceiling Space Above Dining Hall, Hot Water Pipe Work, Foil Wrapped Insulation Material - Suspected SMF

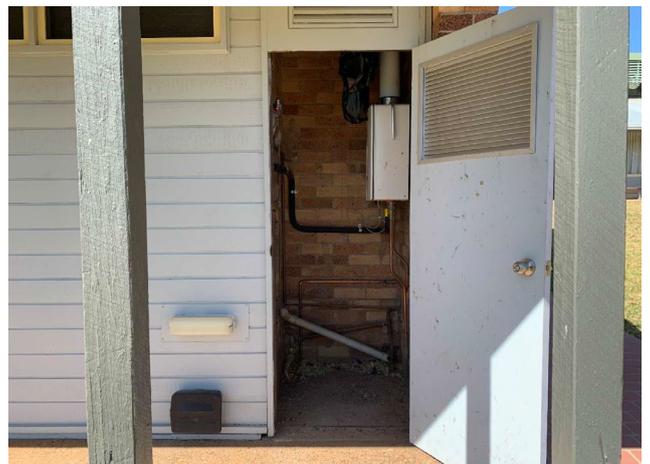
Line ID 162: Internal, Merinda and Curra Gurra Lodge, Utilities Closets, NE and SW Closets, Rheem Hot Water System, Internal Insulation Material - None Suspected

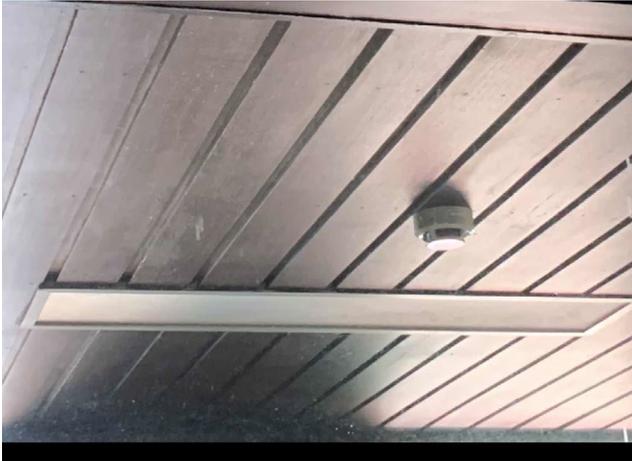
Line ID 170: External, Maintenance Workshop, Garage, East Eaves and Awnings, Twin Long Tube Light, Capacitor(s) - Suspected PCB

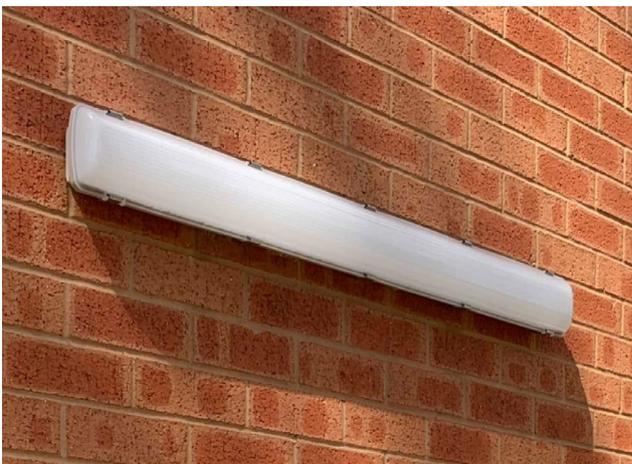
Line ID 178: Internal, Dining Hall Complex, Ceiling Space Above Dining Hall, Ceiling Mounted Fittings Throughout Ground and Level 1, Single Short Tube Lights, Capacitor(s) - PCB Capacitor

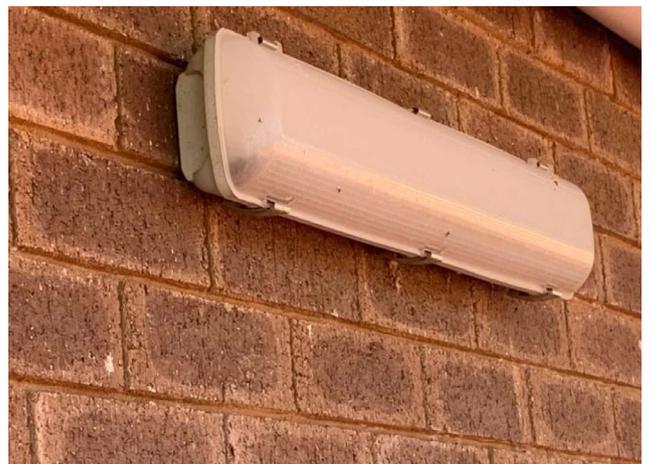
Line ID 179: Internal, Dining Hall Complex, Ceiling Space Above Dining Hall, Ceiling Mounted Fittings Throughout Ground Level, Twin Long Fixtures, Capacitor(s) - PCB Capacitor

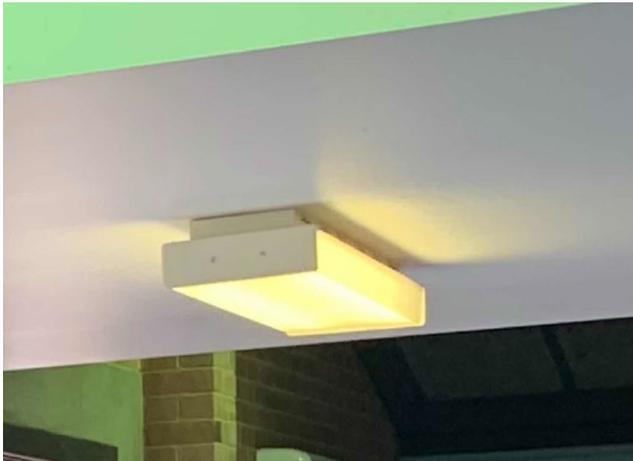
Line ID 181: Internal, Dining Hall Complex, Elevations, Wall Mounted Fittings Throughout, Representative Image Single Short Tube Light Fixtures, Capacitor(s) - PCB Capacitor

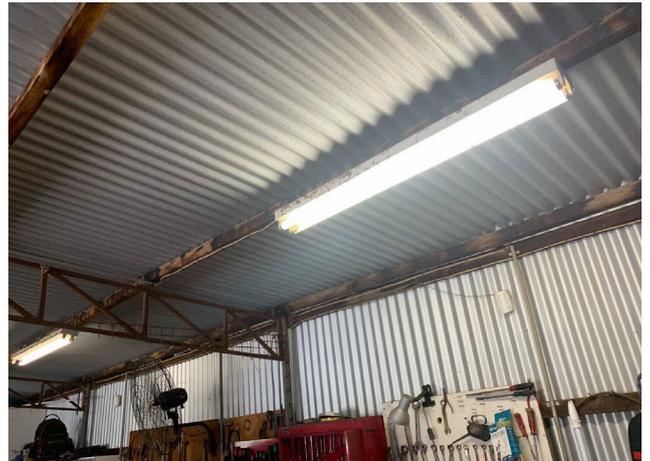
Line ID 182: Internal, Dining Hall Complex, Laundry, Kitchen Office and Freezer Room, Fittings, Triple Long Light Fixture, Capacitor(s) - PCB Capacitor

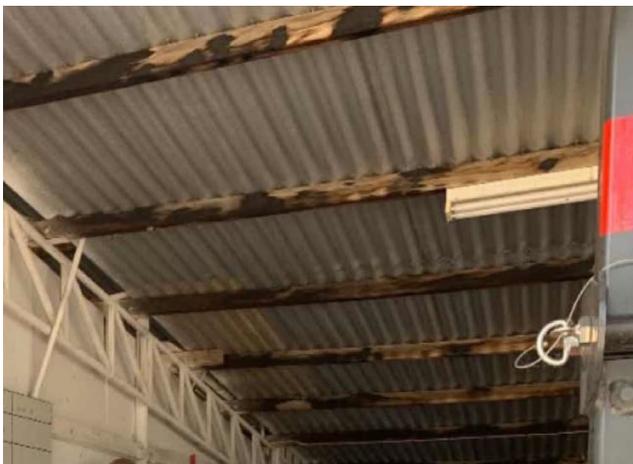
Line ID 186: Internal, Maintenance Workshop, Garage, Storage Room, Twin Long Tube Lights, Capacitor(s) - Suspected PCB

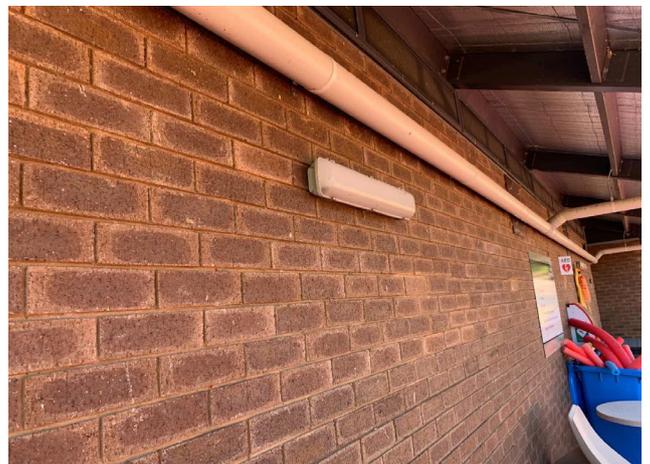
Line ID 189: Internal, Swimming Pool Complex, Pump House and Ablutions Building, Throughout, Single Long Tube Light Fittings, Capacitors - Suspected PCB

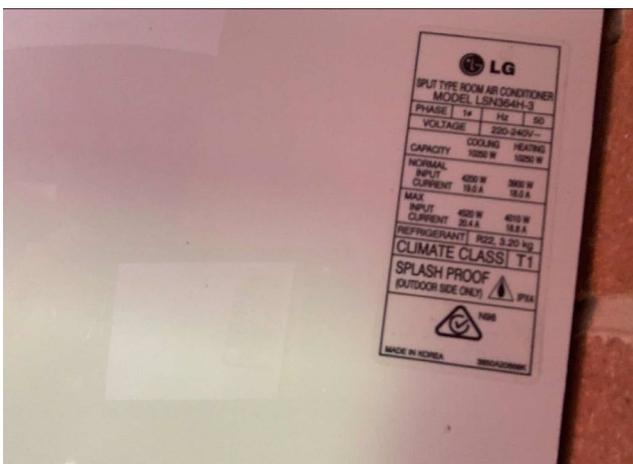
Line ID 190: External, Administration Complex, Elevations, North Side of Complex, Refrigerant Gas to The 'LG' AC Split System, R22 Hydrochlorofluorocarbon (HCFC) - ODS Refrigerant

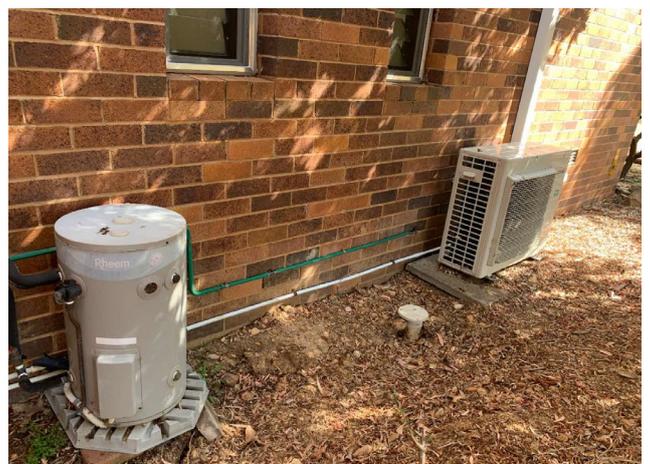
Line ID 191: External, Administration Complex, Elevations, Northwest Garden Area of Complex, R22 Hydrochlorofluorocarbon (HCFC) - ODS Refrigerant

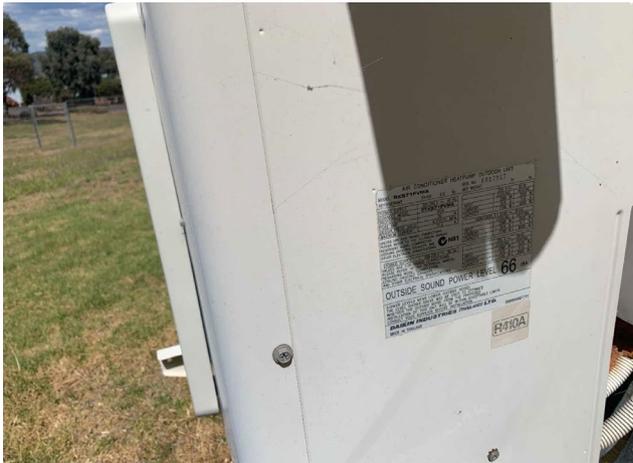
Line ID 192: External, Client Services Coordinator Residence, Residence, West Side, Wall Mounted AC Unit, Non-ODS - Non ODS Refrigerant

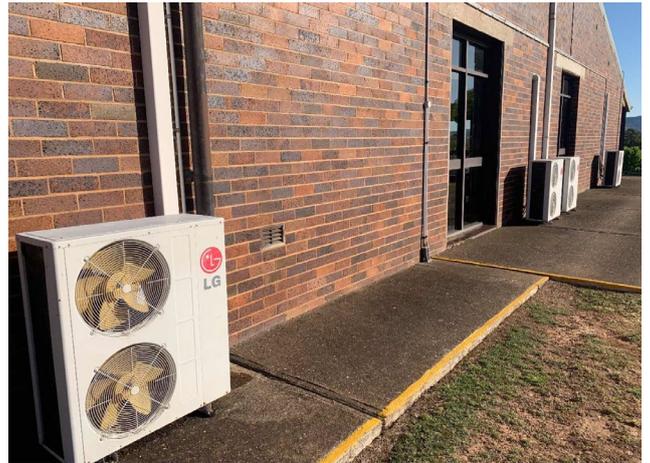
Line ID 193: External, Conference Room Building, North Side, Refrigerant Gas to LG AC Split System, R22 Hydrochlorofluorocarbon (HCFC) - ODS Refrigerant

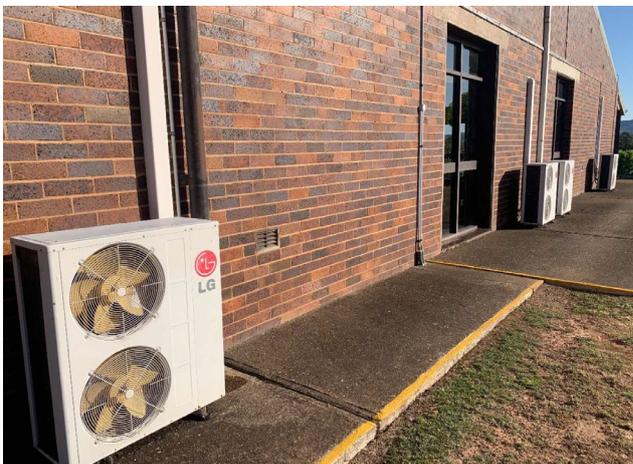
Line ID 194: External, Dining Hall Complex, South Side of Complex, Refrigerant Gas to The 'LG' AC Split System, R22 Hydrochlorofluorocarbon (HCFC) - ODS Refrigerant

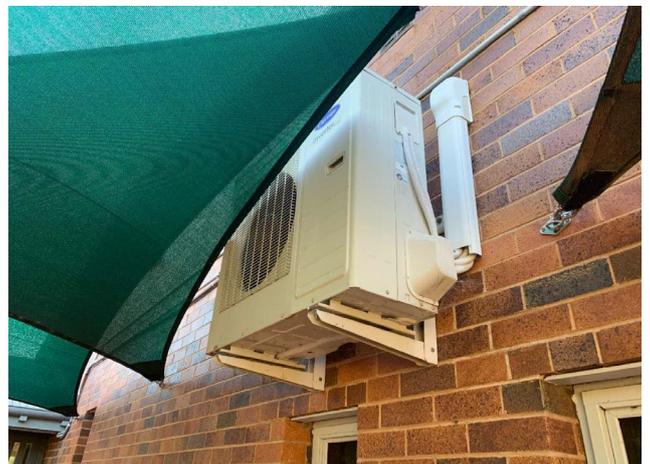
Line ID 197: External, Dining Hall Complex, North Side of Complex, Wall Mounted, Refrigerant Gas to 'Carrier' AC Split System, R22 Hydrochlorofluorocarbon (HCFC) - ODS Refrigerant

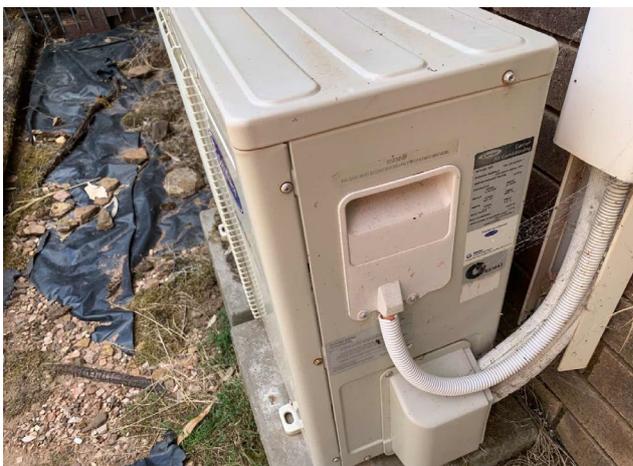
Line ID 198: External, General Managers Residence, East Side, Garden Area, Refrigerant Gas to AC Split System, R410A Hydrofluorocarbon (HFC) - Non ODS Refrigerant

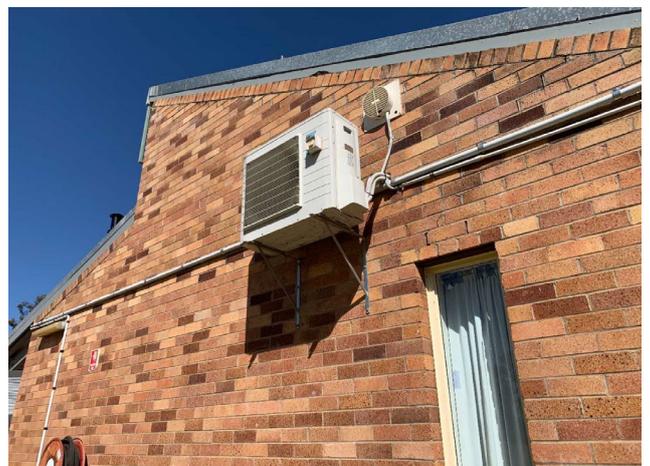
Line ID 206: External, Merinda and Curra Lodge, Elevations, North and South Elevations, Refrigerant Gas to The 'Daikin' AC Units, R22 Hydrochlorofluorocarbon (HCFC) - ODS Refrigerant

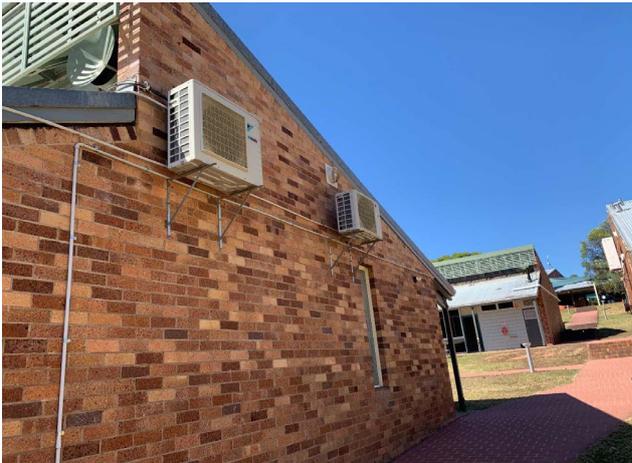
Line ID 207: External, Merinda and Curra Lodge, North and South Side and On Roof and Wall, Within 'LG' Split System, R22 Hydrochlorofluorocarbon (HCFC) - ODS Refrigerant

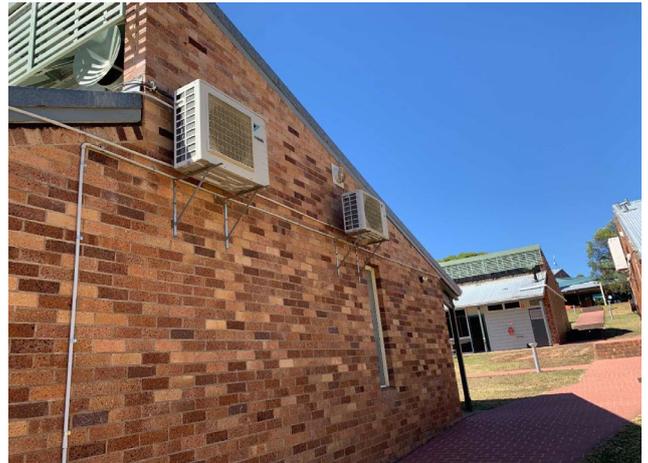
Line ID 208: External, Meroo and Yarraman Lodge, North and South Side and on Roof, Refrigerant Gas to AC System, R22 Hydrochlorofluorocarbon (HCFC) - ODS Refrigerant

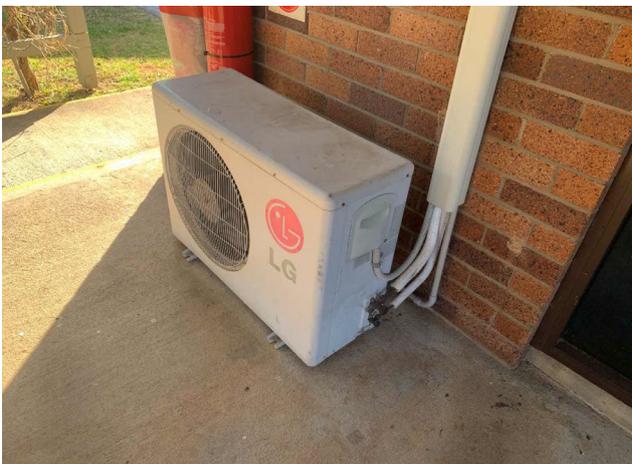
Line ID 209: External, Services Coordinator Residence, Elevations, West Elevation, Refrigerant Gas to the AC System, R22 Hydrochlorofluorocarbon (HCFC) - ODS Refrigerant

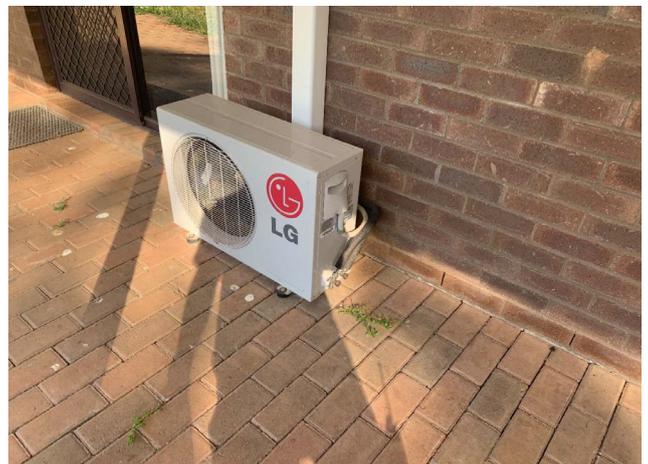
Line ID 210: External, Staff Lodge (Staff Residence), North Side of Building, Refrigerant Gas to AC System, R22 Hydrochlorofluorocarbon (HCFC) - ODS Refrigerant

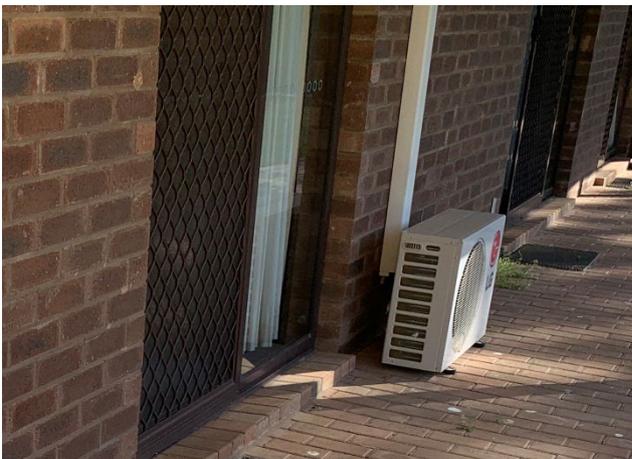
Line ID 211: External, Staff Lodge (Staff Residence), South Side of Building, Refrigerant Gas to 'LG' AC Split System, R22 Hydrochlorofluorocarbon (HCFC) - ODS Refrigerant

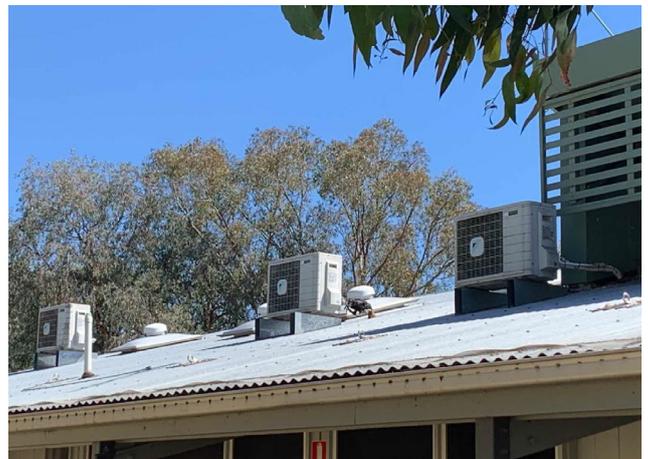
Line ID 212: External, Visiting Staff Rooms, Elevations, Located Adjacent Southern Enclosure, Refrigerant Gas to AC Unit, R22 Hydrochlorofluorocarbon (HCFC) - ODS Refrigerant

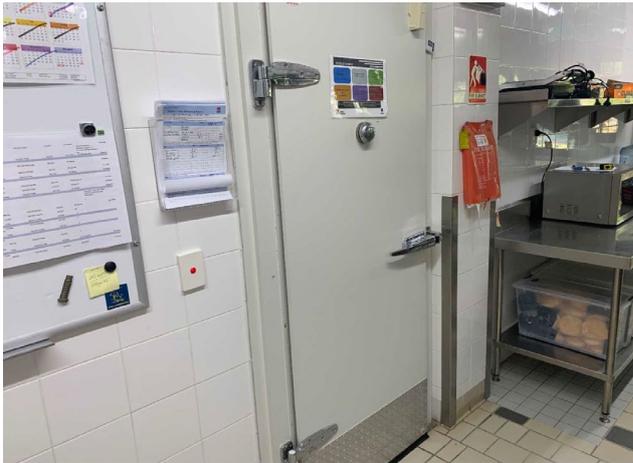
Line ID 215: Internal, Dining Hall Complex, Kitchen Store Rooms And Office, Dining Hall Kitchen Servery Area, Refrigerant Gas to Commercial Fridge, Non-ODS - Non ODS Refrigerant

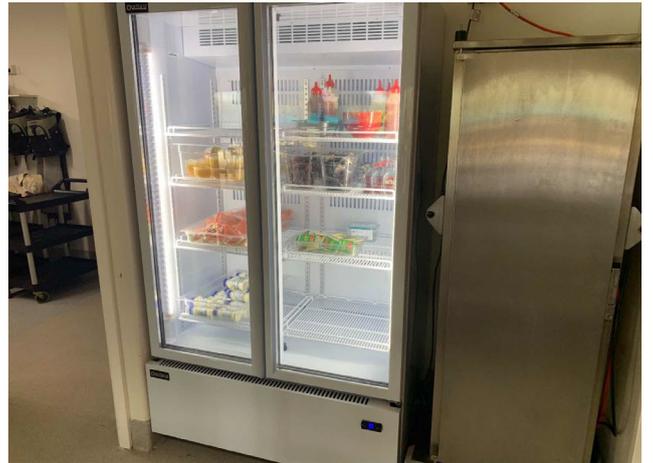
Line ID 216: Internal, Dining Hall Complex, Kitchen Store Rooms And Office, Dining Hall Kitchen, Refrigerant to Gas to The Cool Room and Freezer Compressor, Non-ODS - Non ODS Refrigerant
